# Signal Passed at Danger - Gloucester, NSW

11 March 2008

## Abstract

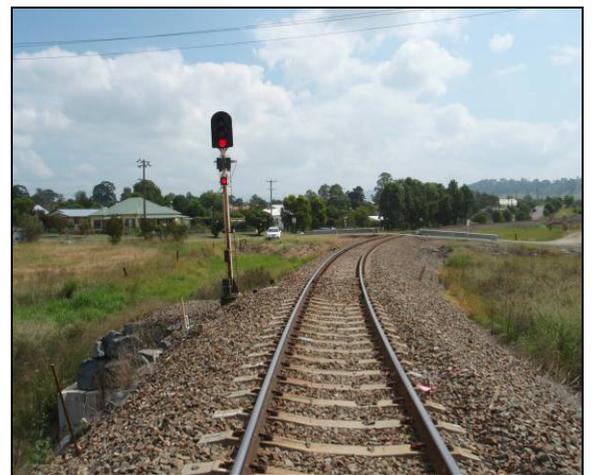
**Figure 1: Outer home signal and Phillips Street level crossing.**

When train 2WB3 came to a halt it was blocking the Phillips Street level crossing 68 m to the north of the outer home signal<sup>9</sup>. As such, the train had to be reversed by about 80 m to clear the level crossing. At 0911 a Special Proceed Authority (SPA) was issued by the network controller that authorised train 2WB3 to set back and clear the road. The driver who was under route tuition then walked to the rear of the train to pilot the reverse movement and by 0931, the train was clear of the Phillips Street level crossing.

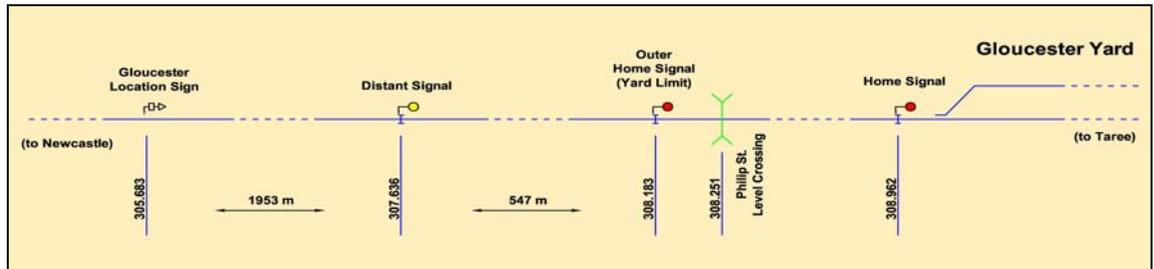
Figure 2: Site diagram

In order to determine the events before and after the SPAD, the data obtained from the data logger of the leading locomotive NR 78 was examined. In the context of this examination it is pertinent to note that there is 547 m between the down distant and the down outer home, the approach to both signals is on a 1:80 down hill grade and that signal sighting distance for the down distant signal in clear weather (day or night) has been estimated at between 200 and 250 metres (see figure two).

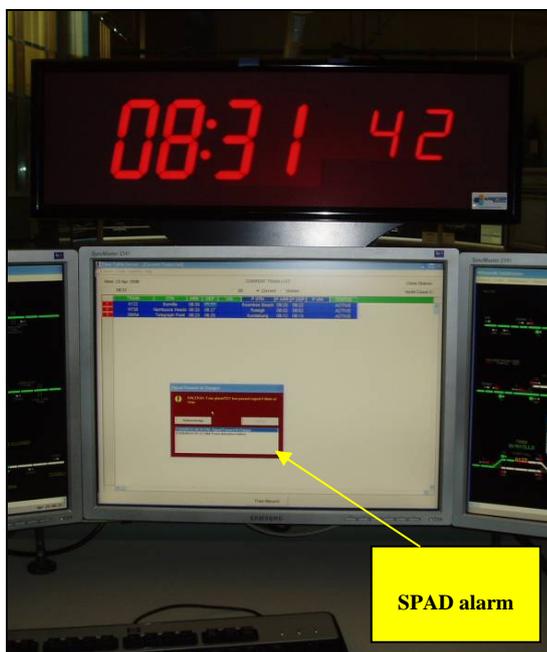
**Figure 3: Example of visual SPAD alarm at Broadmeadow Train Control Centre**

It has been confirmed, both at interview with the network controller and by the examination of the CTC logs, that the SPAD alarm operated as intended at 0750:10. At 0750:32 the network controller answered a call from a track worker requesting the fulfilment of the TOA between Gloucester and Bulliac that was granted at 0643. The TOA was fulfilled at 0750:39 (recorded by the network controller as 0750:00) and the transmission between the track worker and the network controller finished at 0751:36. At 0753:13 the network controller answered the call from train 2WB3 and, 11 seconds later at 0753:24, was told by the driver that they had passed the outer home signal at Gloucester at stop. This was 3 minutes and 14 seconds after the SPAD.

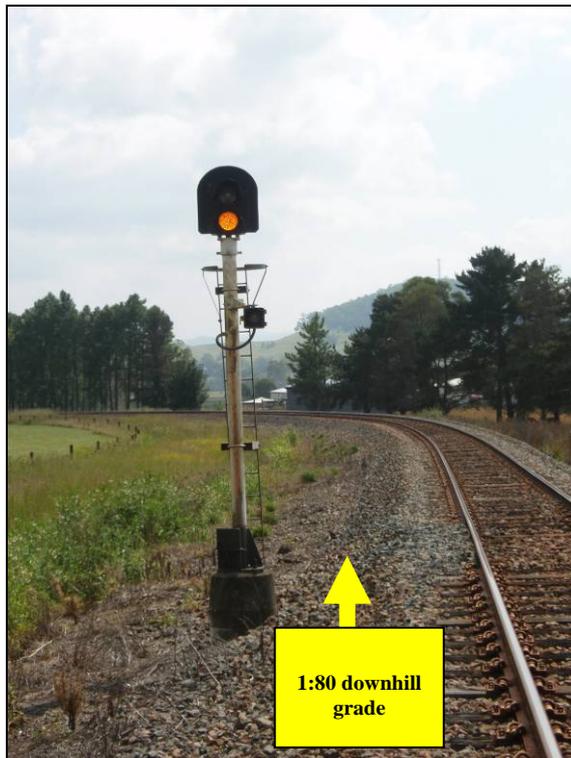
Figure 4: Down distant signal at Gloucester

Distant signals are provided to give an advance indication of what the outer home or home signal is displaying. A colour light distant signal can display a green (clear) or yellow (restricted) indication only. A three position home or outer home signal can display a green, yellow or red (stop) indication. If a distant signal is green, the driver knows that the next signal in advance will be showing a proceed aspect. If yellow, the

driver knows that the next signal in advance may be at stop. The distant signal is the only advance indication that the train driver receives of what aspect an outer home or home signal may be displaying.

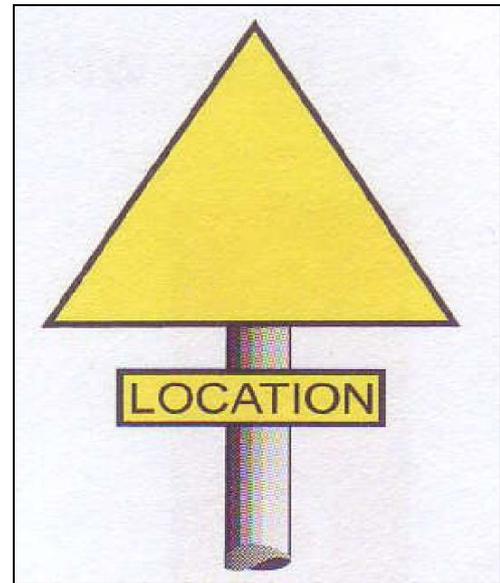
Figure 5: Example of a location sign

Location signs are currently provided at Gloucester, 2.5 km from the Up and Down outer home signals.

Other than indicating that the train is approaching a signalled location (in RVD territory), the wording of rule ANSG 606 seems unclear. For example, regardless of whether a location board is present or not, trains must always be driven while being prepared to respond to the next signal. The train is then driven according to the indication of that signal. This is a basic safeworking premise.

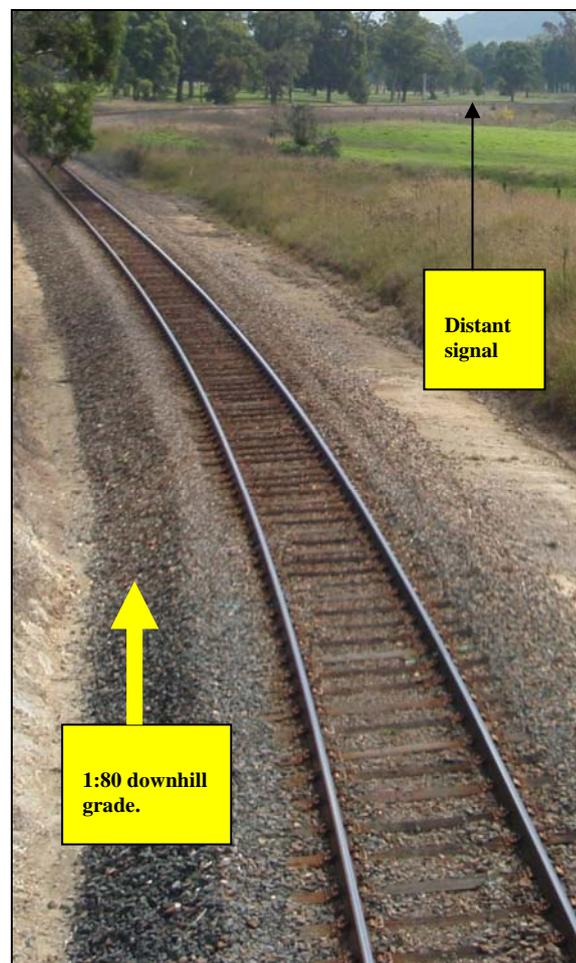
Figure 6: Approach to the Down distant signal at Gloucester

Of note is that track and signal diagrams and route standards documentation refer to a 55 km/h advisory speed sign being located 374 m south of the Down distant signal at Gloucester. However, this advisory speed sign was removed some time before the ARTC took over the management of the corridor in September 2004. Evidence from drivers who had worked this corridor since the 1990s confirmed that this advisory speed sign was in place some years ago.

The provision (previously) of an advisory speed sign 374 m from the Down distant signal at Gloucester would imply that the sum of the sighting distance of the Down distant signal and the distance between the distant and outer home signals (200 - 250 m + 547 m) was not considered to be within 'braking distance' for larger freight trains travelling at the permitted track speed of 70 km/h.
