Independent Investigation Report

Collision Indian Pacific Passenger Train 3AP88 and Freight Train 3PW4N

Zanthus, WA

18 August 1999

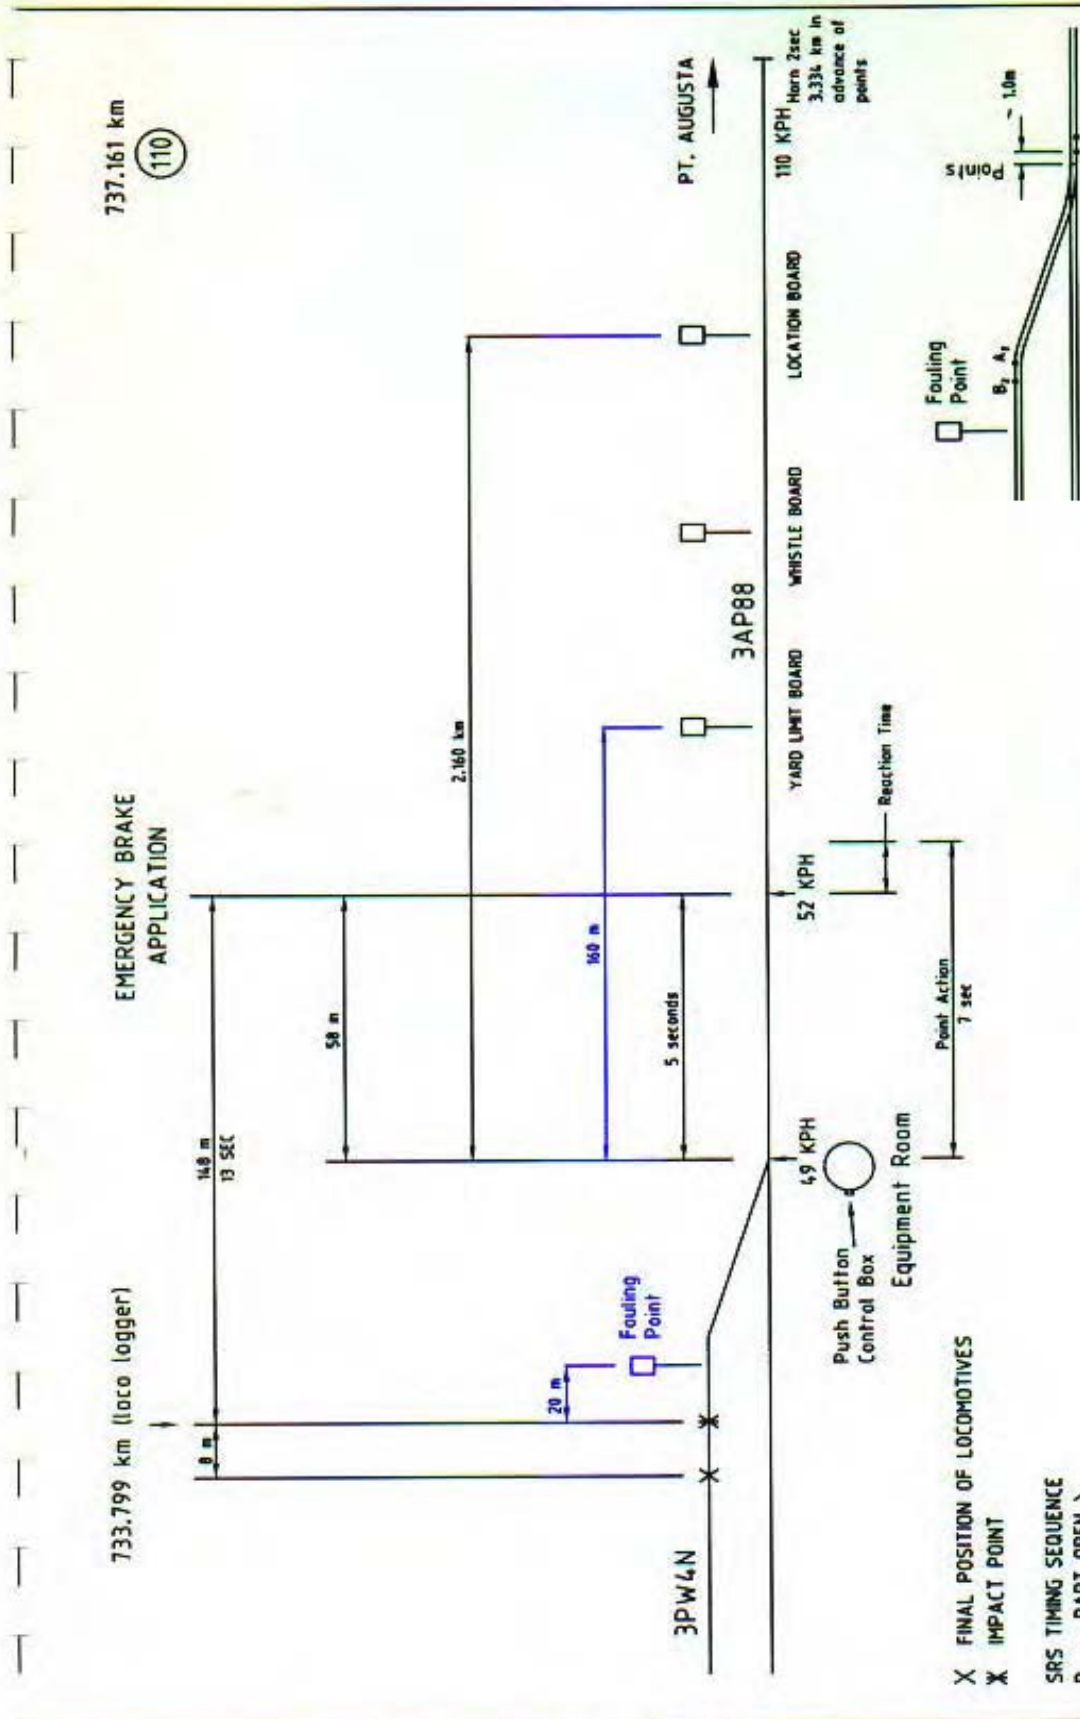
FIGURE 2
Diagrammatic Representation
of Data Logger Information

X FINAL POSITION OF LOCOMOTIVES
 X IMPACT POINT

SRS TIMING SEQUENCE
 R - PART OPEN \ /
 R - O
 N-R EST 6
 N 0/7

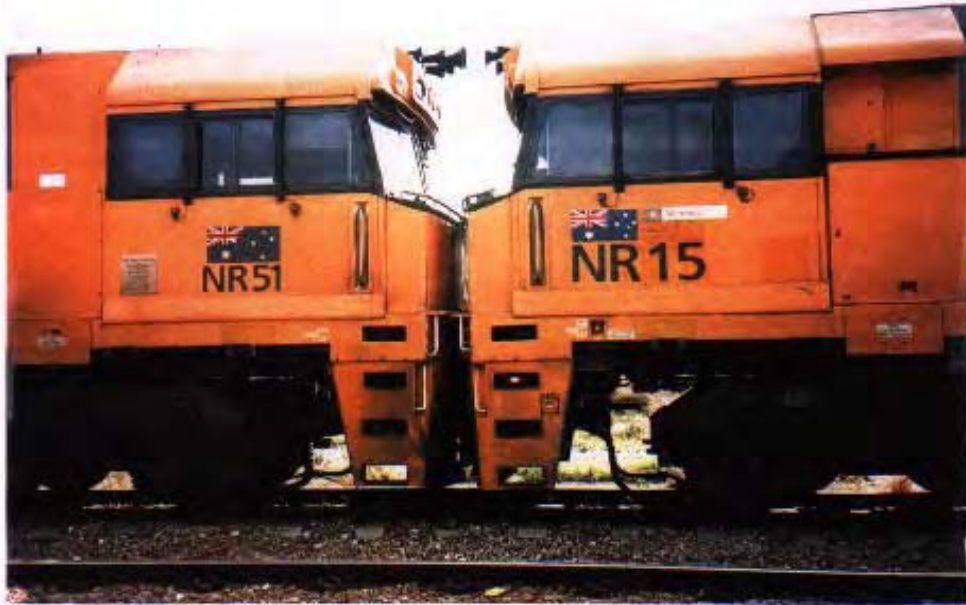
Figure 3: Locomotive NR51 and NR15 'nose to nose'.

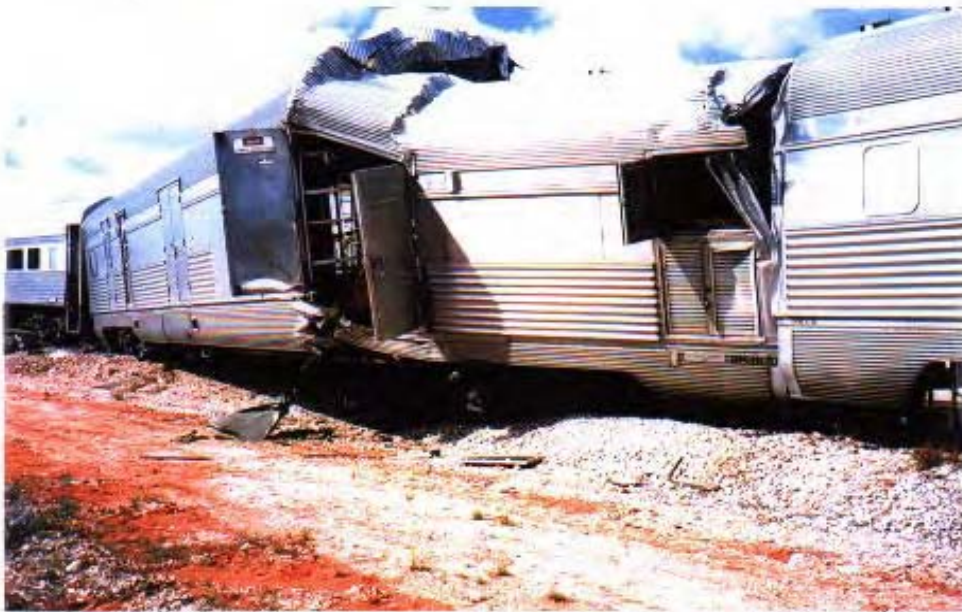
Damage to Great Southern Railway passenger vehicles occurred in varying degrees of severity to all 19 coaches from minor internal damage to severe under carriage damage and write off of one luggage/smoking lounge car. Great Southern Railway have advised that estimated damage cost to coaches is \$5.0 million, however, this is not expected to be finalised for about three months.

Figure 4: Damage to IP Coach HM311

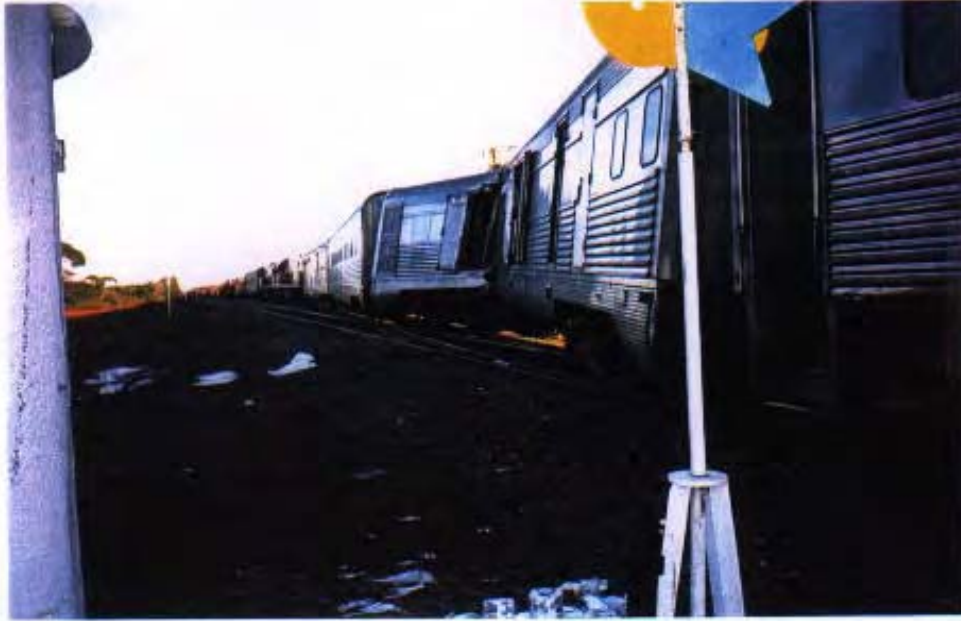
Figure 5: Damage to IP Coach HM311 positioned on turnout.

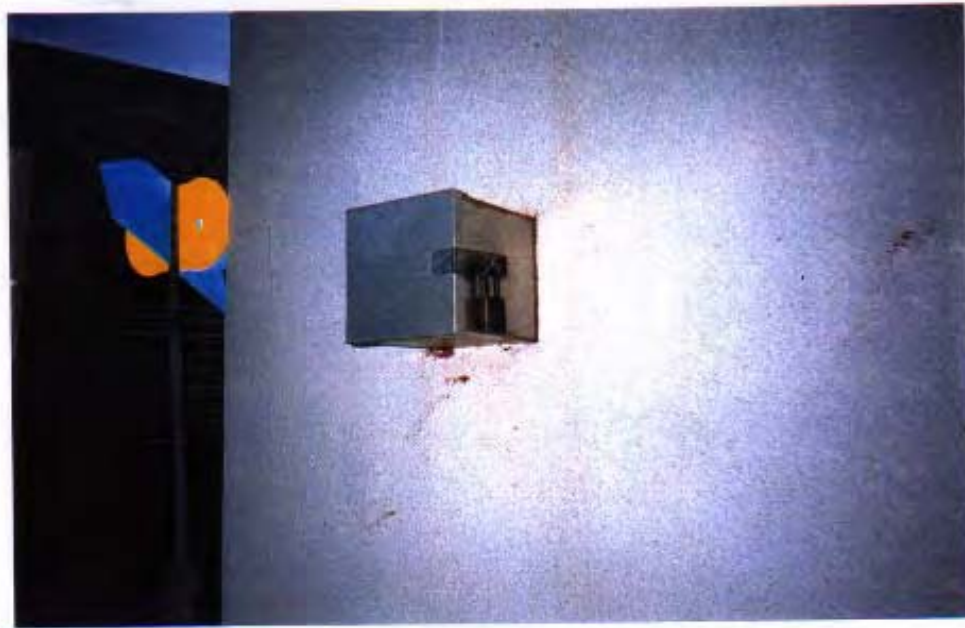
Figure 6: View of locked push button control box and yellow dumb bell indicating points set for loop

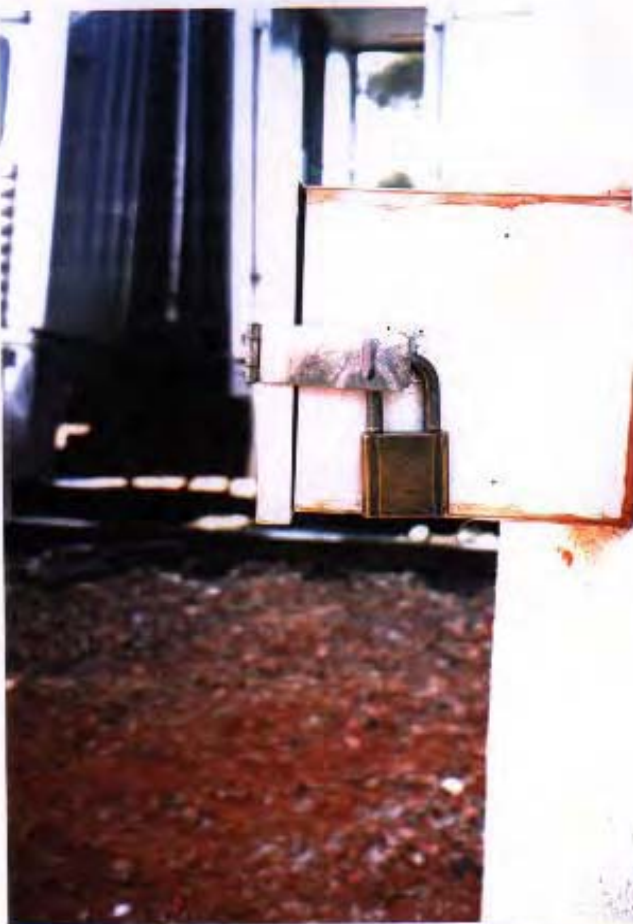
Figure 7:

Open push button control box on side of equipment room. As found on arrival of company representatives 19-08-1999

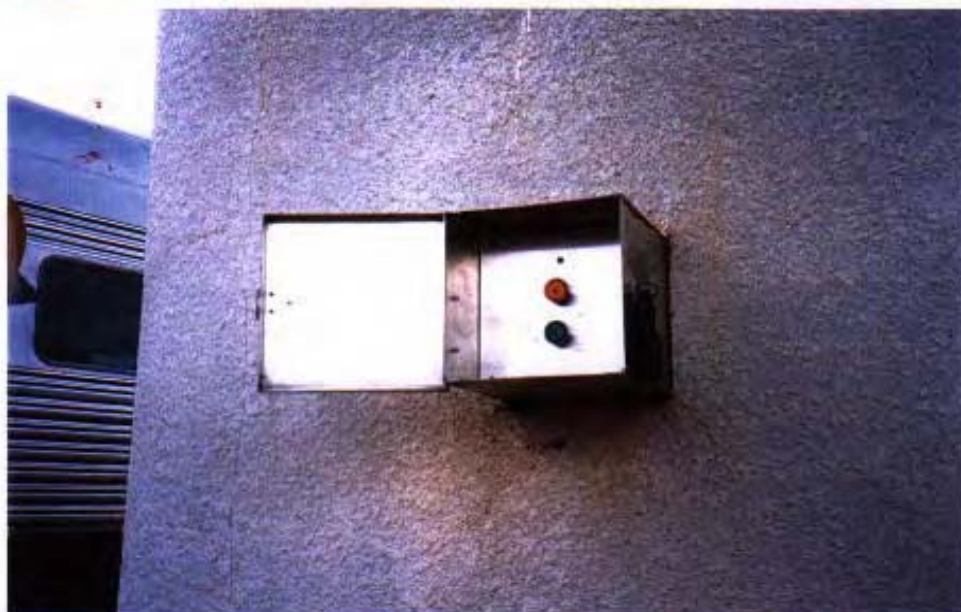
In common with most accidents, the collision at Zanthus involved an active failure committed by a person. This was the error of pushing the points reverse button as the Indian Pacific was approaching the main line facing points. Almost certainly, the driver intended to open the push button control box and then wait for the train to pass before pushing the points reverse button.

Figure 8: Push button controls for normal and reverse setting of points.

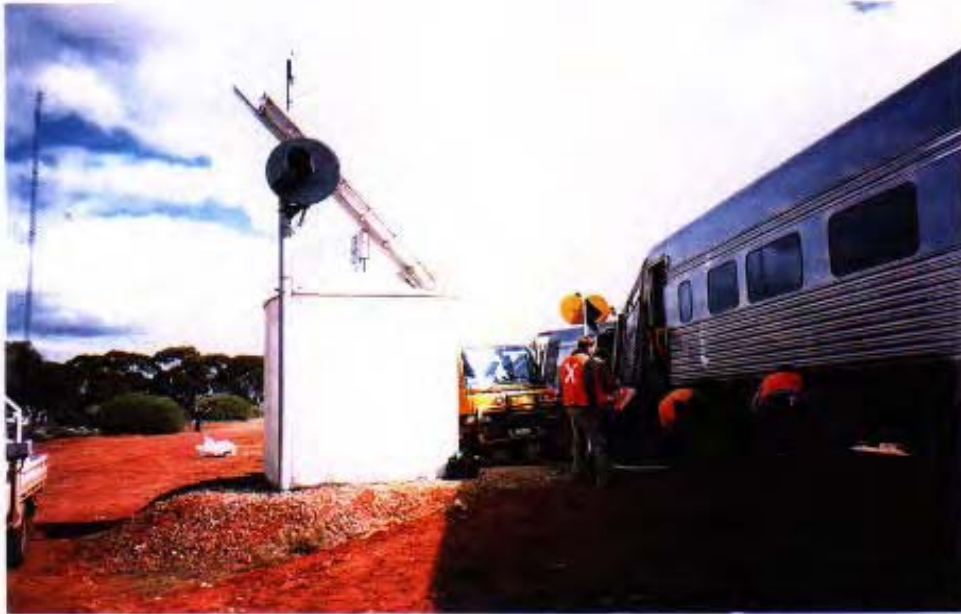
Figure 9: Flashing light indicator and yellow dumb bell showing points set for loop.

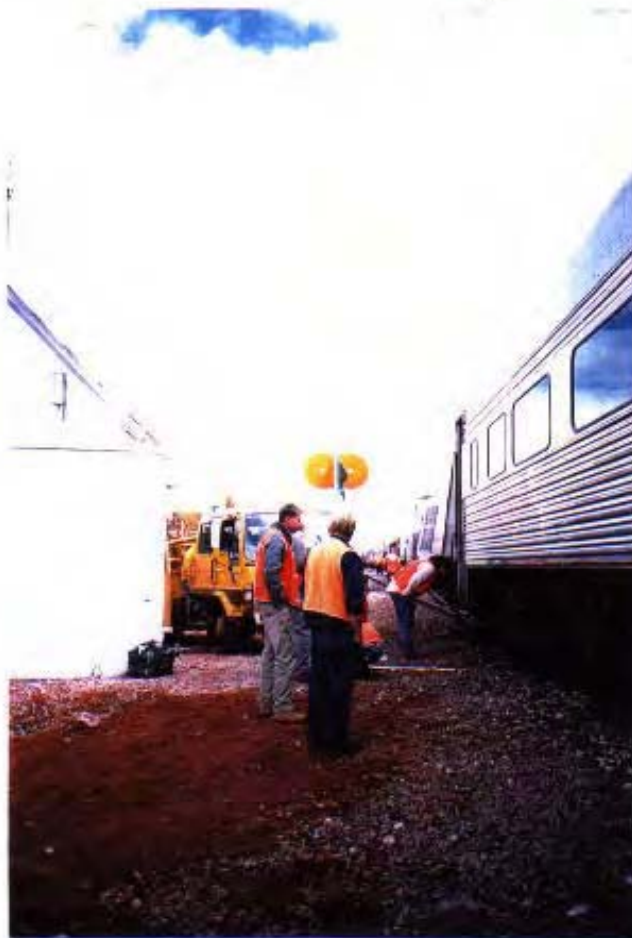
*Figure 10:
Yellow dumb bell showing points set for the loop.*

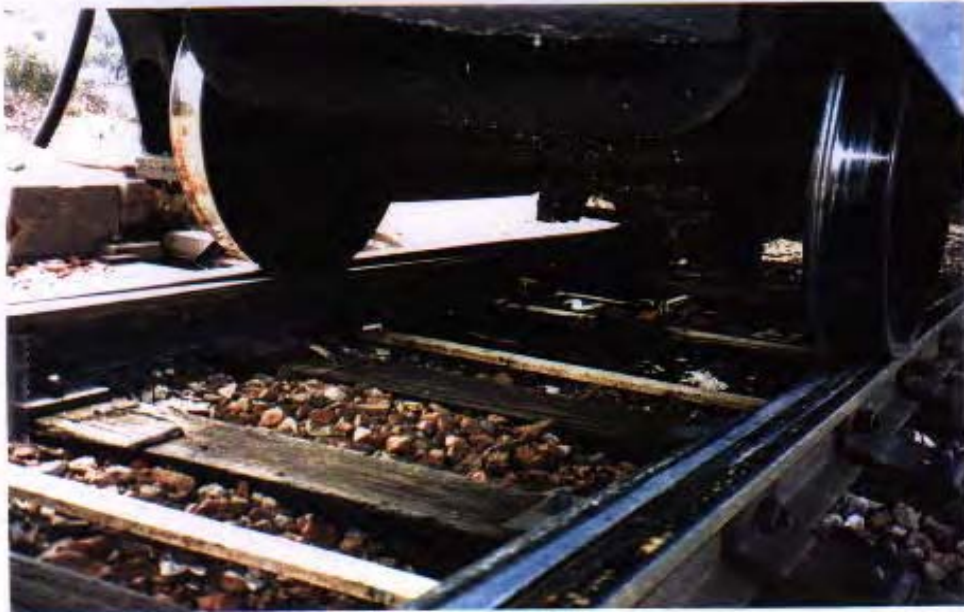
Figure 11: Carriage on points which are clearly set for loop.

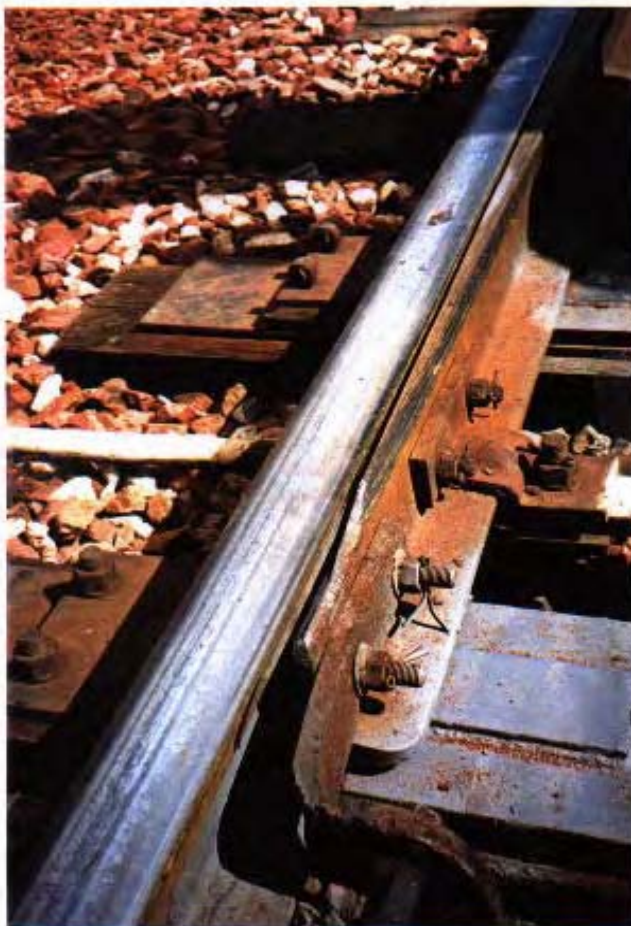
Figure 12:

*Point operation –
after train
removed but
before operating
points. Points
commenced
reversal to normal
but not completed.*

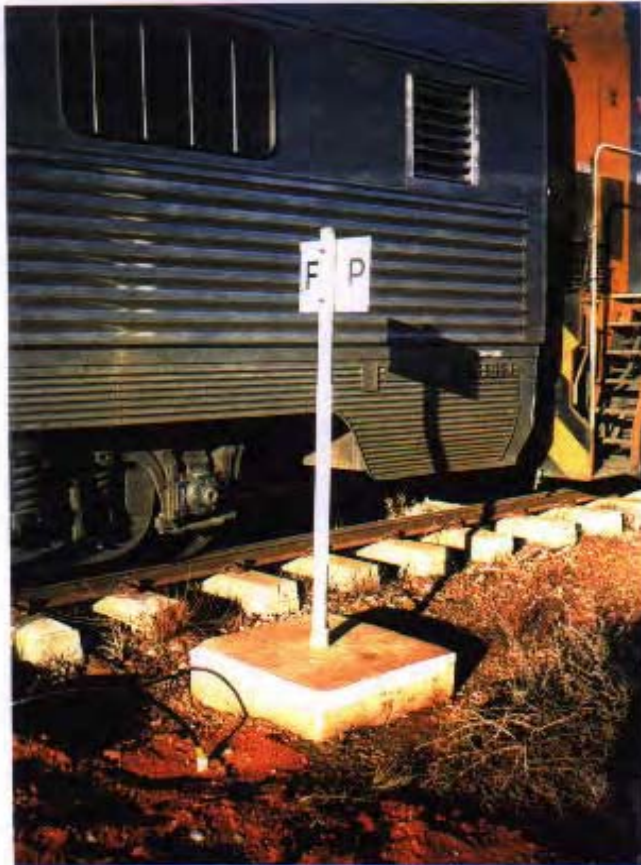
*Figure 13:
Shows Fouling
Point and new
cable for
upgraded control
system.*

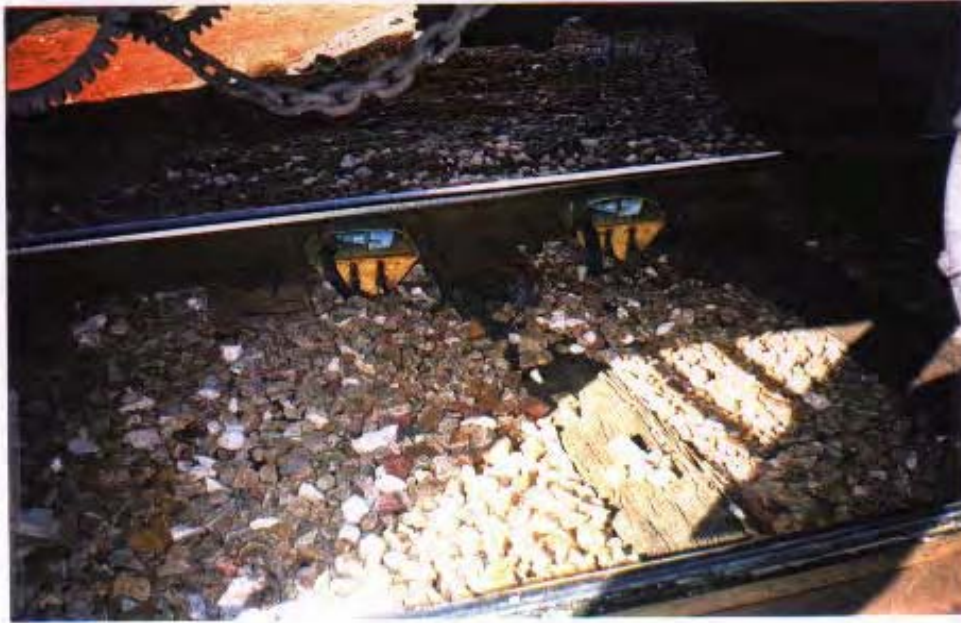
Figure 15: Proximity switches on main.

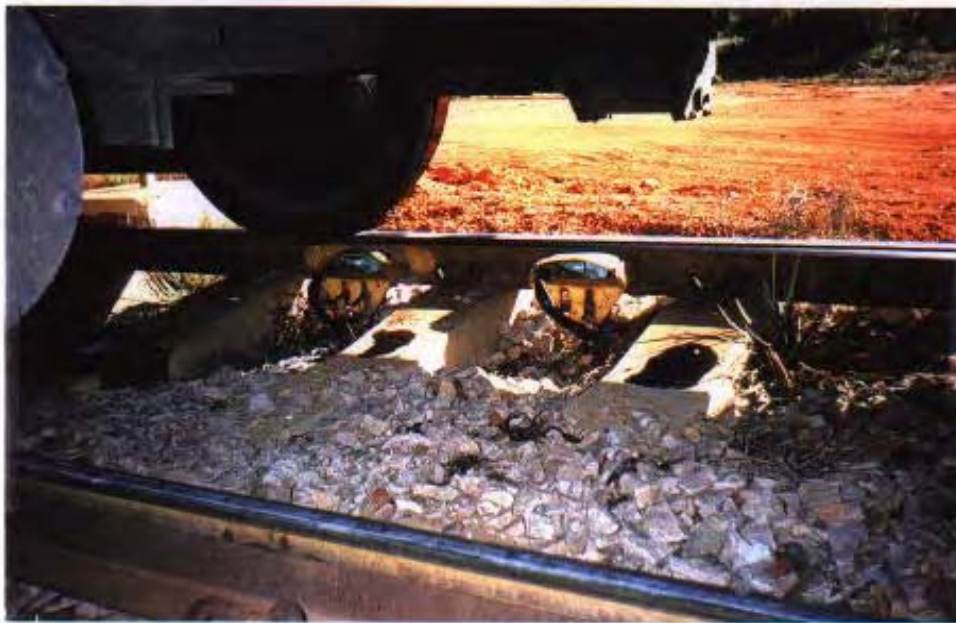
Figure 16: Proximity switches on loop.
