Collision Between Freight Train 9784 and Ballast Train 9795

RAIL INVESTIGATION REPORT

**Collision Between Freight Train 9784 and
Ballast Train 9795
Ararat, Victoria**

26 November 1999

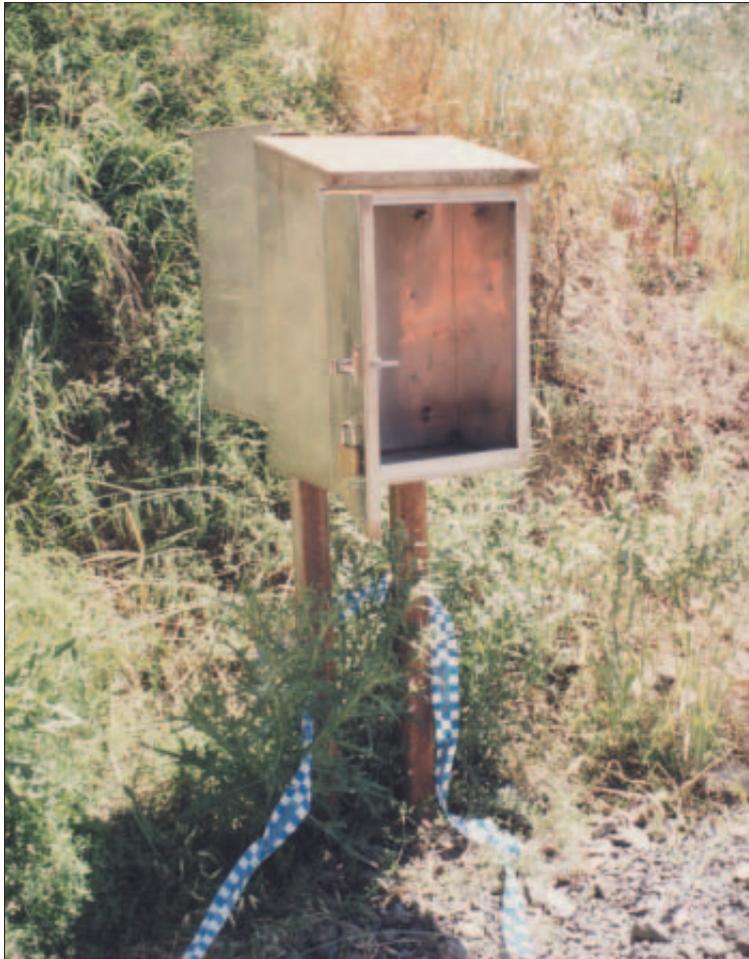
FIGURE 2.

Steel box in which the Annett key at Ararat was housed, as found following the accident

The location of the steel box at the base of the road bridge was such that members of the public could readily observe rail personnel access the box and its contents. Indeed, on the evening before the accident, three youths had observed a Second Person access the box and use the Annett key to unlock and operate the points at Ararat. Even if the steel box had been secured with a more secure padlock, it would have been possible for a rail employee or a member of the public to gain unauthorised entry to the box by using force.

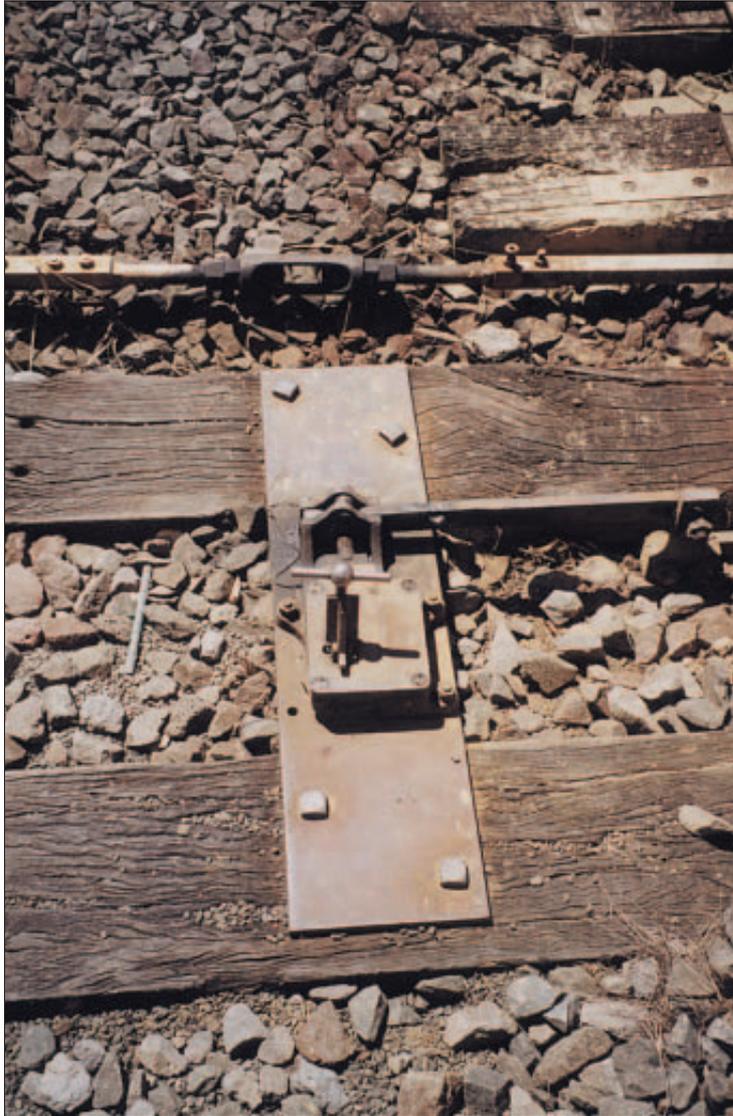
FIGURE 3.
Detail of the Annett lock and key controlling the points at the Adelaide end of the Ararat siding, as found following the accident

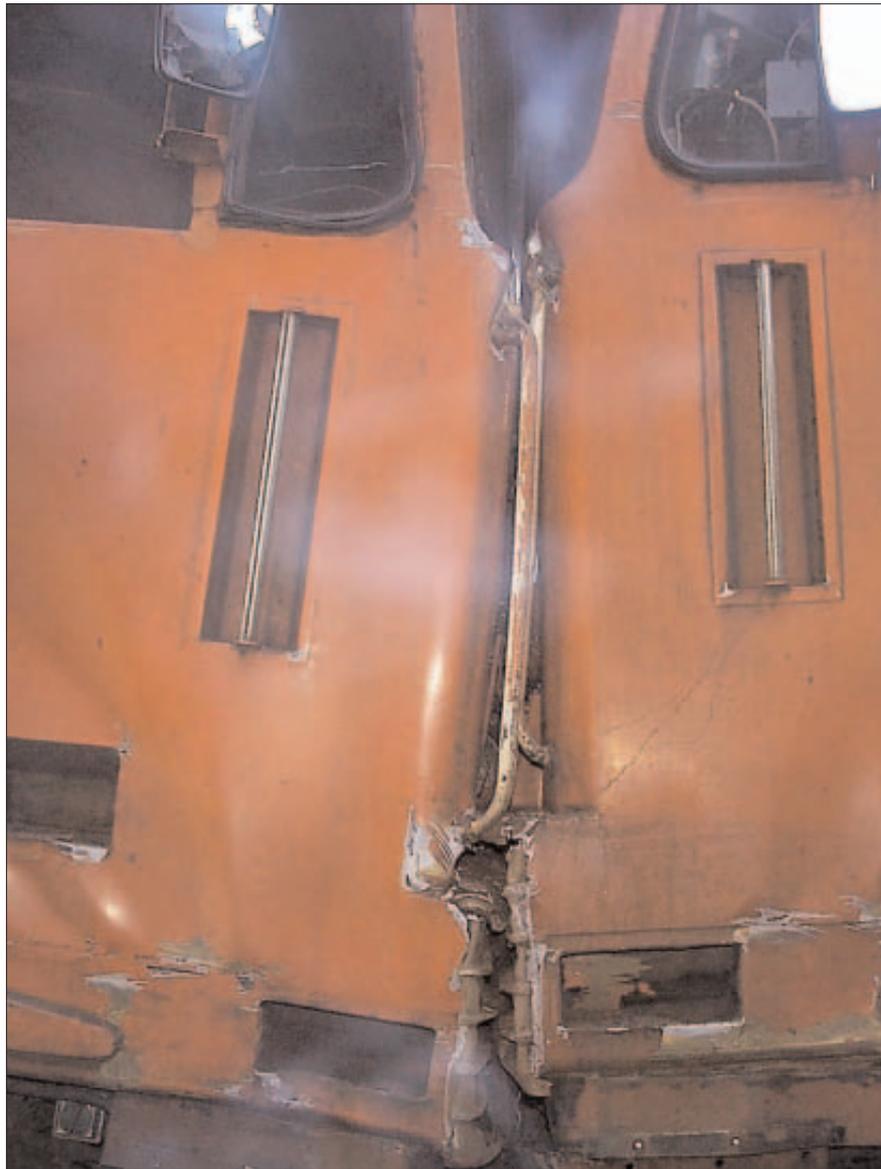
The two locomotives locked together, the anti-ride bars preventing either locomotive from riding over the other (fig 4). The leading cabs largely retained their shape, although the remaining sections of both locomotives suffered extensive damage during the impact sequence.

FIGURE 4.
View of the leading cabs of the two locomotives showing the anti-ride bars. The impact speed of the collision was approximately 74 kph

The anti-ride bars on the locomotives successfully prevented one locomotive riding up and over the top of the other. While the locomotive of train 9784 sustained extensive damage, the cab retained sufficient integrity to permit the survival of the crew. By mitigating the consequences of the accident, the design and construction of this locomotive appears to have been a final, successful defence in the overall system.

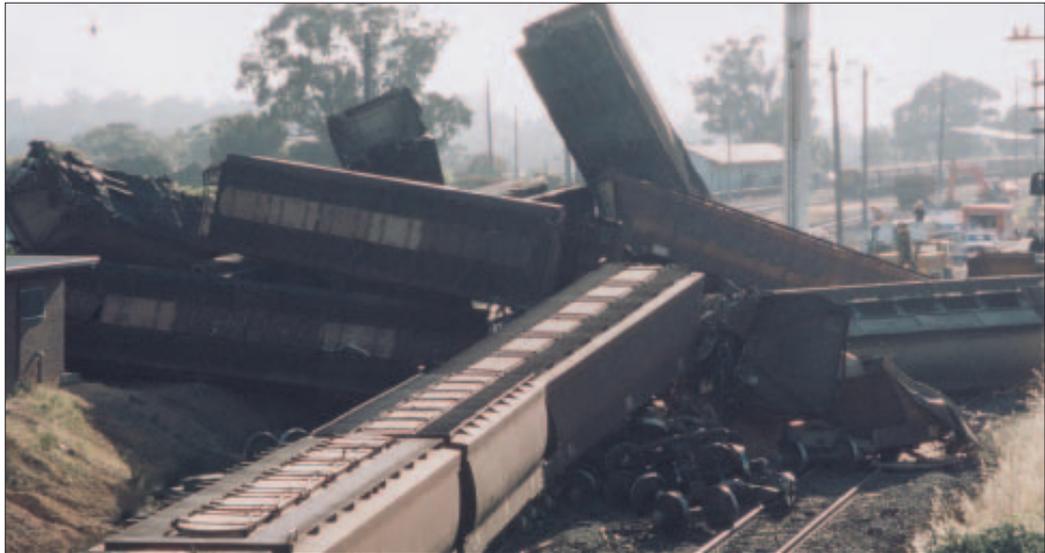
FIGURE 5.

The first 12 grain wagons (11 empty and one loaded) of 9784 were projected over the top of its locomotive and came to rest in various positions. Some wagons blocked the main line, while others mounted the embankment on the northern side of the No. 2 Road (fig 5). Few of those wagons remained upright and most sustained extensive impact damage. The locomotive of 9784 was extensively damaged by the impact of the wagons passing over it, and by bogies, wheels, undergear and grain being deposited in the exposed engine room. In addition, the fuel tank on the locomotive was ruptured and its contents spilt.

The accident site as viewed from west to east. The main line is on the right of the picture and is blocked by an overturned grain wagon and several bogies, wheels and undergear. The embankment that the crew members of 9795 ran up to escape the collision, is at the left of the picture

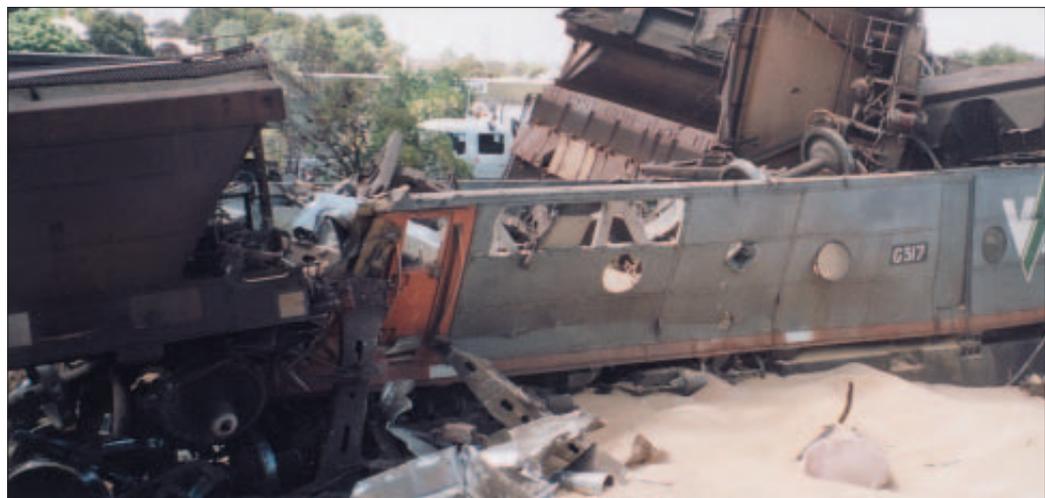
FIGURE 6.

View of the extensive damage to the engine room and rear-cab sections of the locomotive of 9784

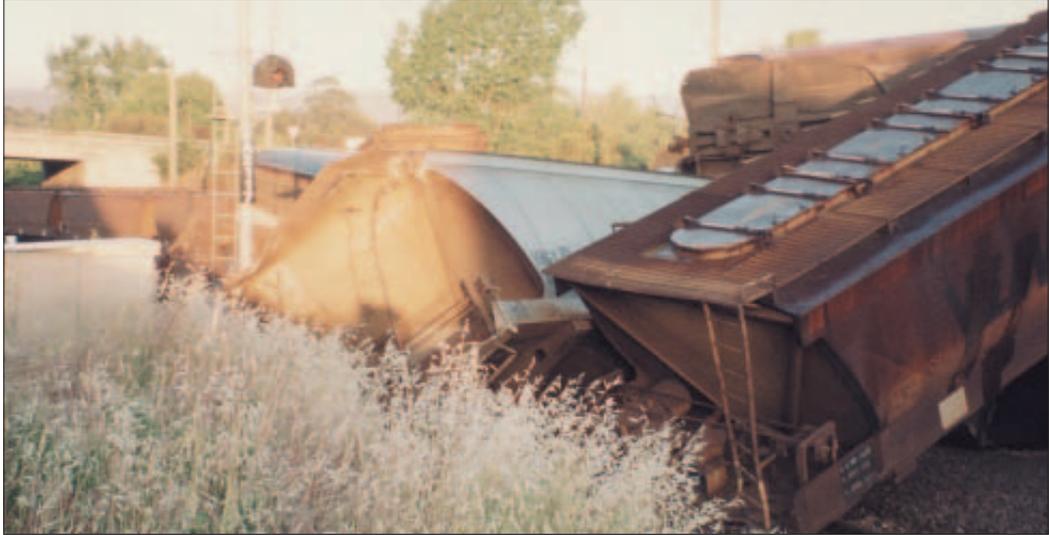
FIGURE 7.
The accident site as viewed from east to west. Picture shows the grain wagons at the rear still intact and on the rails under the road bridge

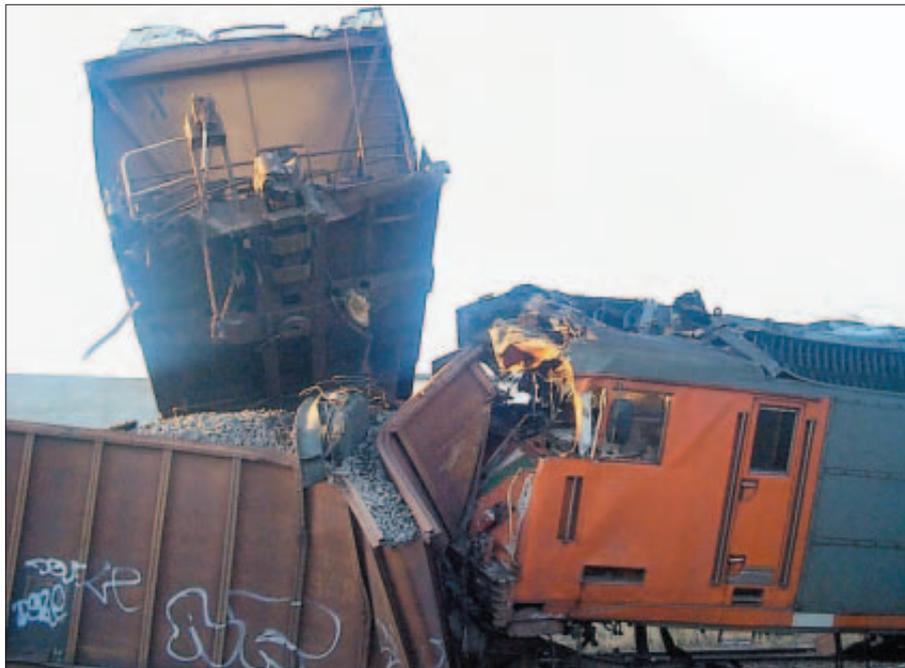
The leading ballast hopper wagon absorbed most of the impact of the locomotive of 9795 being propelled along the No. 2 Road, and caused extensive damage to the trailing cab of the locomotive. The locomotive of 9795 also suffered extensive impact damage from the grain wagons passing over it (fig 8).

FIGURE 8.
View of the rear cab of the locomotive of 9795

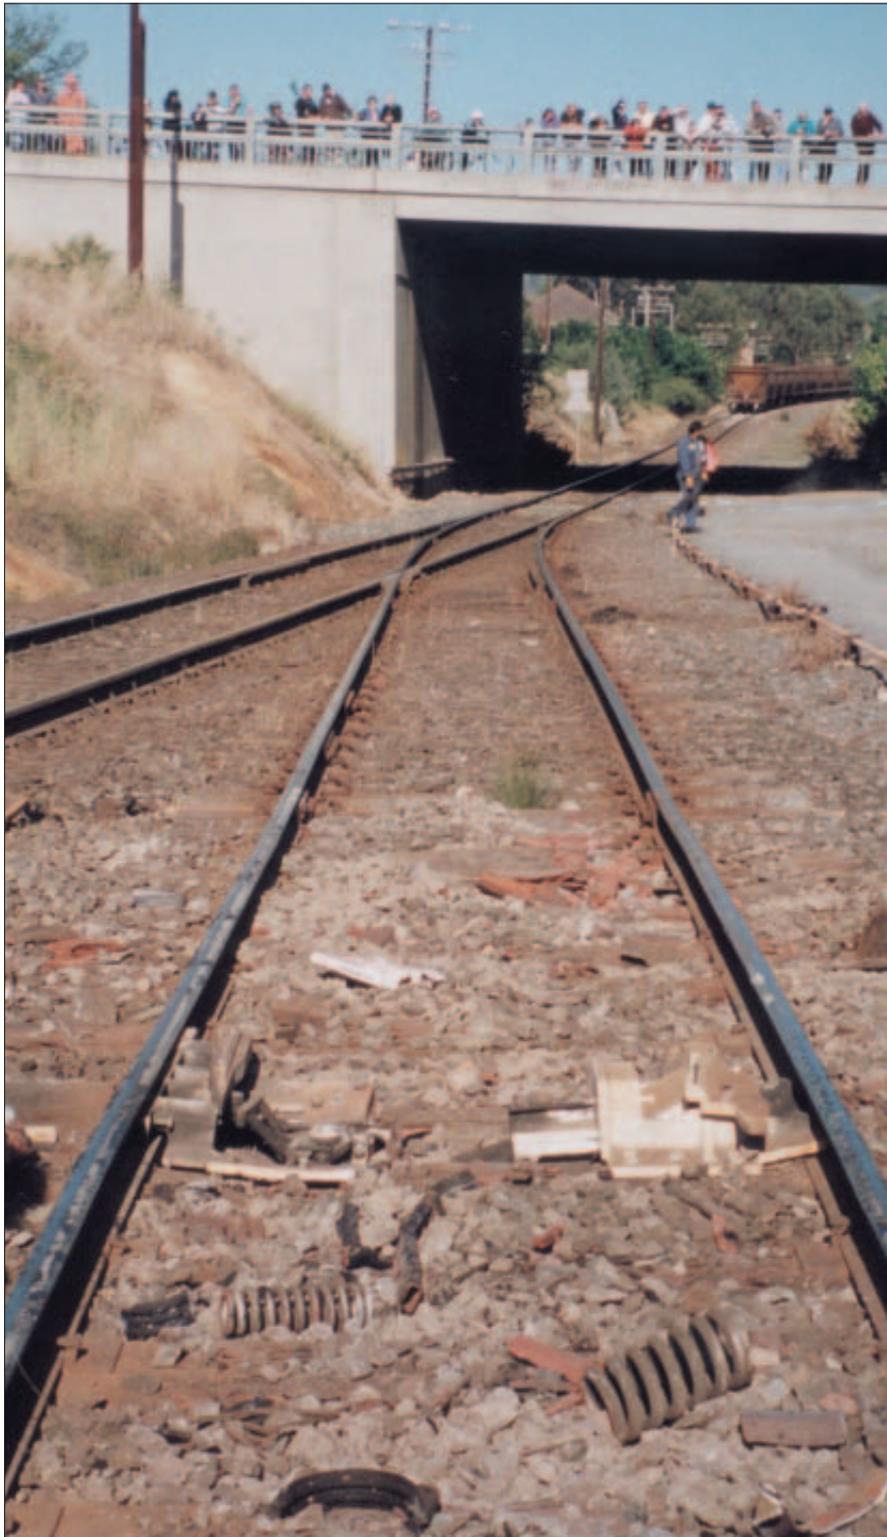
stationary locomotive. A train travelling at 75 kph (20.8 m/s) would take 9.6 seconds to cover that distance. The abutments and road structure of the road bridge also obstructed the view of locomotive crews waiting at Ararat although at night, the lights of a locomotive would be visible several seconds before the locomotive itself rounded the curve (fig 9).

FIGURE 9.
Daytime view west toward the Pyrenees Loop from the approximate location of a locomotive waiting to proceed onto the main line from the No. 2 Road at Ararat

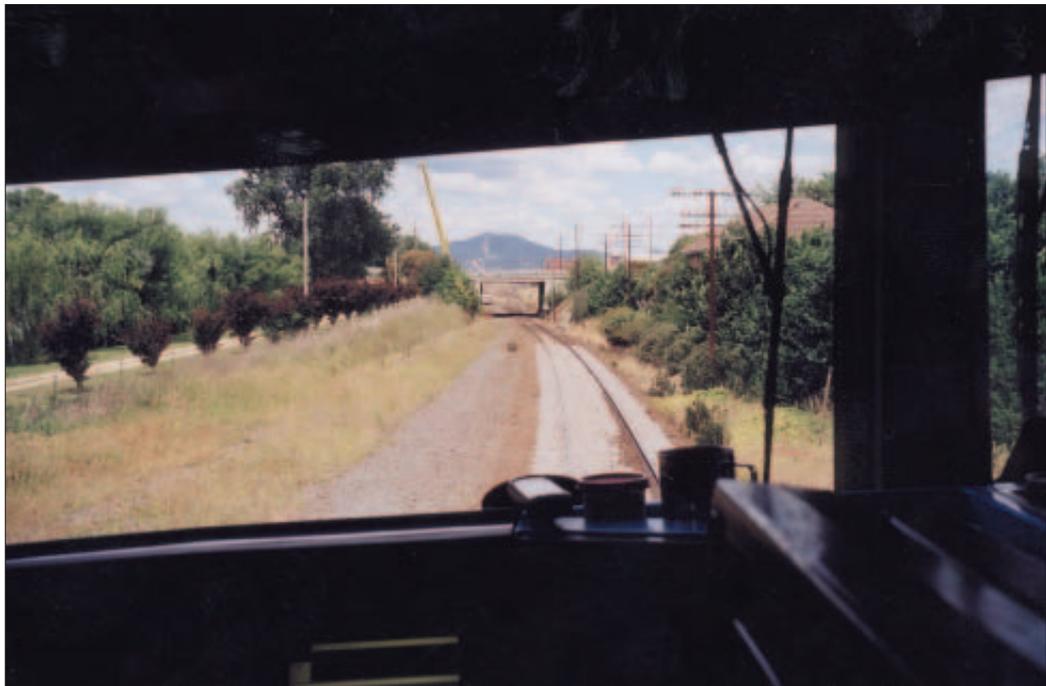
FIGURE 10.

The crew of a locomotive approaching Ararat from the west at night, would not be able to visually acquire the setting of the points until shortly before arriving at them. Therefore, a Driver would have little opportunity to slow his train if he became aware that the points were not set for the main line (fig 10).

Daytime view east toward Ararat from the cab of a locomotive. The No. 2 Road at Ararat commences shortly after the road bridge
