RAIL SAFETY INVESTIGATION

2002/0003

**Level Crossing Collision Between
Steam Passenger Train 8382
and Loaded B-double Truck
Benalla, Victoria, 13 October 2002**

September 2004

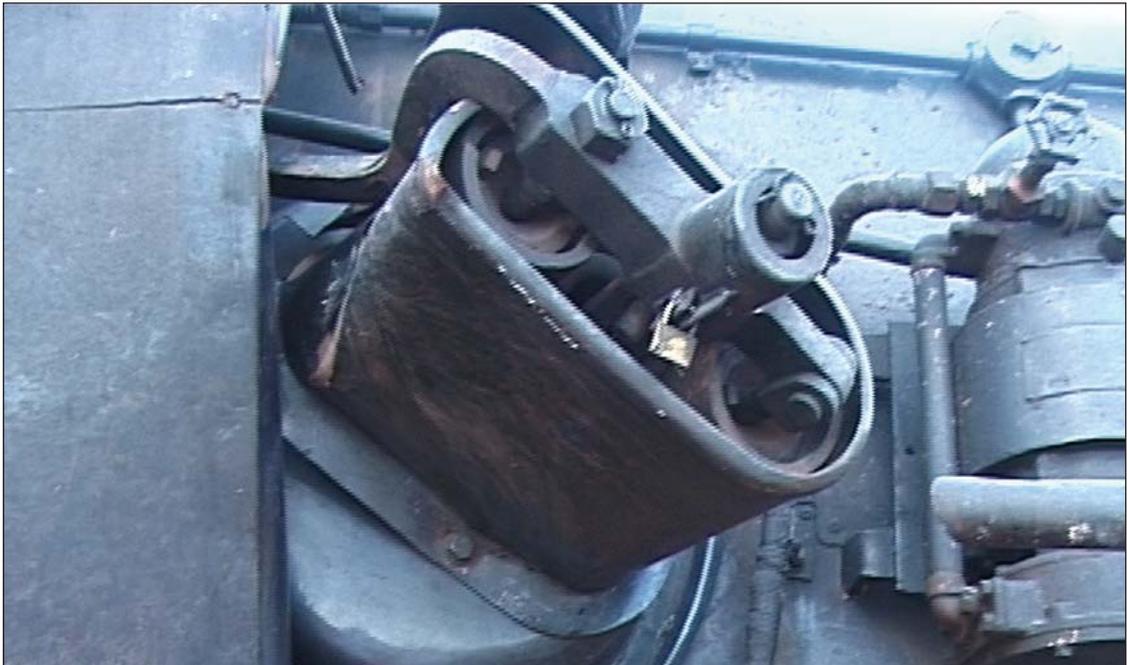
Locomotive K183 and tender left the tracks and ploughed into soft earth. The momentum from the following carriages rolled the locomotive and tender on their right side, folding the tender and locomotive together causing the tender to come in contact with the backhead of the boiler of K183. The tender also came in contact with the locomotive cab roof forcing the leading edge against the safety valve assembly, shearing the holding bolts and lifting the valve assembly from its mount on the boiler.

FIGURE 2:
Cab roof pushing against safety valve assembly

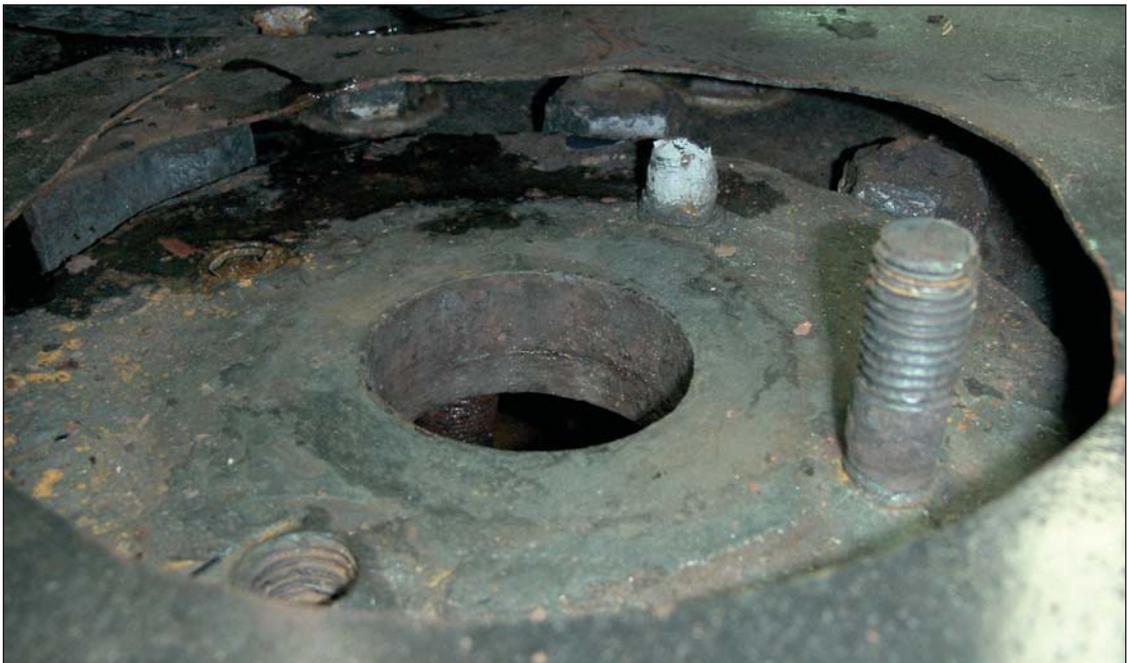
FIGURE 3:
Damaged mounting studs on boiler

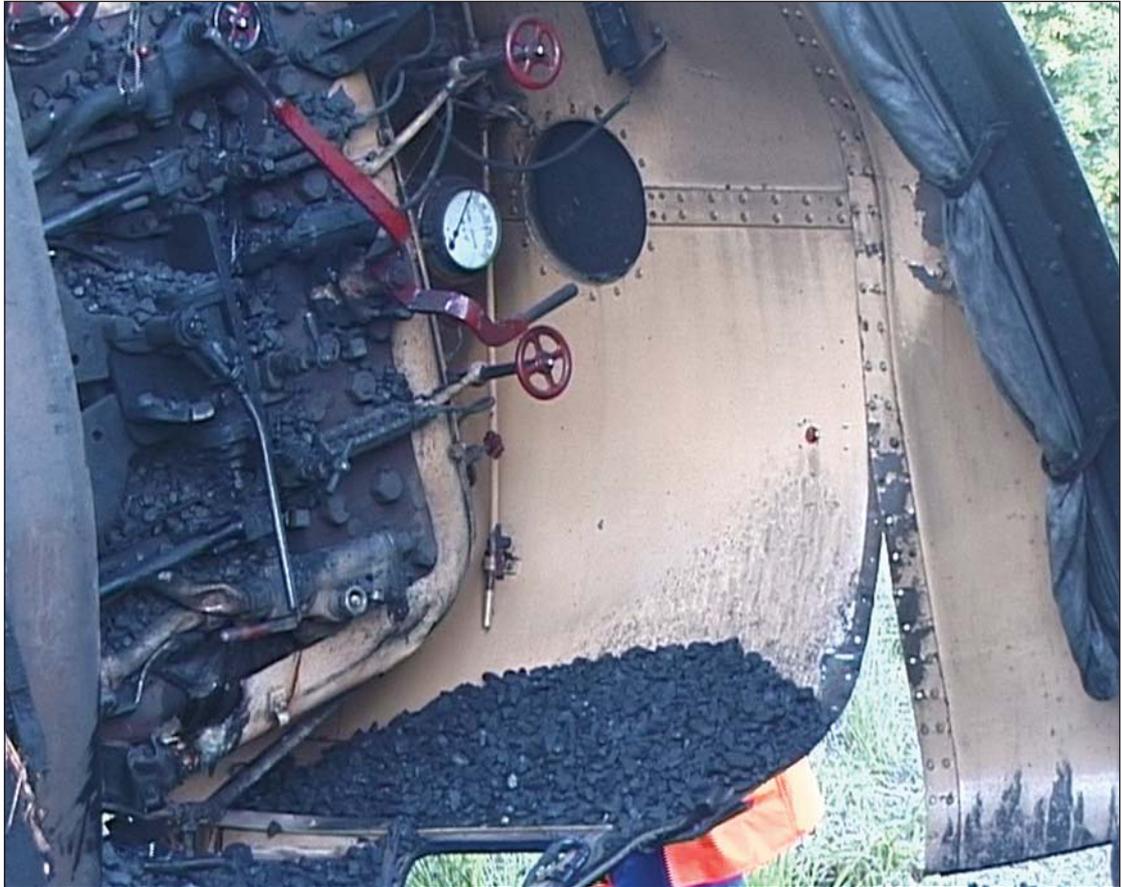
The resulting release of pressure vented steam from the boiler into the atmosphere and the cabin area. A large area of the cabin roof was clean of soot and coal dust, indicating a steam blow entering the cabin, which would have inundated the crew with steam.

FIGURE 4:
Evidence of steam blow in crew cab

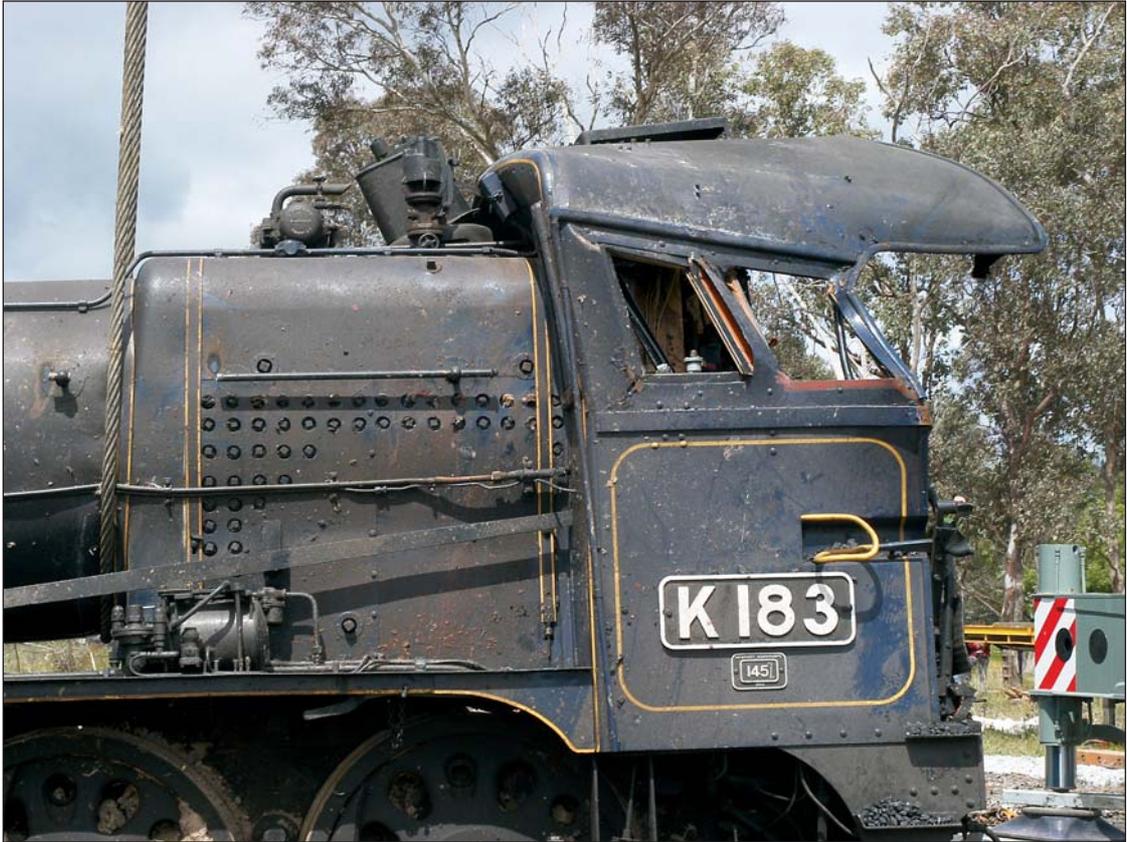
The locomotive, K183, and tender were substantially damaged as a result of the collision and subsequent derailment. The motion gear and the cabin of the locomotive were damaged. The boiler was suspected to be damaged. The fusible metal plugs⁶ located inside the fire box had partially fused when the water level dropped as a result of the locomotive lying on its side.

FIGURE 5:
Damage to crew cab

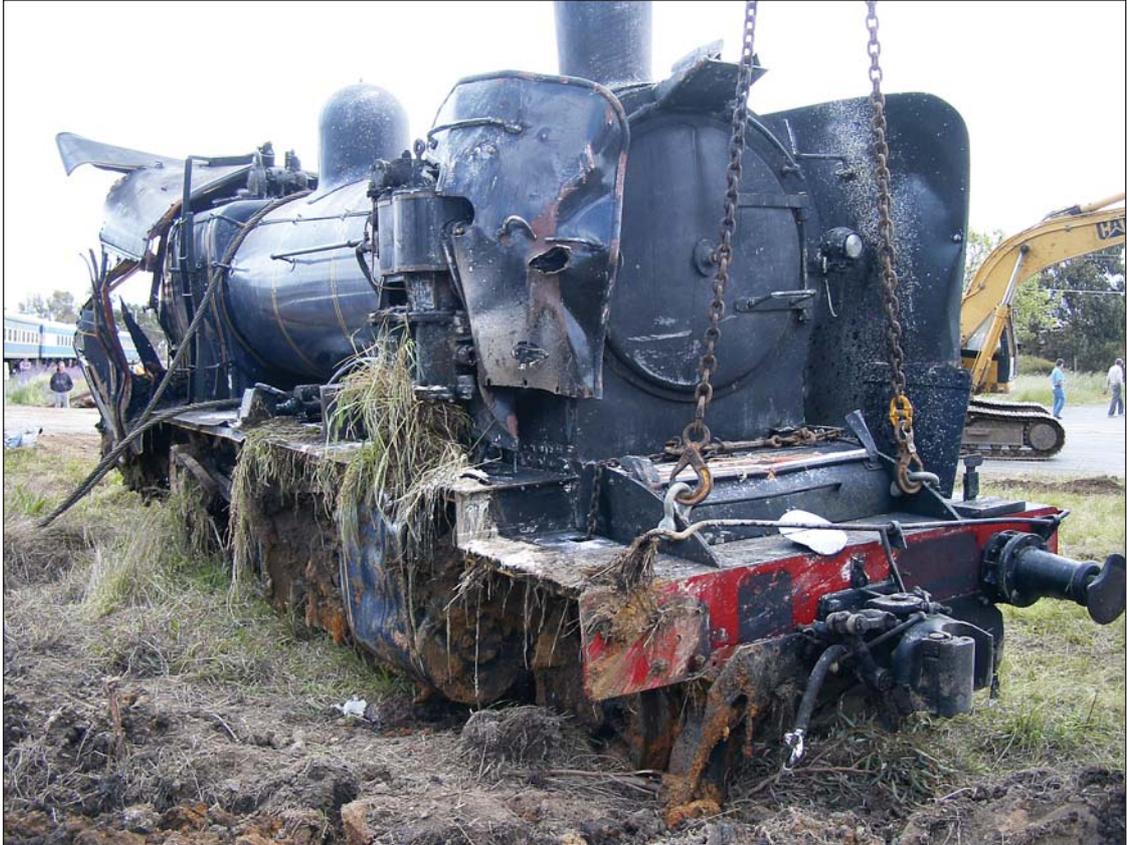
The consist of the train was relatively undamaged. The power van DT319, the carriage following the tender, had derailed and sustained body damage on the leading end from the locomotive tender. The passenger carriage after the power supply van, BK712, had derailed a leading bogie, with no visible signs of damage. The remaining carriages, BRS221, BRS225, and WAL951 trailing, were undamaged.

FIGURE 6:
Damage to locomotive K183

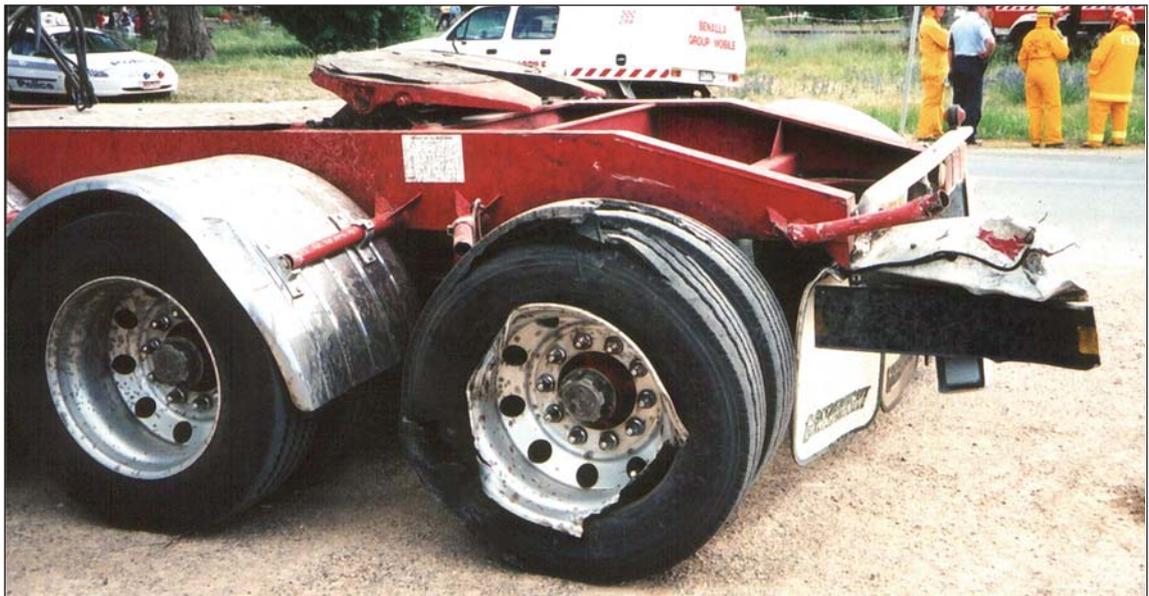
The steam locomotive impacted with the last trailer of the B-double. The impact point was in the front half of the last trailer, above the first trailer's tri-axle wheel set. The last trailer received major damage. The first trailer received damage to the tri-axle wheel set. The prime mover was undamaged.

FIGURE 7:
Damage to leading triaxle set

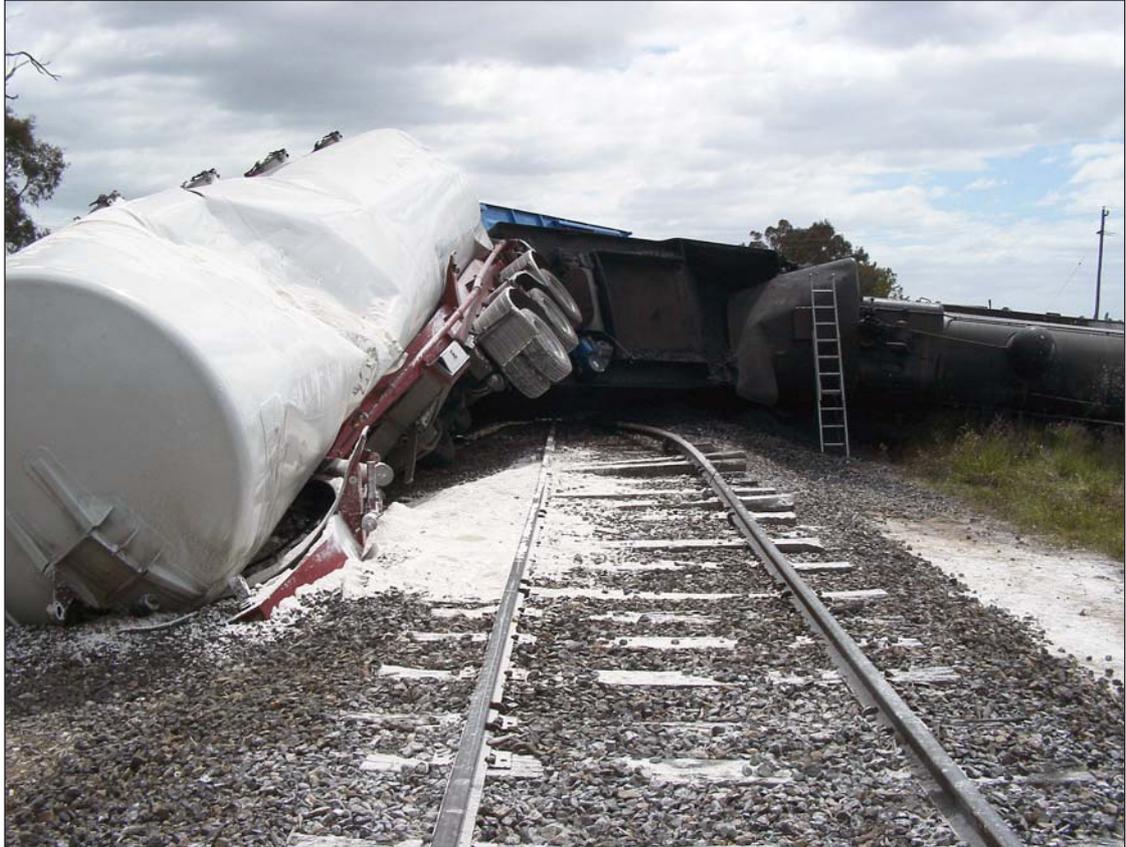
FIGURE 8:
Damage to second trailer

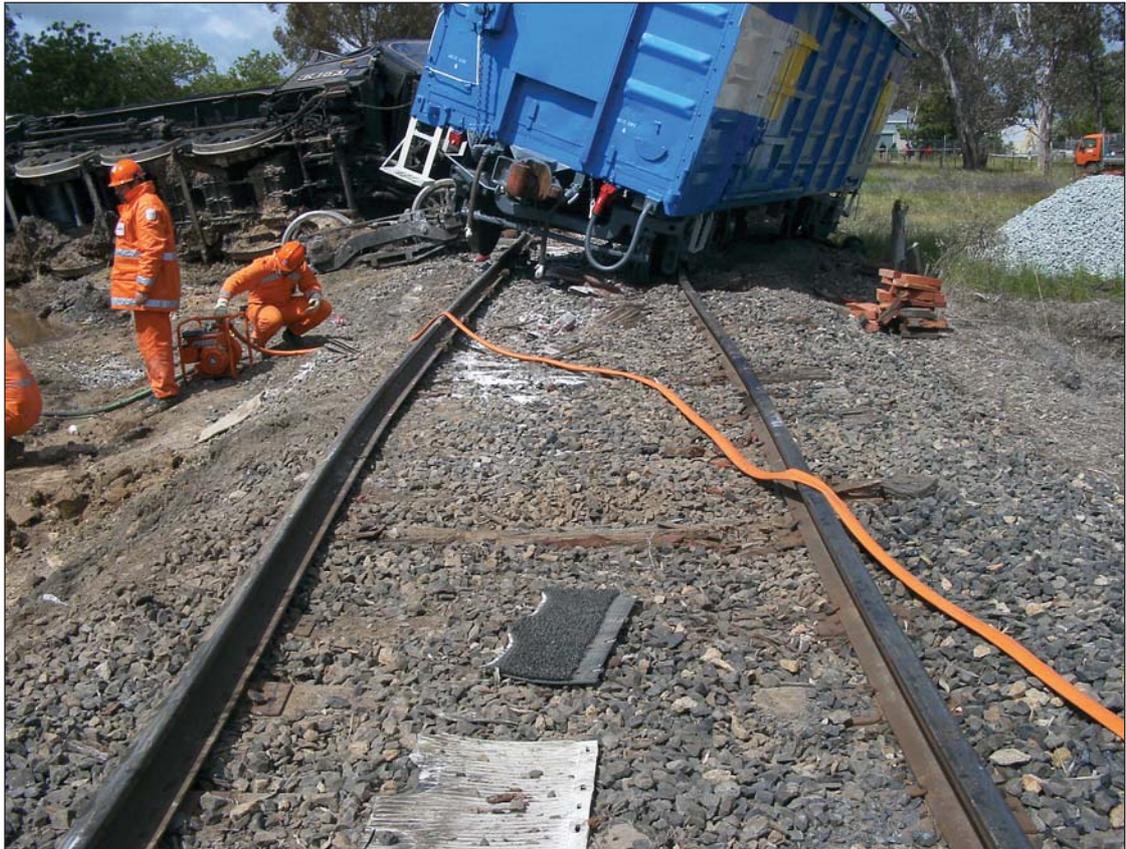
The collision caused the leading wheel set (pony truck) on the steam locomotive to derail on the level crossing. The wheel set was forced against the gauge face of the rail causing the left wheel to climb over the rail. The force applied to the rail caused the rail to warp or kink, consistent with sudden high lateral flange forces. Approximately 25 m of line was torn from its correct position after the initial point of drop off.

FIGURE 9:
Damage to infrastructure

After the recovery process, re-railing commenced, replacing the damaged portion of track including resurfacing of the level crossing.
