ATSB TRANSPORT SAFETY INVESTIGATION REPORT  
Rail Occurrence Investigation 2004/004  
Final

# Signal FS66 Passed at Danger, Freight Train 8868

Fisherman Islands, Queensland  
20 September 2004

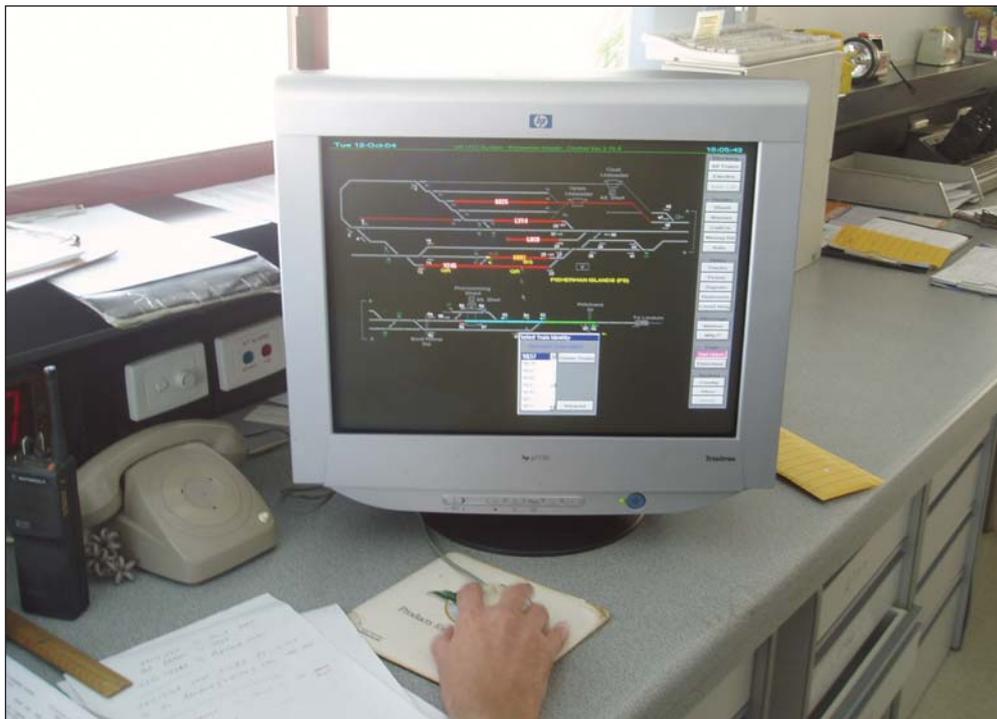
**FIGURE 3: Fisherman Islands area coordinator's workstation**

The area controller who was controlling the passage of train 8868 from signal FS66 to the Fisherman Islands terminal was stationed at Fisherman Islands in the upper floor of the administration building. The work area was essentially a large office that, from time to time, housed operational staff of varying disciplines. The area controller had verbal and visual contact with trains in this area in the form of radio and VDUs that 'mimic' the position of train, signals and points 'in the field'. At times a person from the station officer's grade performed some of the operational tasks of the area coordinator.

The ATSB recommends that QR examine methods of ensuring continued attendance by appropriately qualified employees at the Fisherman Islands area coordinator/station officer workstation.

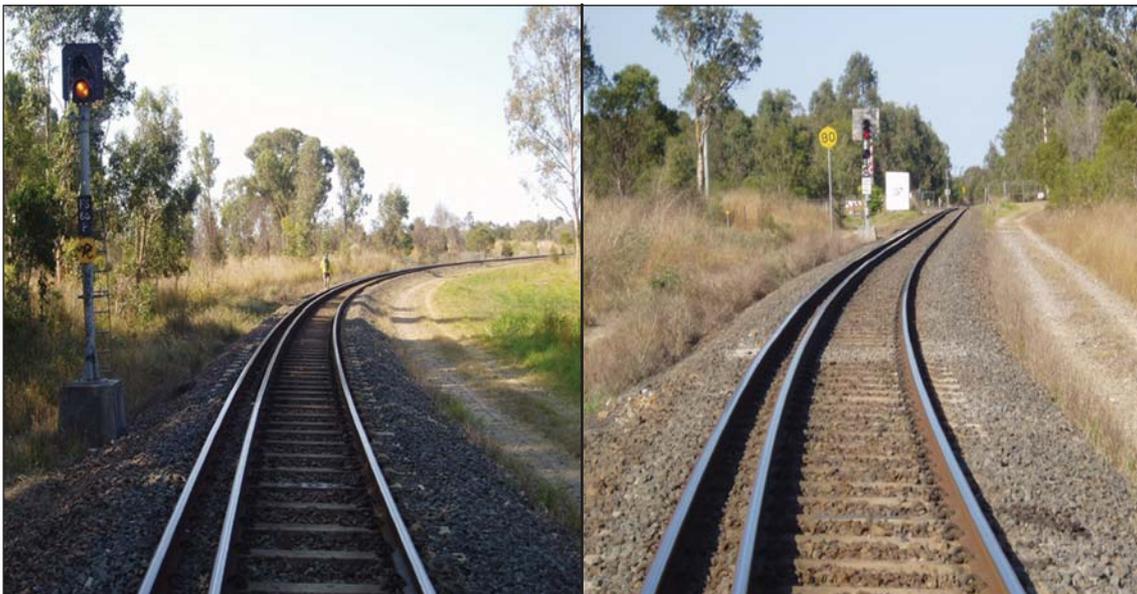
**FIGURE 4: Signal FS66P (left photograph), 360 metre radius curve, signal FS66 (right photograph)**

Between signals LJ2 and FS66 is the repeat signal<sup>5</sup> FS66P. This signal is located 350 metres in advance of signal FS66 and displays a yellow aspect if signal FS66 is at red or a green aspect if signal FS66 is at proceed (yellow or green aspect). The sighting distance of signal FS66P is 1027 metres and the sighting distance of signal FS66 is 193 metres, the track curving to the right between these two signals. This curve is rated for a maximum speed of 60 km/h. There were no obstacles that hindered the observation of these signals within these distances.

At the time of the SPAD, one filament of the bulb illuminating the red aspect of signal FS66 was blown; however, the red aspect was still illuminated and, based on evidence, the defective filament is not considered to be a contributing factor in this incident.

The ATSB recommends that QR evaluate the installation of wayside secondary protective/prompt device/s in advance of signal FS66. Such device is to be compatible with all operators. This recommendation is made in light of the position of FS66 and the number of SPADs that have occurred at this signal.

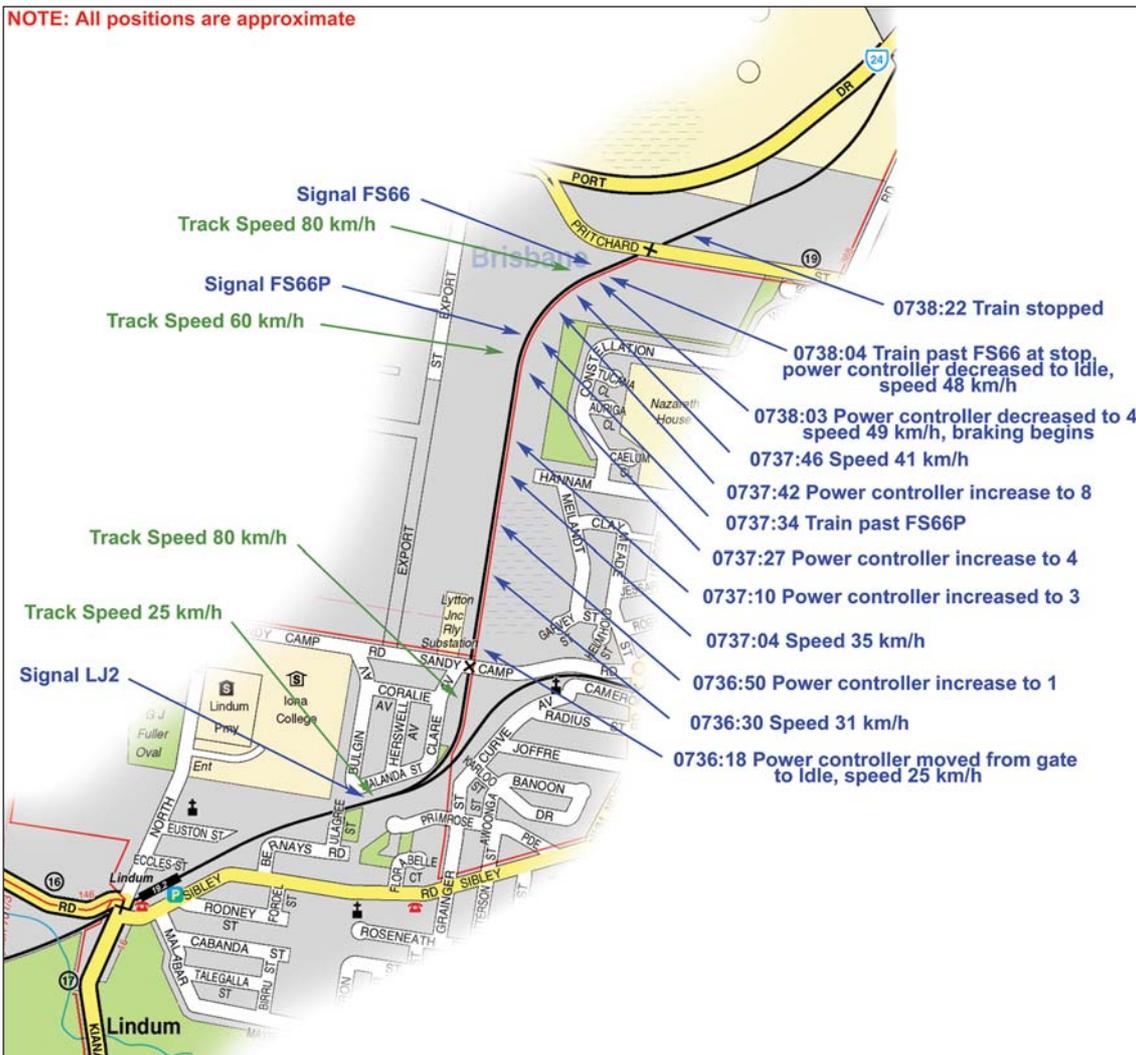
**FIGURE 5: Overview of events, signal FS66 and Pritchard Road level crossing**

As train 8868 passed signal FS66 the protection cycle for the level crossing was only partially complete and the boom barriers were not horizontal. Train 8868 stopped about 175 metres beyond signal FS66 and 74 metres beyond the level crossing.

Pritchard Road level crossing is 101.3 metres beyond signal FS66. If signal FS66 is showing a proceed indication, the level crossing protection is 'called' upon the occupation of LJ2F track circuit. However, if signal FS66 is at red, the level crossing protection is not 'called' to operate. If the track circuit immediately beyond this signal is detected as being occupied the level crossing protection will operate regardless of the aspect displayed in signal FS66. Train 8868 occupied track circuit LJ2F at 0737:27.

The Fisherman Islands area coordinator was anticipating the approach of train 8868. After seeing the prompt on his VDU he started setting the route at 0737:51 from signal FS66 through to Fisherman Islands. This meant that the level crossing warning lights would have started flashing at 0738:00 and the boom barriers would have started to move from the vertical eight seconds later at 0738:08. Nominally, boom barriers take ten seconds to drop to the horizontal position. Train 8868 started crossing the Pritchard Road level crossing 0738:11, 11 seconds after the initiation of the warning lights and three seconds after the booms started to fall.

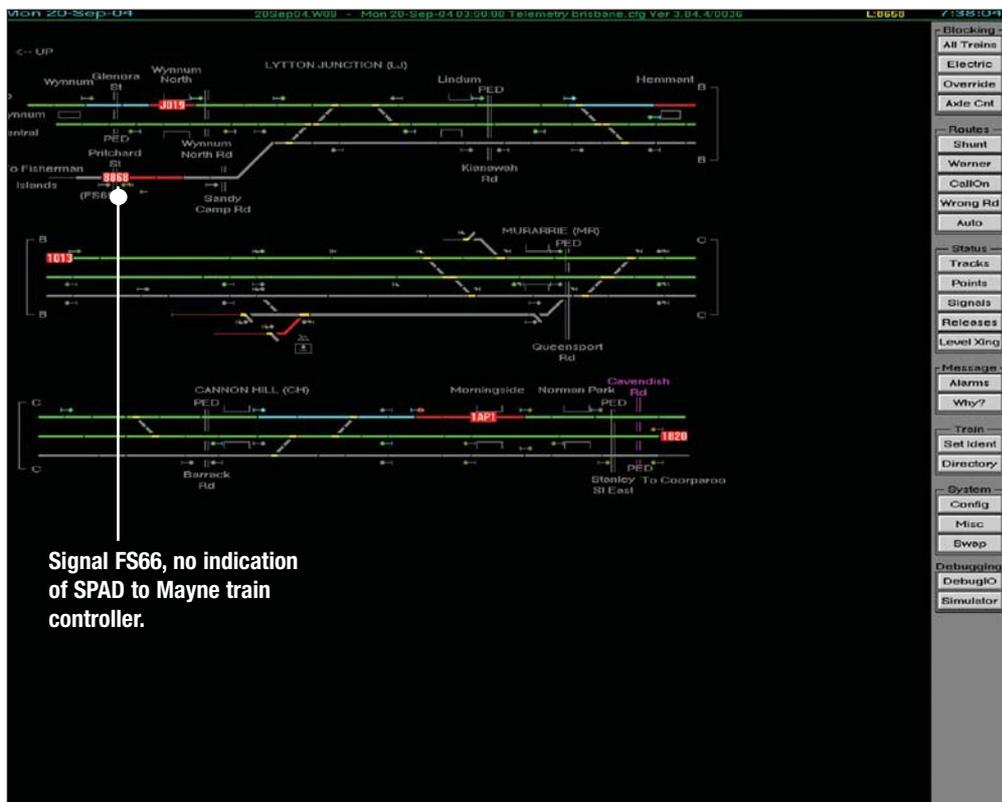
FIGURE 6: Mayne train controller's UTC screen at the time of the SPAD 0738:04

The train controller of the UTC2 panel at the Mayne train control centre stated that he had not talked to the driver of train 8868 prior to the advice of the SPAD at signal FS66. The train controller confirmed that they have no indication of the aspect displayed in FS66 and that their role is to set the route as far as signal FS66 only. Once a train proceeds past this signal the Mayne train controller has no indication of where any train may be.

The Mayne train controller evidence was that, as far as he was aware, there is no interface procedure between the Mayne train control centre and Fisherman Islands for the handover of trains. He said that normal practice is for the Mayne train controller to call Fisherman Islands, although sometimes this is not possible because the area coordinator is not at the workstation. On other occasions the Fisherman Islands area coordinator will just accept the advice of an approaching train as it appears on his VDU screen without talking to the Mayne train controller. Equally, for Down trains from Fisherman Islands, sometimes the Fisherman Islands area coordinator will send a train to signal FS65 and, if there is no problem, the Mayne train controller will accept the train and without any conversation taking place.

The ATSB recommends that QR amend the interface procedures between Mayne train control centre and Fisherman Islands with the intention of ensuring that all trains are contactable by the Fisherman Islands area controller/station officer when in signalled territory controlled by the Fisherman Islands area coordinator/station officer. Boundaries of signalled territory should be clearly defined and current discrepancies in regard to radio channels and signal control should also be amended.

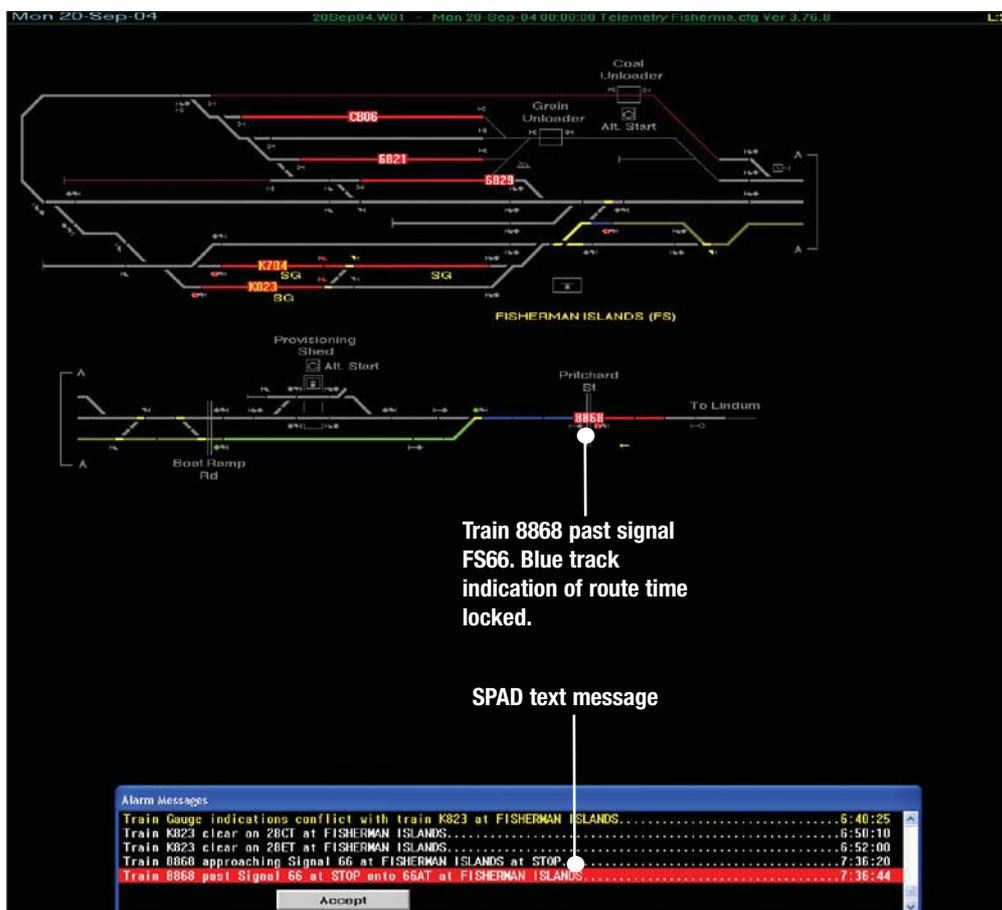
**FIGURE 7: Fisherman Islands UTC screen at 0738:06 (synchronised time) as SPAD alarm sounding**

area coordinator's workstation. The message 'Train 8868 past Signal 66 at STOP onto 66AT at FISHERMAN ISLANDS' was then displayed on the VDU monitor. Ten seconds later, at 0738:16, the message was accepted and the SPAD alarm stopped.

The ATSB recommends that QR amend the emergency response procedures applicable to Fisherman Islands to ensure that initial notification of a SPAD is sent to the officer who has control of the signal in question.

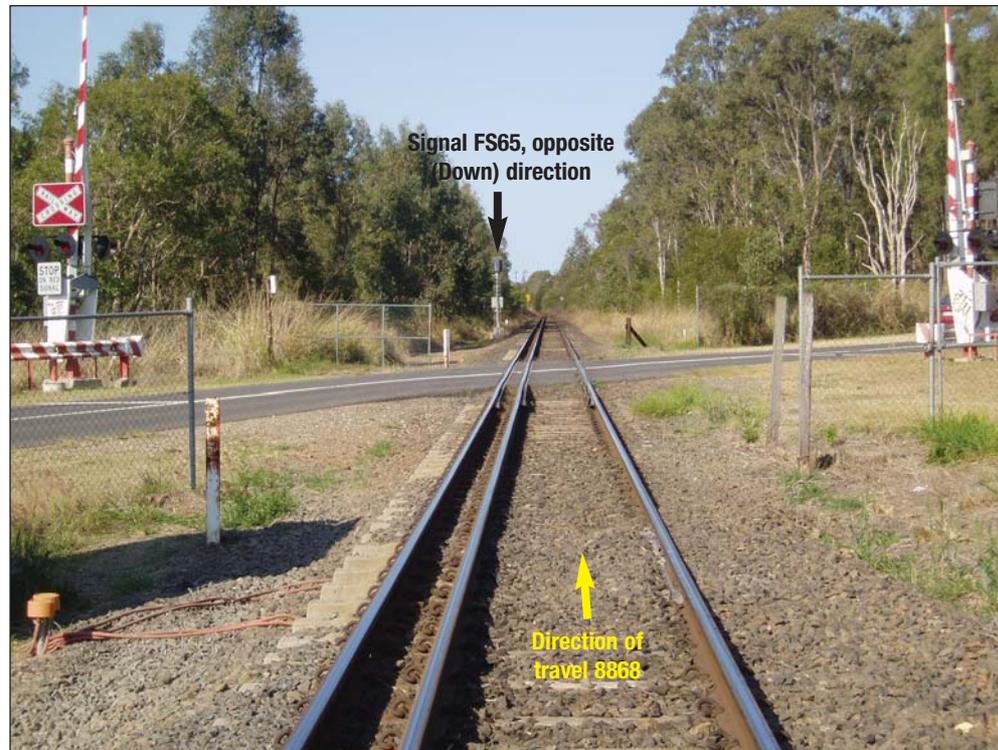
**FIGURE 8: Pritchard Road level crossing**

Pritchard Road level crossing is located 101 metres beyond signal FS66 and is an active level crossing consisting of signage, flashing lights and boom barriers. Pritchard Road is a major thoroughfare for road traffic from the bayside areas to the Fisherman Islands port and industrial facilities. At the time of the incident the traffic flow on Prichard Road was described as moderate to heavy.

have been a greater possibility of road vehicles being caught on the level crossing as the train passed through.

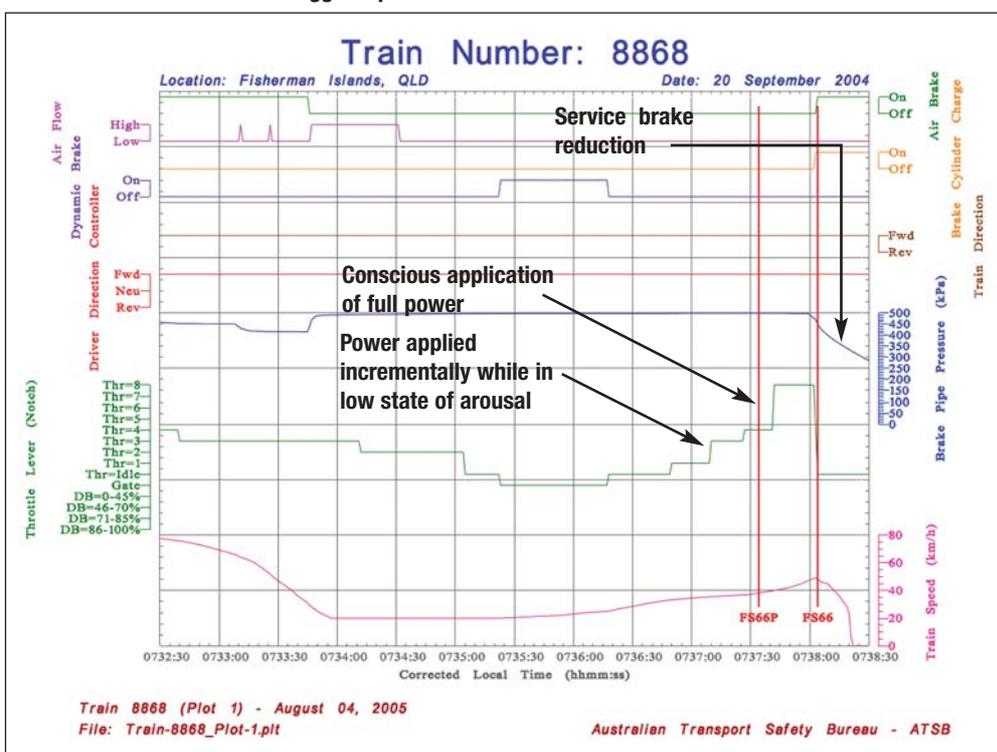
**FIGURE 9: Locomotive data logger reproduction**

Eight seconds later, at 0737:42, the driver placed the power controller in eight notches (full power) because he thought the train was travelling too slowly. At this time, train 8868 was travelling at 41 km/h and was 226 metres from signal FS66. Full power was maintained for about 177m past the point at which signal FS66 should have been sighted (193.5 m) with a red aspect. The time was now 0738:03 and the speed of train 49 km/h. At this point, at 15 metres from signal FS66, a service rate<sup>14</sup> application of the train brake was made and brake pipe pressure reduced from 500 kPa<sup>15</sup> to 324 kPa over the 19 seconds it took for the train to stop (at 0738:22). After stopping, brake pipe pressure continued to reduce to 229 kPa at the service rate for 21 seconds until the brake pipe started recharging.

There is also the possibility that habit patterns could have contributed to this incident. The distance between signal LJ2 and FS66 (about 1450 metres) could result in a driver normally driving to road speed rather than the aspect of signal LJ2, particularly as there is a repeat signal (FS66P) that is positioned to give advance indication of the aspect of signal FS66. The driver's perception that signal LJ2 only ever displayed a yellow proceed aspect and that he did not recall seeing the repeat signal could have influenced the driver's deliberate actions in applying full power when only 226 metres from signal FS66. The comments at interview that he '... woke and realised going too slow ... opened the throttle up ...' lend themselves to this possibility.

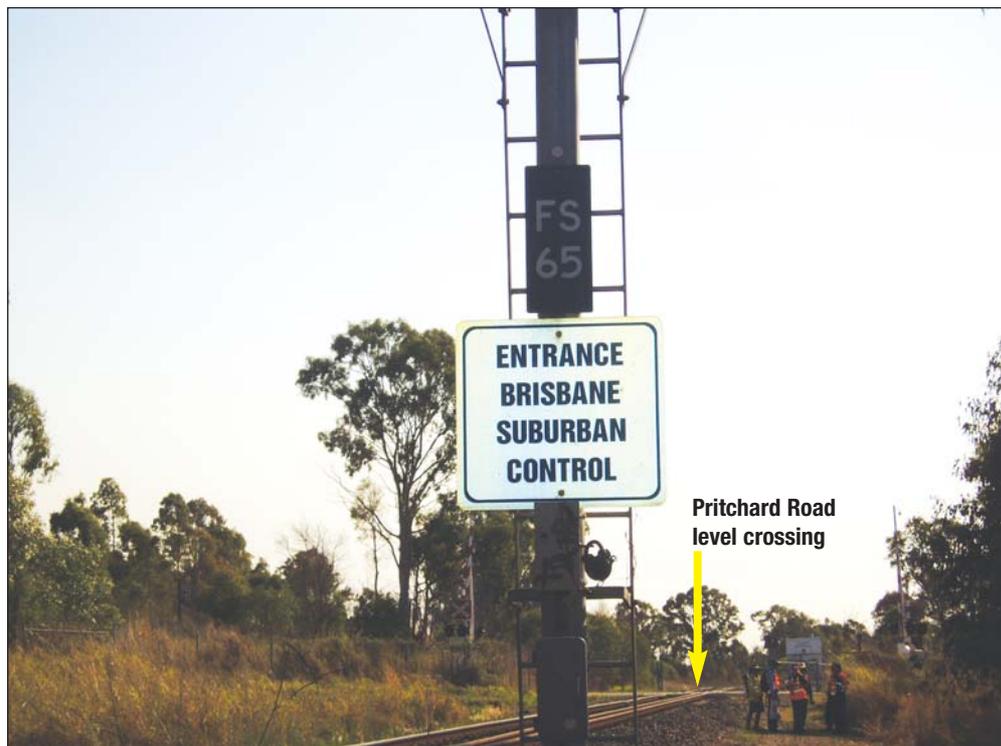
**FIGURE 10: Signal FS65, Interface for Down trains**

level crossing. For departing (Down) trains the procedure is similar to that for arriving (Up) trains, except that the train controller at Mayne gives permission for train departures from Fisherman Islands. Although signal FS65 is controlled by the Fisherman Islands area coordinator, the signal will not clear to proceed unless the Mayne train controller operates an 'acceptance function'. This is an added measure to ensure that a Down train is not permitted to leave Fisherman Islands terminal and enter suburban traffic unless the Mayne train control centre is ready to accept it. Procedure NAG-BI-1834 requires drivers of Down trains to be available for contact with the Fisherman Islands area coordinator until departure. As shown in figure 10, a sign is affixed to signal FS65 that reads: 'Entrance Brisbane Suburban Control'.
