ATSB TRANSPORT SAFETY INVESTIGATION REPORT
Rail Occurrence Investigation 2005001
Final

Collision Between Freight Wagons (for train 4MP5) and Passenger Train 8622

Moonee Ponds Creek Junction, South Dynon, Victoria

19 January 2005

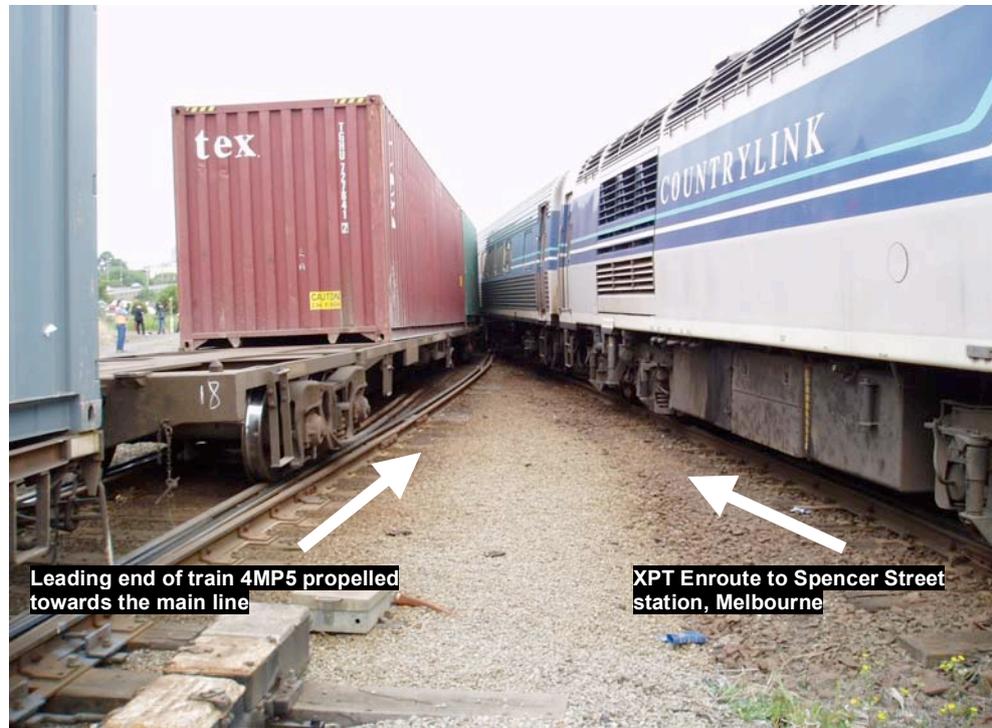
Figure 4: The occurrence scene at South Dynon. The photograph shows the trailing power car (Car A) and coach (Car B) of the XPT and the second freight wagon from the leading end of the shunting movement resting against Car B of the XPT. Part of the third freight wagon is on the left and the first freight wagon to derail is hidden behind the second freight wagon in the photograph.

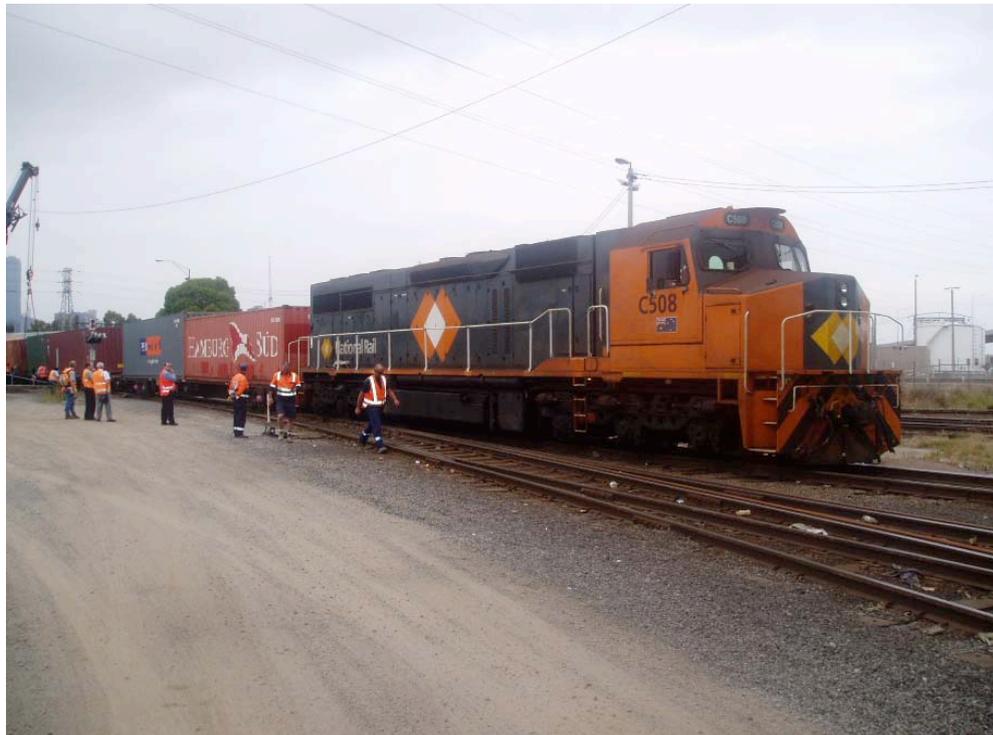
Figure 5: South Dynon Pilot Locomotive C508 engaged in recovery of the rear three wagons of 4MP5 following the occurrence

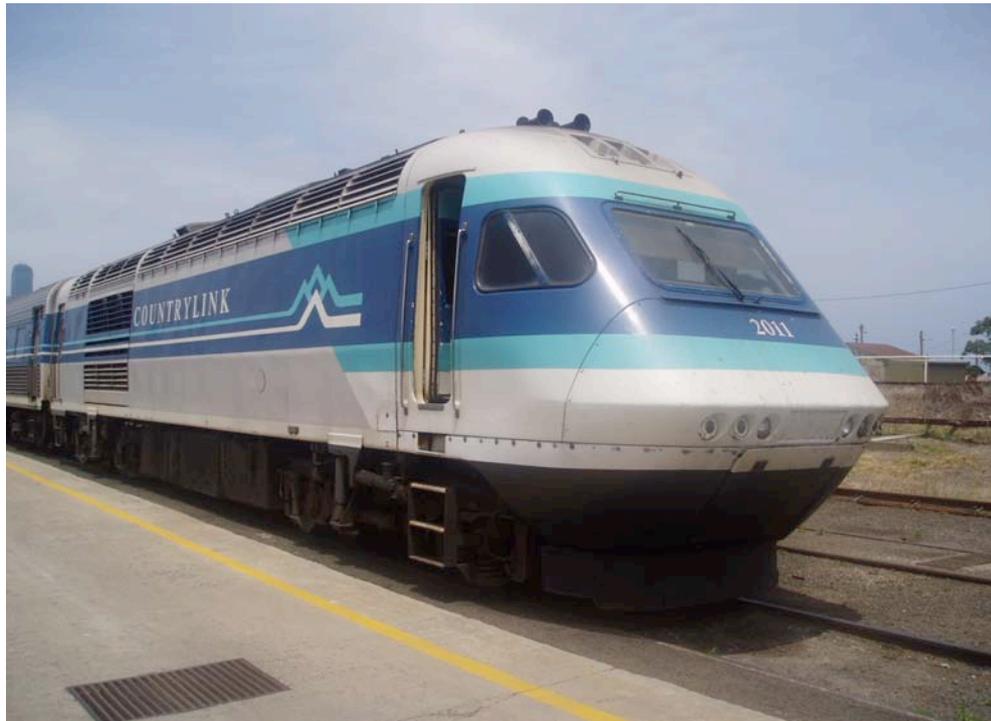
Figure 6: RailCorp XPT Driving/Power Car (Car A) standing in the Great Northern Siding (now Southern Short Haul Railroad Siding) following the occurrence

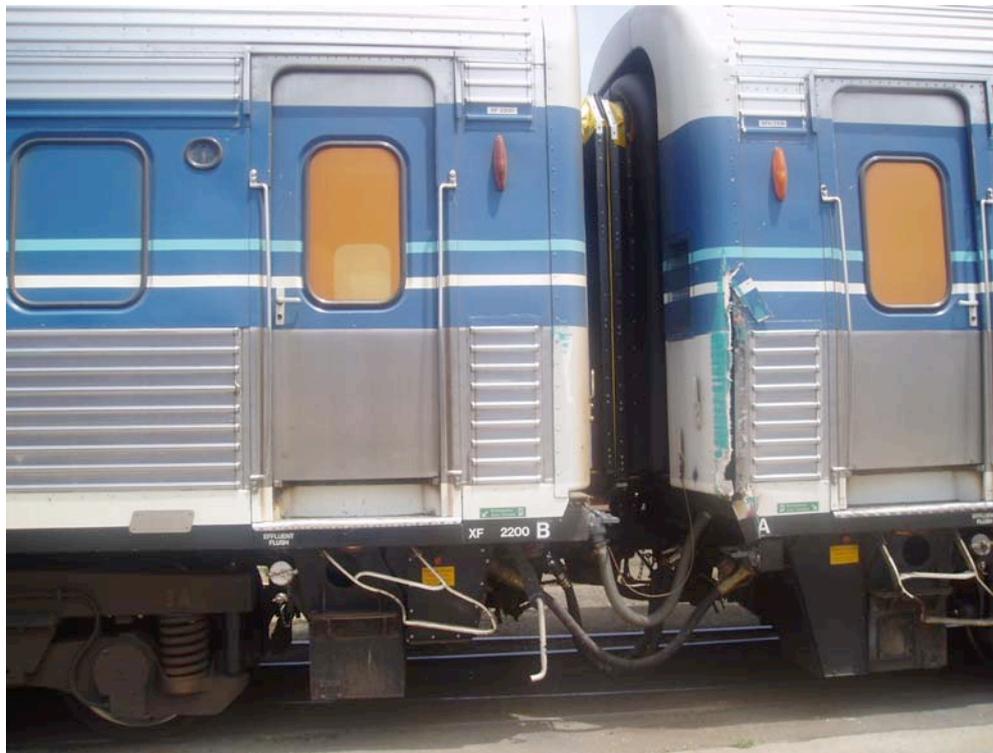
The collision resulted in damage to the XPT. The damage included car body fibreglass fractures, skidded brakes, bogies, skirting, and inter-car diaphragm damage. The damage was confined to cars XF2218 (Car D), XF2200 (Car C), and XFH2106 (Car B). Car XF2218 sustained most of the damage and was withdrawn for repairs with car XFH2106. The cars remained out of service for a number of weeks following the collision.

Figure 7: Example of fibreglass and door step damage to XPT cars C and B.

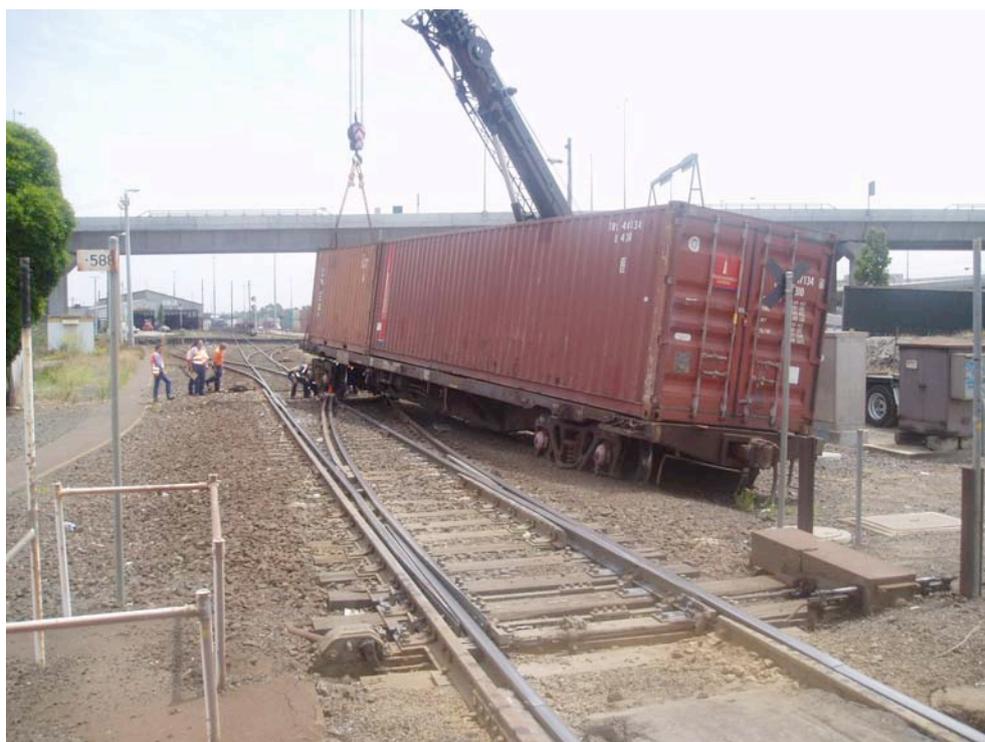
There was minimal damage to the wagons of the freight train with the rear-most two wagons, RQSY 34384B and RQPW 60077T, sustaining bogie and minor body damage. Some post-occurrence damage also came about as a result of oxy-acetylene cutting during recovery.

Figure 8: Recovery of rear-most wagon RQSY 34384B, in its final stopping position, being carried out following the removal of the XPT on Thursday 20 January 2005.

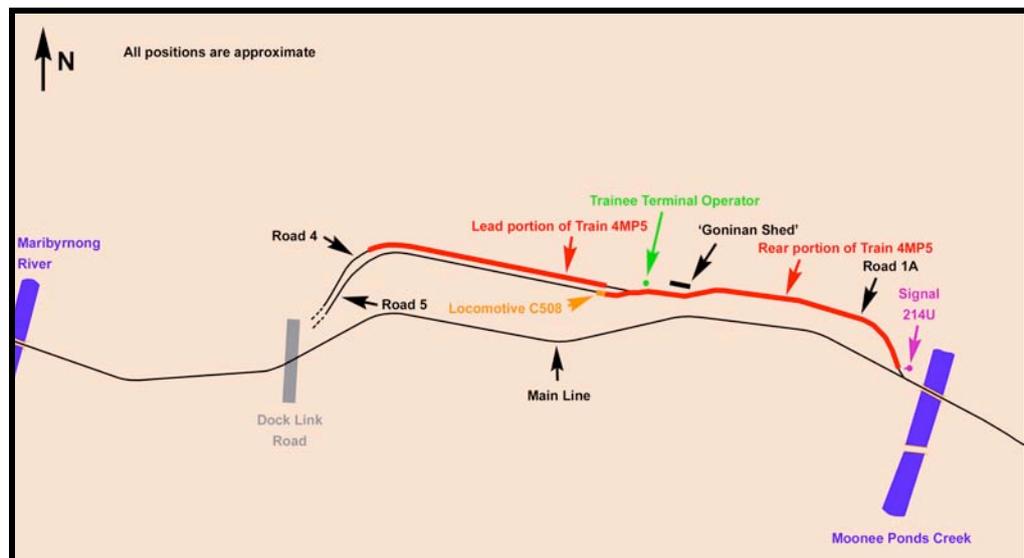
Figure 9: With the 697.2 metres rear portion in '1A' road and up against signal 214U, approximately three wagons would have remained in '5' road. The front portion would then have been required to move towards the western end of the yard and then propel into '5' road to amalgamate with the rear portion.

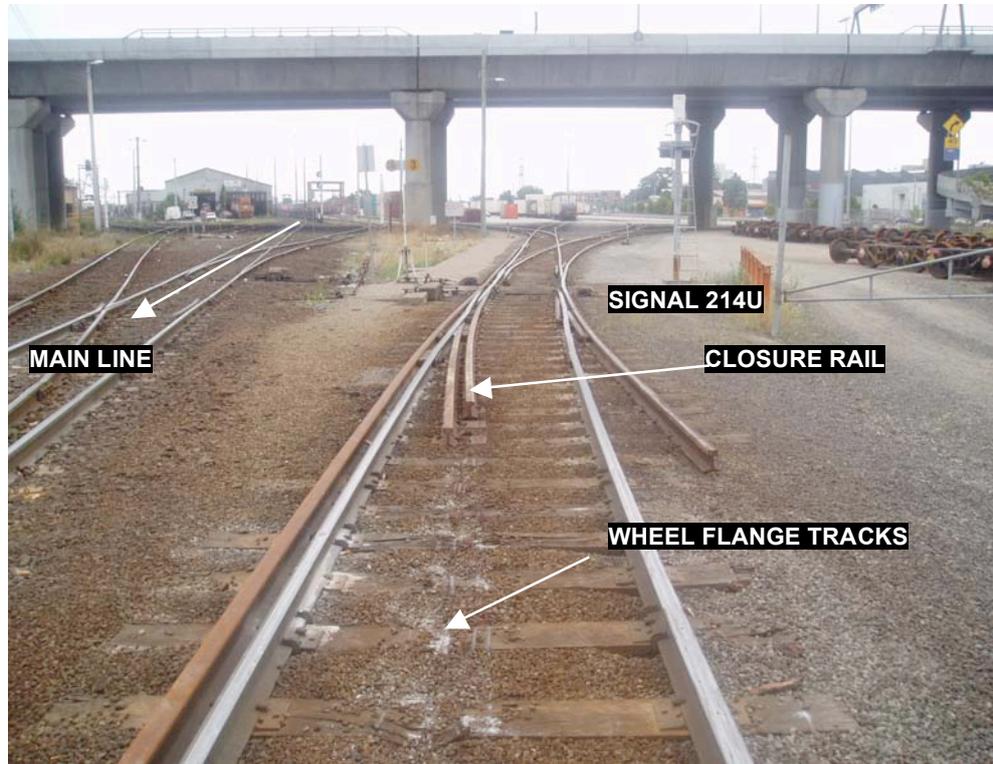
The propelling movement passed signal 214U at stop and engaged catch-points 215D set to divert moves away from the main line. The effective length of the catch-points was 12.8 metres, or 13.75 metres beyond signal 214U. The catch-points had initially deflected the wagon away from the main line, but only for a limited distance. Had the leading wagon stopped at this time, an ‘unsafe movement’ would have been prevented.

Figure 10: Looking from the east, wheel flange tracks indicate the path of the derailed wagons and their reversion towards the main line once leaving the closure rails of the catch-points (flange marks on the opposite side had been erased during recovery work)

The ATSB recommends that the Victorian Department of Infrastructure consider the level of performance and implement improvements to the Moonee Ponds Creek Junction, South Dynon catch-points number 215D. The development of improvements should be based on the outcomes of a risk assessment and control measures may include but not be limited to the use of a throw-off rail or cross-over 'natural trap' style catch point or equivalent.

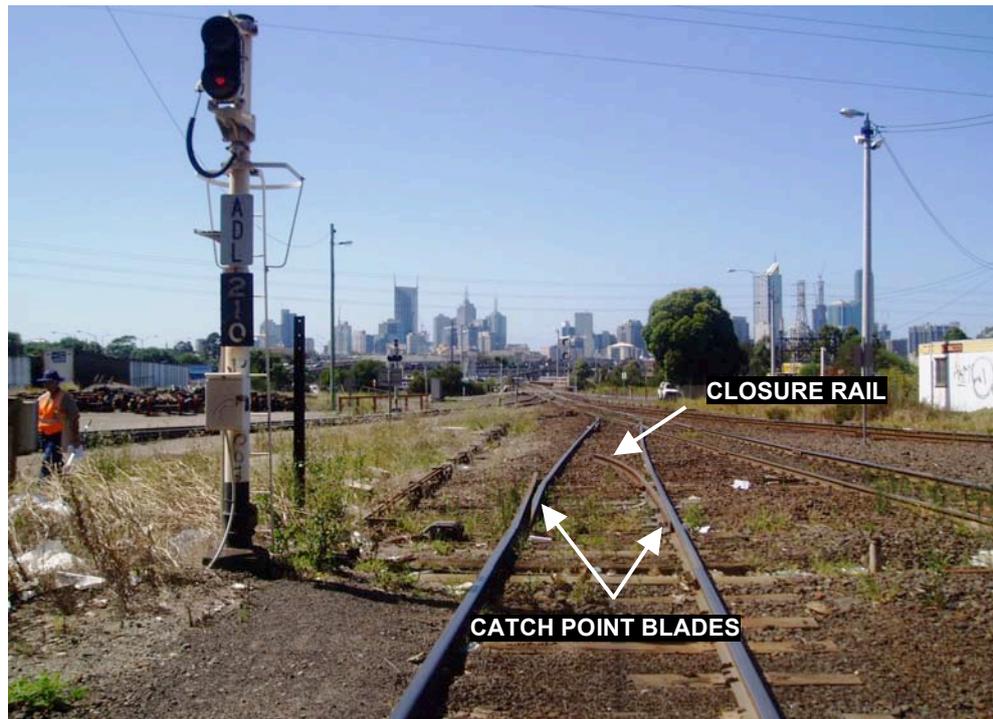
Figure 13: Double blade catch-points at South Dynon
