ATSB TRANSPORT SAFETY INVESTIGATION REPORT
Rail Occurrence Investigation 2005/005
Final

Collision between Freight Train 5BS7 and Track Vehicle Greenbank, Queensland

25 August 2005

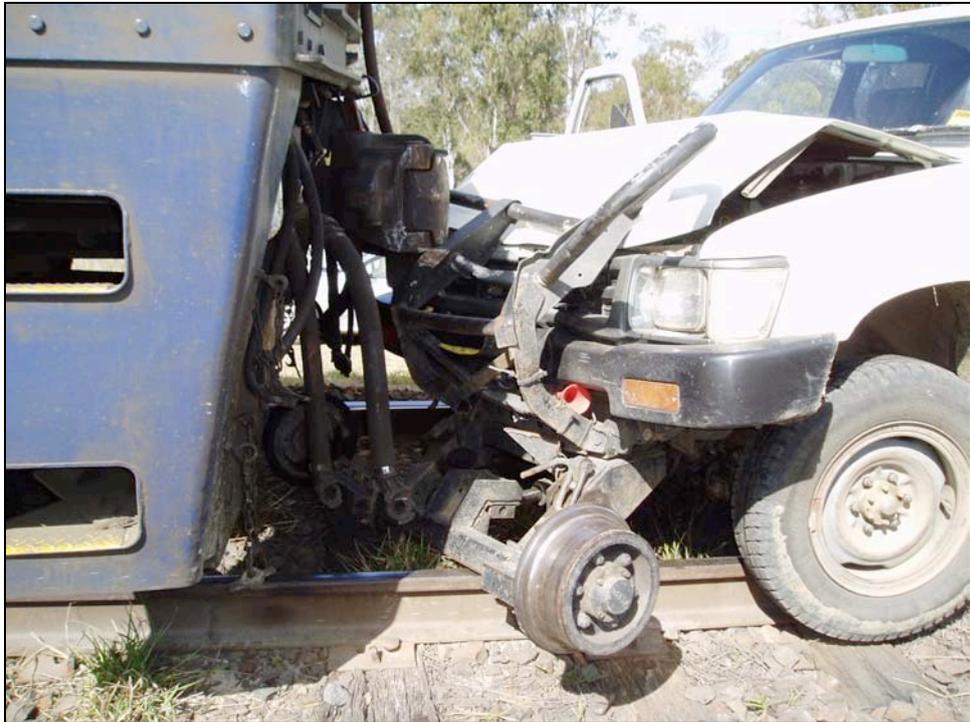
Figure 6: Track vehicle wedged under locomotive coupler

The force of the collision had wedged the front ‘bull-bar’ of the track vehicle under the automatic coupler of locomotive EL51. At 1355 a crane arrived on site to extract the track vehicle and lift it clear of the track. This task was completed at 1415.

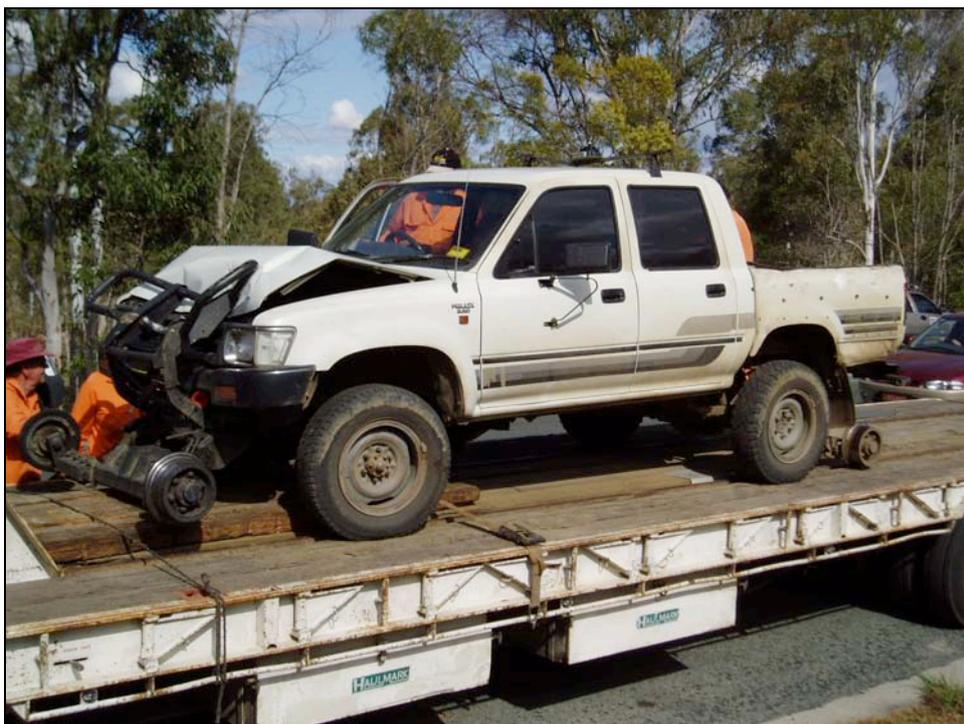
Figure 7: Damage to track vehicle

The track vehicle suffered considerable damage to the front end and was rendered inoperable as a result. The lead locomotive of train 5BS7 was not damaged to any significant extent.

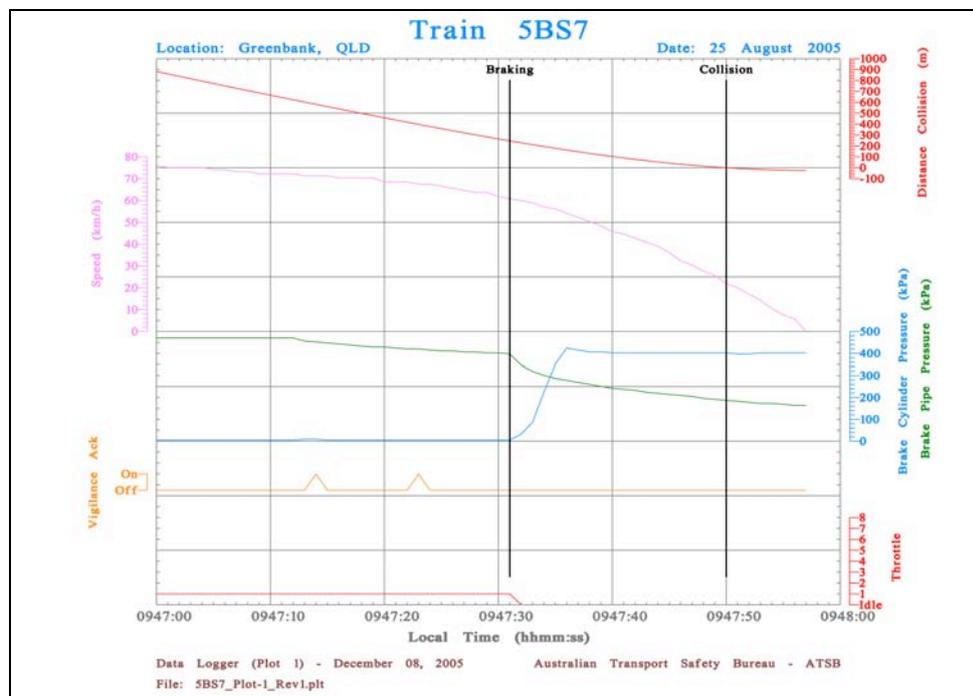
Figure 12: Data logger reproduction

²⁷ The wheel size of locomotive EL51 was 966mm compared to 1016mm for a new wheel. 966mm is near the minimum diameter allowed. Fischer Mark One data loggers can be adjusted to take account of wheel wear, however in this case no adjustment had been entered. Therefore the speed and distance recorded were corrected by a factor of 0.9508 to reflect the actual wheel diameter.

metres before stopping. The operation of the locomotive whistle and headlight are not recorded.

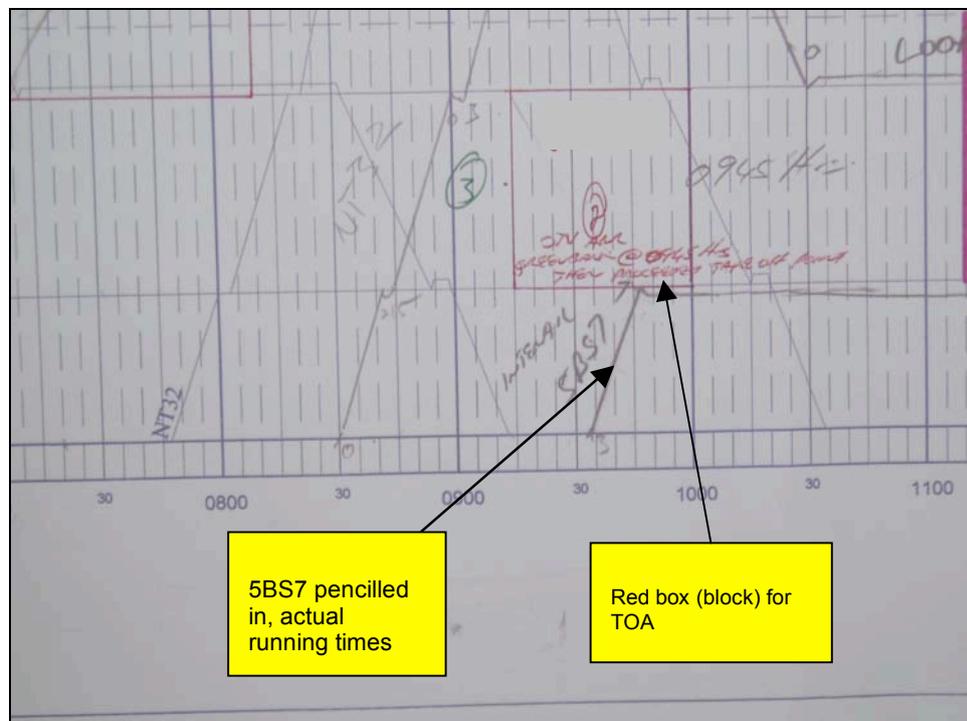
Figure 13: Endorsement of train diagram

comments ‘on arr Greenbank @0945hrs³⁰ then proceed to take-off point’. Train 5BS7 is shown as having departed Acacia Ridge at 0933 and arriving at Greenbank at 0948. There is no line ‘pencilled in’ for this train beyond Greenbank.

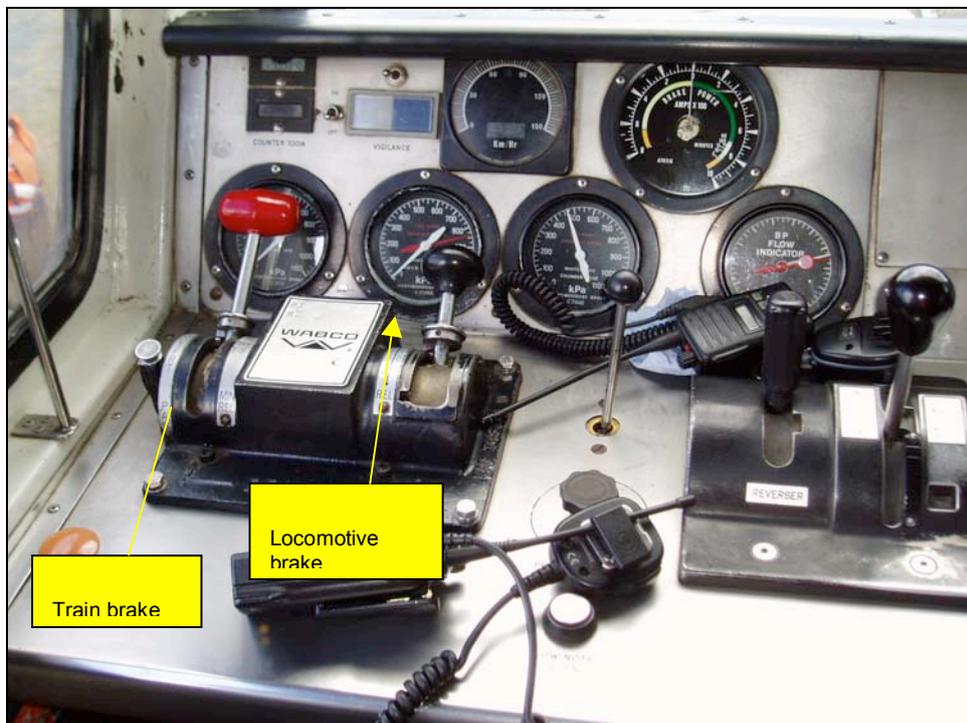
Figure 14: Train brake in emergency, locomotive brake fully applied EL51

Apart from the active response in trying to stop train 5BS7 before colliding with the track vehicle at Greenbank, the actions of the train crew played no part in the collision as they had authority to occupy the section of track from Acacia Ridge and into Greenbank yard. The locomotive data download shows that at 246 metres from impact action was taken to stop that train as quickly as possible. Although the illumination of the headlight and whistle operation was not recorded by the data logger, the evidence of the track workers matches that of the train crew in that the headlight was illuminated and the whistle sounded.

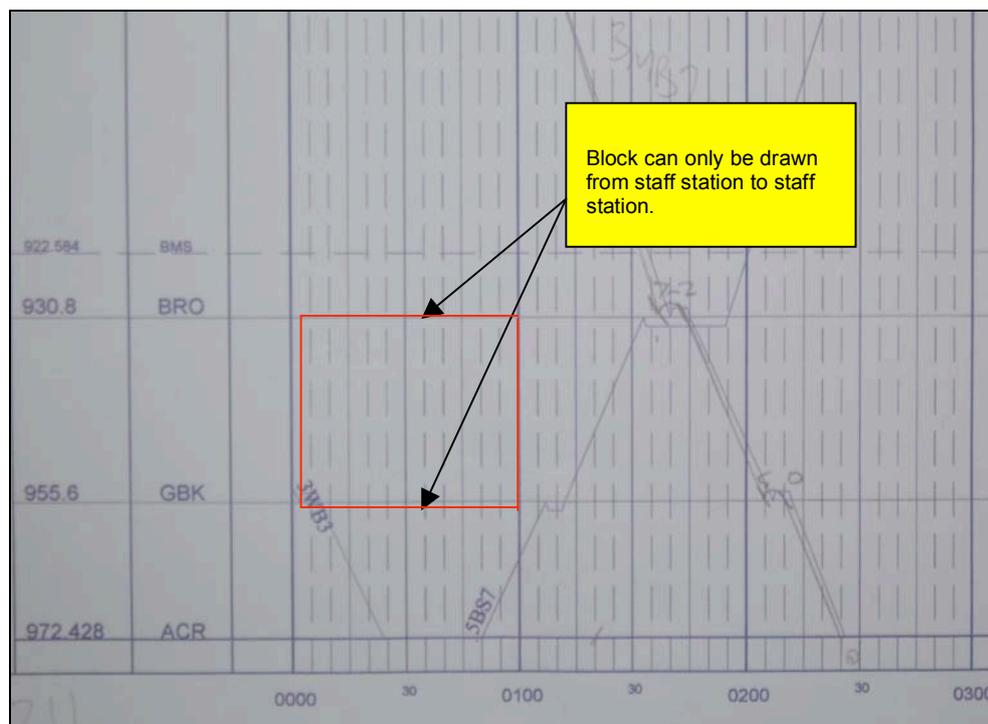
Figure 15: Example, block drawn on train graph

On the Acacia Ridge to Glenapp corridor, the home signals at the unattended staff stations are approach cleared uncontrolled signals and cannot be changed by the controller. The block, as drawn on the train control diagram, is from staff station to staff station and does not differentiate between station yard limits (home signals) and the section itself. An electric staff gives authority to the home signal and a proceed indication in the home signal gives authority to enter the staff station yard limits.

Therefore, to ensure a block between a non-track-circuited track vehicle and another movement (train or track vehicle) these opposing movements cannot be allowed to simultaneously enter the unattended station yard limits. This can be achieved by either holding the track vehicle at the home signal by not issuing the final paper-based TOA to enter the station yard limits, or by holding the train or the track vehicle at the previous staff station. In both examples this restraint would be until advice is received that the opposing movement has arrived within the unattended staff station yard limits.

The ATSB recommends that Queensland Rail ensure that appropriate blocking facilities are applied on the Acacia Ridge to Glenapp corridor to prevent conflicting movements between trains and non track-circuited track vehicles. Such measures to be progressed conjointly with the custodians of the rules and procedures that apply on the Glenapp to Casino corridor.
