ATSB TRANSPORT SAFETY INVESTIGATION REPORT
Rail Occurrence Investigation 2006/003
Final

Signal 161 Passed at Danger TransAdelaide Passenger Train H307

Adelaide, South Australia

28 March 2006

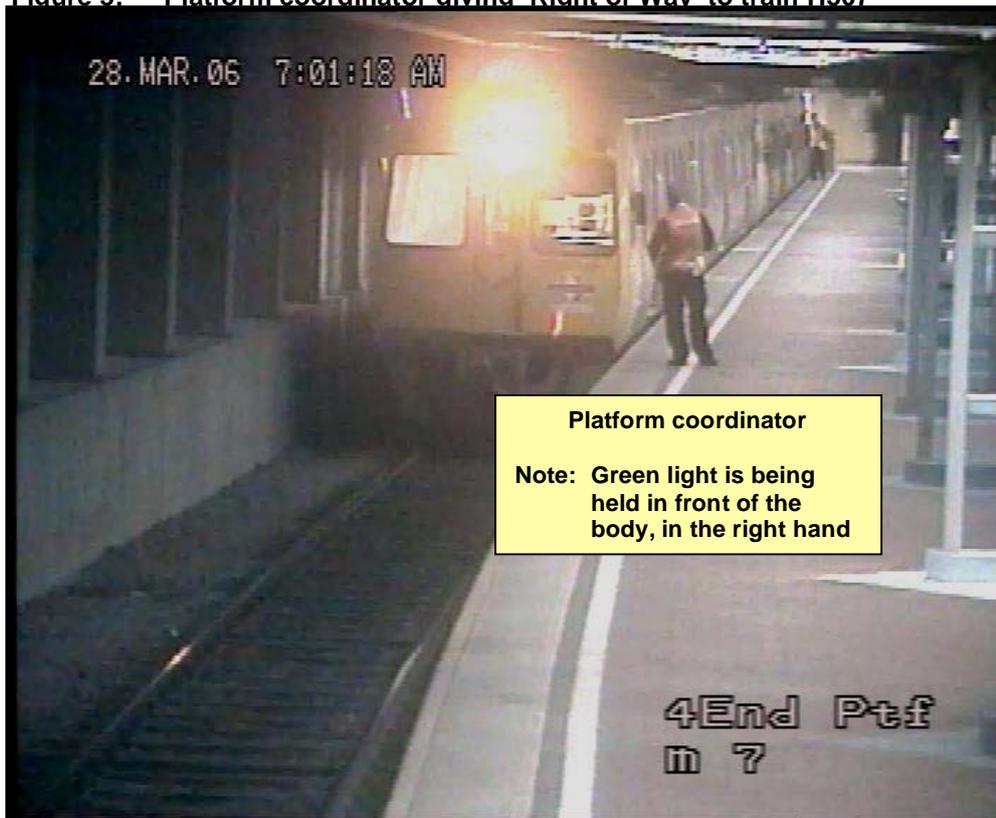
Figure 5: Platform coordinator giving 'Right of Way' to train H307

At the time when the platform coordinator provided RoW, signal 161 was displaying a red light. The steady green light directed at the driver by the platform coordinator was a 'cue' which was in direct conflict with the red light displayed by the signal. It is possible that the driver responded to the cue to proceed represented by the green signal from the platform coordinator and had failed to check that there was a similar indication showing on signal 161.

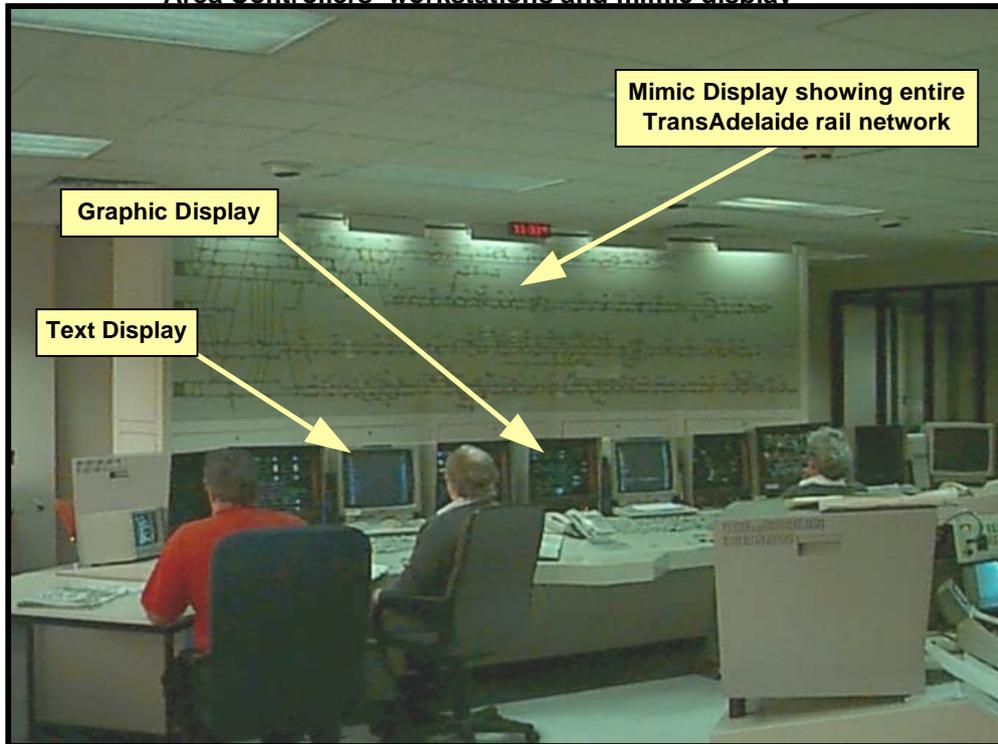
Figure 6: TransAdelaide CTC – Area Controllers' workstations and mimic display

Train H307 passed signal 161 at 07:01:37. The SPAD notification, mimic and graphic indication at train control would have occurred within one or two seconds. At, or around this time, it would be normal for the controller to attempt a command to clear signal 161 for the scheduled service. The failure of points AD54 was approximately 34 seconds after H307 passed signal 161. By this time, all of the indications listed above had occurred. However, train H307 continued to travel undetected on the wrong track for a further 440 m.
