Overrun of authority involving train 6MP5

Blamey, Western Australia, 14 July 2013

ATSB Transport Safety Report
Rail Occurrence Investigation
RO-2013-019
Final – 7 July 2014

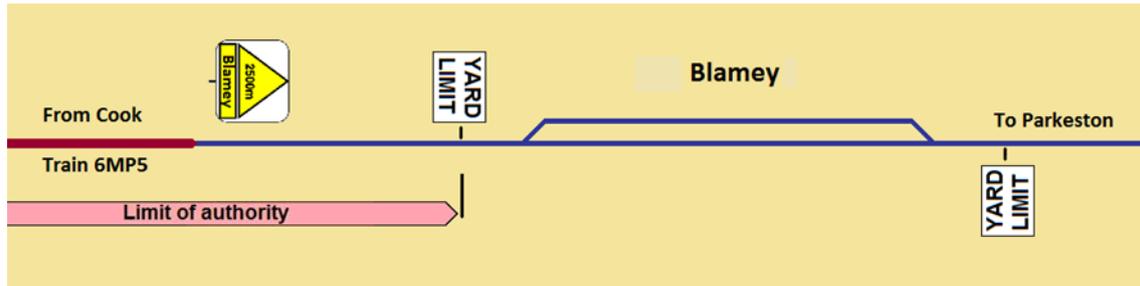
Figure 2: Illustration of 6MP5 limit of authority at Blamey

Train authority TA W97 did not specify which line train 6MP5 was to occupy at Blamey. Therefore, the limit of authority for train 6MP5 was the Yard Limit sign at the eastern end of the yard as per the rules contained in the CoP.⁸ Yard Limit signs are located 100 m prior to the facing points at each crossing loop. Location Ahead signs are placed 2,500 m before the Yard Limit to warn train crews or other rail safety workers that they are approaching a crossing loop (Figure 2).
