Safeworking irregularity

Glenrowan, Vic | 29 October 2013

ATSB Transport Safety Report
Rail Occurrence Investigation
RO-2013-025
Final – 23 January 2014

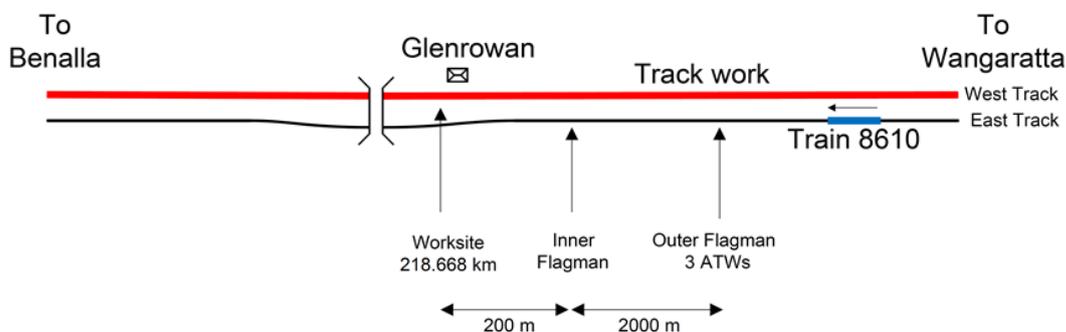
Figure 2: Glenrowan location of track works and Track Force Working

At approximately 0730, V/Line passenger train 8610, travelling between Albury and Melbourne on the east track, stopped at Wangaratta to pick up passengers. The track force coordinator at Glenrowan was made aware of the train by the flagmen on the west track. The track force coordinator then instructed the flagmen on the east track to remove the ATWs and allow the train to pass the work site unrestricted. This was done without informing the work site supervisor or any of the track workers.

At about 0744, the outer flagman observed train 8610 and contacted the inner flagman to let her know that the train was approaching. The inner flagman attempted to contact the track force coordinator multiple times, but did not get a response. The track force coordinator was in conversation with the work site supervisor and not within earshot of either of his radios. The inner flagman then tried to alert the track force coordinator by whistle without success.

At about the same time, the work site supervisor observed train 8610 approaching and called out 'Train on' on the work site radio. The track workers also saw the train and took action to ensure

that they and their machines were clear of the east track. The driver of train 8610 did not notice anything unusual as the train passed through the worksite (without incident) at about 0746.

- A post-incident meeting was held with all BRP³ personnel to discuss the incident and reinforce the necessity to follow procedures when providing track protection.
- The program manager instructed all site personnel that ATWs were to be left on track to warn of trains approaching worksites.
- Follow up training and recertification was provided regarding the relevant network safeworking rules.
