Collision between freight trains 2MP9 and 2MP1

Mile End, South Australia | 31 March 2015

ATSB Transport Safety Report
Rail Occurrence Investigation
RO-2015-007
Final – 16 December 2015

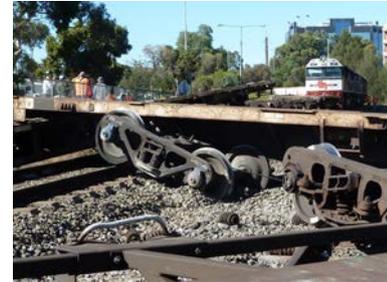
Collision site near Mile End

At about 0730 (CDT) on 31 March 2015, intermodal freight train 2MP9 passed No. 1 signal at the southern end of the Mile End crossing loop (South Australia). The signal was displaying a 'Calling on/Low speed' indication. The train proceeded at low speed, but subsequently collided with the rear end of intermodal freight train 2MP1, which was stationary on the main line. The collision resulted in moderate track damage and the derailment of three wagons at the rear of train 2MP1. There were no injuries to train crews.

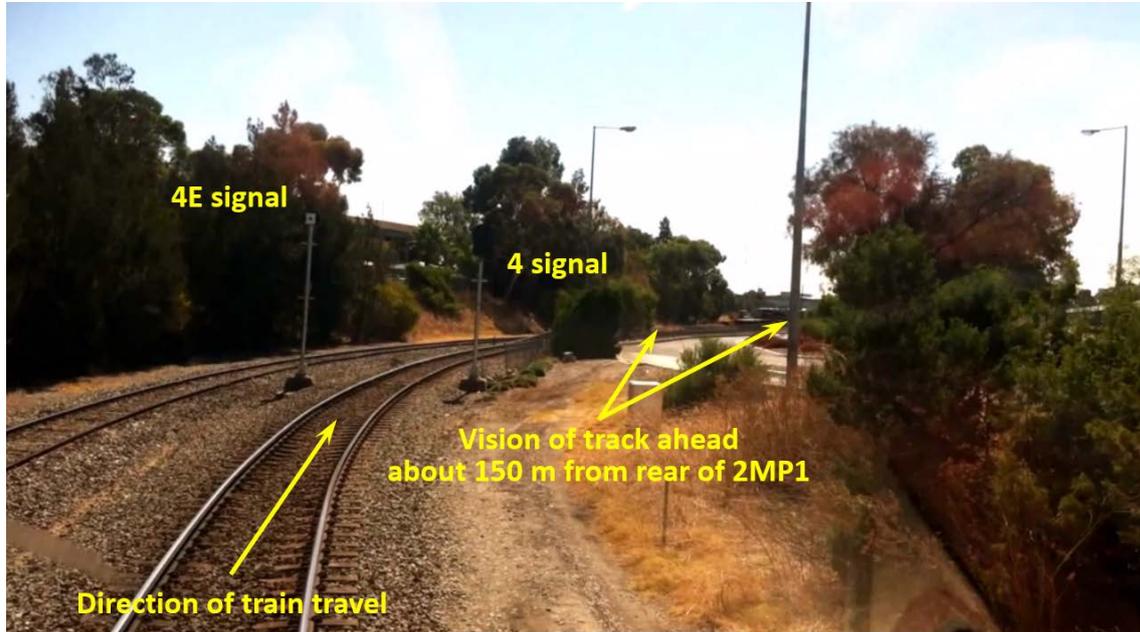
Figure 4: Cab view post-collision reconstruction, about 150 m from the rear end of 2MP1

Train 2MP9 continued on a very mild down grade, reaching a speed of 25 km/h before entering a sweeping right curve. Just after clearing the APT Access Bridge, the driver was able to see the track to a distance of about 150 m ahead, which initially, to him, appeared clear (Figure 4).

It was also noted (post-collision) that the rear end of train 2MP1 was partially obscured by stumpy vegetation and a low fence (Figure 4). As is evident in Figure 4, after passing under the APT Access Bridge the train driver and observer could see parts of the track ahead as it swept gradually to the right. However, the vegetation (part of which is outside the ARTC rail corridor) and fence obscured parts of the track. It was likely that with intermittent opportunities to observe the track ahead, the empty flat wagons at the end of train 2MP1 were not sufficiently conspicuous against the visual background as to be perceived by the crew of 2MP9. Thus, the driver did not recognise the need to slow the train (below 25 km/h) as there was no apparent obstruction in his visual field.

The ATSB recommends that the ARTC takes action to improve the sighting distances available within the Mile End crossing loop by removing unnecessary vegetation and other obstructions.

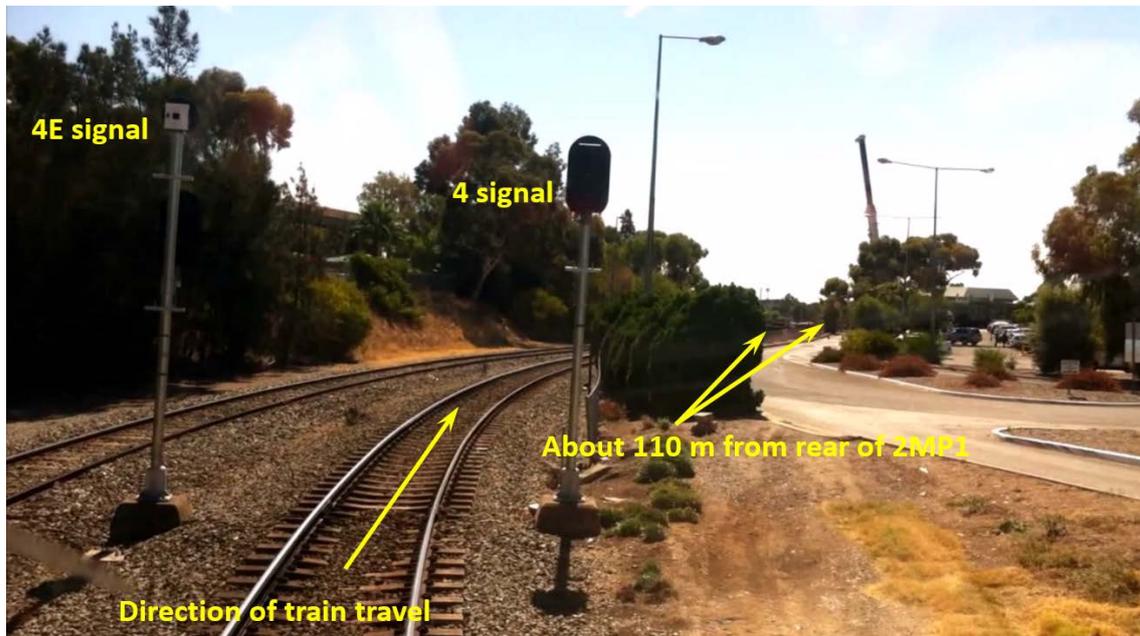
Figure 5: Cab view post-collision reconstruction, about 110 m from the rear end of 2MP1

After travelling, a further 40 m (Figure 5) the driver saw what appeared to be a series of empty flat wagons on the track ahead. He applied the train's dynamic brakes (D8) and immediately followed this with an emergency brake application.

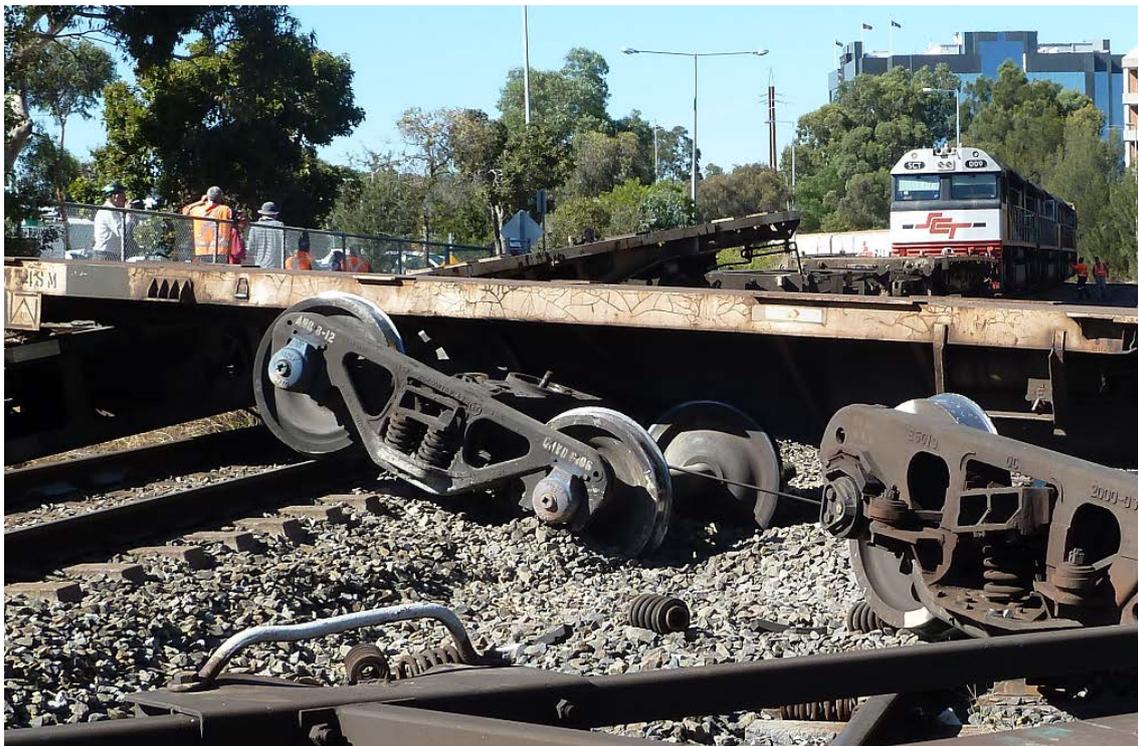
Figure 7: Collision site - lead locomotive SCT009 in the background

He was unable to stop the train before colliding with the rear end of 2MP1 (Figure 7) at an estimated speed of 22 km/h.

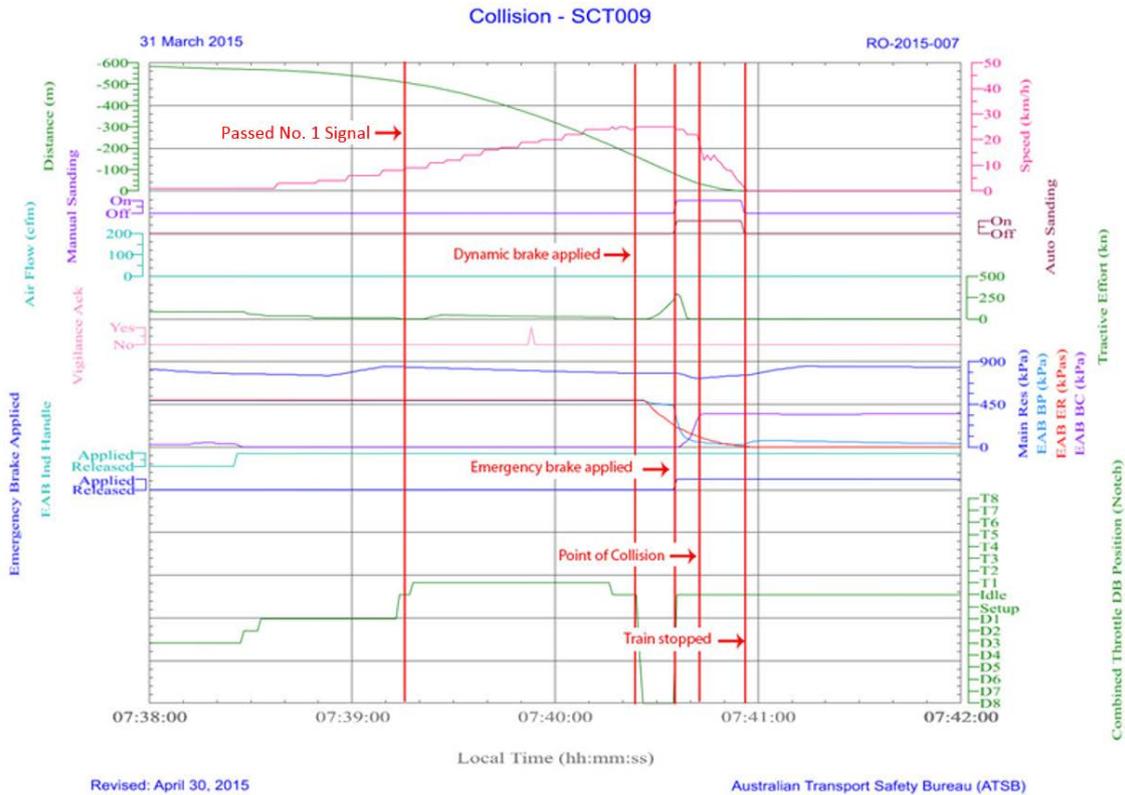
Figure 9: Graph derived from Loco-log SCT009

Analysis of data extracted from the Loco-log (SCT009) for train 2MP9 (Figure 9) established:

- As the train approached No. 1 signal, the driver progressively reduced the train speed and reached a near crawl (1 km/h) before commencing to accelerate.
- When train 2MP9 passed No. 1 signal it was travelling at a speed of 8 km/h and continued to accelerate, reaching a maximum speed of 25 km/h. The driver then set the throttle to idle.
- Eight seconds later the driver applied the dynamic brakes (D8) and immediately followed this with an emergency brake application.
- About 6 seconds after the emergency brake application, a sharp decrease in train speed was evident, probably coinciding with the time that train 2MP9 collided with train 2MP1.

- About 15 seconds later (post-collision), train 2MP9 was at stop.
- Loco-log data established that while approaching Mile End, the driver of 2MP9 was actively controlling/maintaining the train’s speed by applying a range of throttle commands.

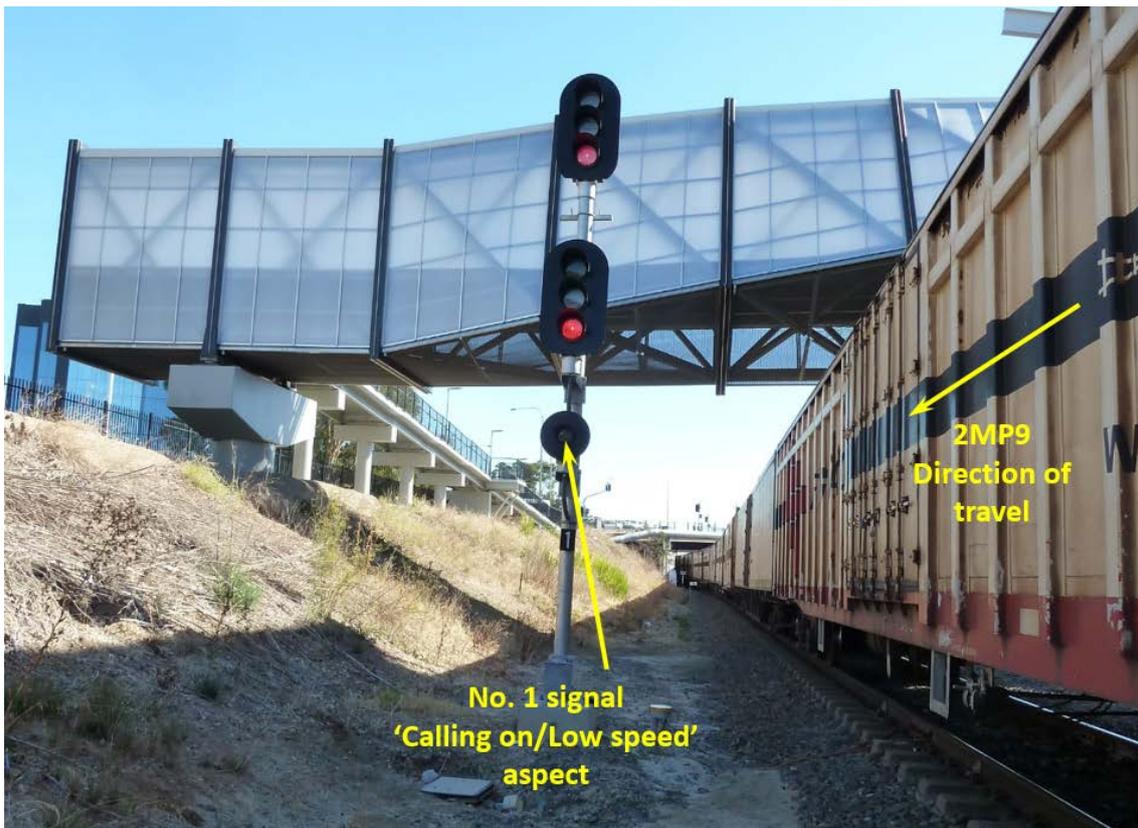
Figure 10: No. 1 signal showing position of Calling on/Low speed aspect

The Mile End crossing loop was controlled by fixed colour light signals using track circuits for train detection. From No. 1 signal (Figure 3 and Figure 10) at the southern end of the Mile End crossing loop, the track leading into the collision site basically comprised two relatively tight sweeping curves, the first to the left followed by a curve to the right. The track is on a very mild down grade before entering the crossing loop. Sighting along this section of track was intermittently obstructed by fixed infrastructure (Anzac Highway Bridge and APT Access Bridge) in addition to low bushes and a small tree.
