ATSB TRANSPORT SAFETY REPORT
Rail Occurrence Investigation RO-2009-002
Final

Safeworking irregularity involving the *Indian Pacific* (4SA8) and the XPT (WT28) Tarana, NSW

14 January 2009

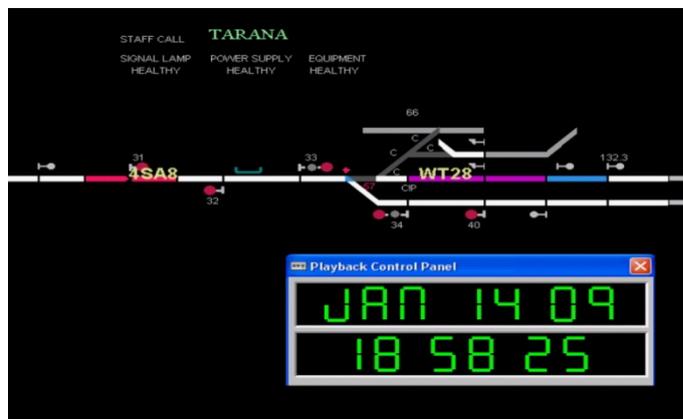
Figure 4: Phoenix replay at 1858:25 (enhanced)

At about 1850, the network controller set number 57 points at Tarana to the reverse position in anticipation of routing train 4SA8, the *Indian Pacific*, to Bathurst via the Up Main line, also an unsignalled move and in the wrong-running-direction. Being an unsignalled movement, this required a SPA for the train to proceed. SPA 38 was issued at 1851 authorising the *Indian Pacific* to pass signals TA31 and TA33 at 'Stop', over 57 points set reverse, then along the Up Main line in the wrong-running-direction to the first controlled signal, 105 at Kelso (near Bathurst). The *Indian Pacific* passed signal TA31 at 1858:25 (Figure 4) clearing it at 1859:33 at an average speed of 18.9 km/h.

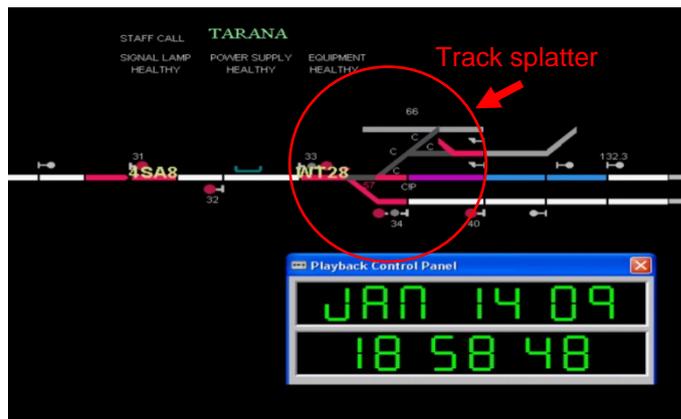
Figure 5: Phoenix replay at 1858:48 (enhanced)

At 1858:48, the *XPT* was recorded as occupying 57 points track circuit, represented by 'track splatter'¹⁰, see Figure 5. Shortly after the train driver noticed 57 points in the reverse position. The driver immediately stopped the train, bringing it to stand adjacent to the 198.500 km post near signal TA34. Had he continued, the train would have traversed and damaged 57 points, as they were set in the wrong position for his movement. The *XPT* would then have been in direct conflict with the *Indian Pacific*.

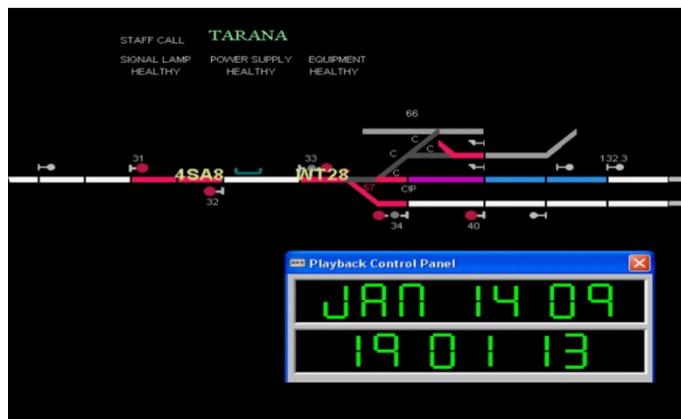
Figure 6: Phoenix replay at 1901:13 (enhanced)

The driver of the *Indian Pacific*, on seeing the *XPT* standing near 57 points, brought his train to a stand at 1901:13, see figure 6, at that time about 524 m from the *XPT*.

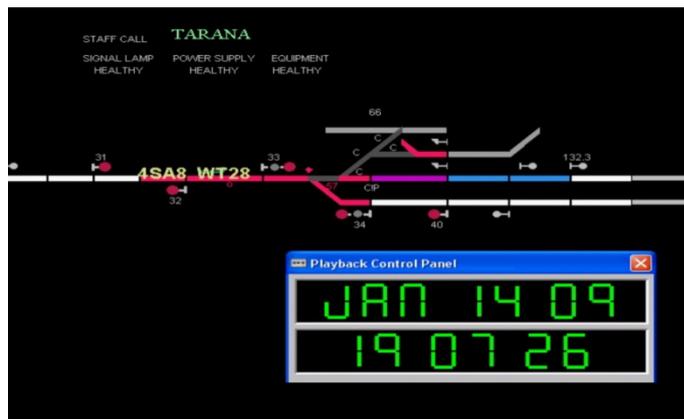
Figure 7: Phoenix replay at 1907:26 (enhanced)

At 1907:26, the *Indian Pacific* departed Tarana traversing 57 points set reverse and onto the Up Main line (Figure 7). The rear of the train cleared signal TA32 at 1907:36.

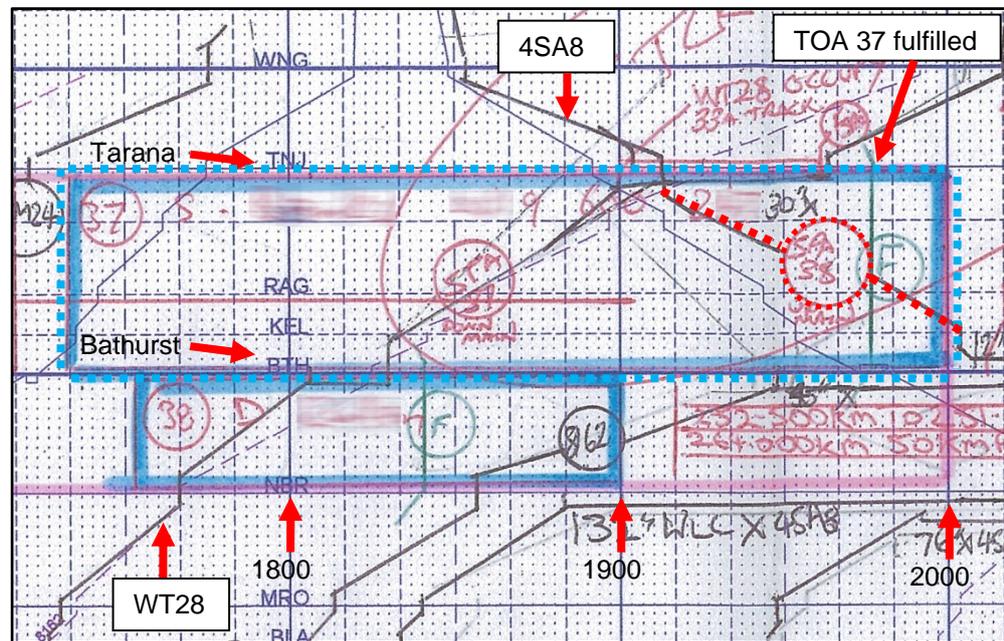
Figure 8: Extract from train control graph (West Board)

At 1720, Track Occupancy Authority (TOA) number 37 was issued for the Up Main line between Bathurst and Tarana. At 1846, the TOA was fulfilled but the network controller incorrectly recorded 1946 on the train control graph. However, the same network controller issued SPA number 38 at 1851 to the driver of train 4SA8 to travel over the Up Main line.

..... TOA 37 authority, SPA 38 Authority.

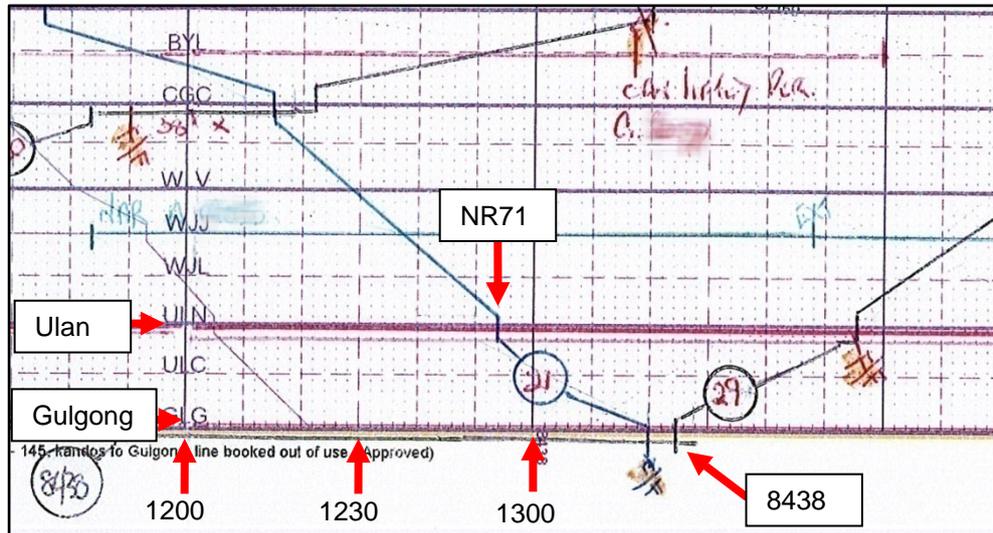
Figure 9: Extract from train control graph (Upper Hunter 2)

An investigation into the incident established that on 22 November 2008, SPA working was in operation between Ulan and Gulgong, NSW, due to a staff instrument/signalling system failure (see train control graph Figure 9). At about 1225, the crew of train 8438, standing at Gulgong, contacted Broadmeadow train control for an authority to enter the section. Another train, NR71, was programmed to enter the section at Ulan and travel to Gulgong before train 8438. However, a SPA form (number 29) was pre-filled for train movement 8438. The form was dated 22 November 2008 and time stamped 1225, making it a valid authority to enter the

section before NR71 had entered and completed its movement through the Ulan to Gulgong section. Fortunately, the train crew of 8438 were aware of the intended movement and waited for NR71 to exit the section before entering and fulfilling it at 1355. The crew of train NR71 were issued SPA number 21 at 1248, fulfilling it at 1320.

In this instance, the network controller from one area (West Board) pre-issued a SPA and unwittingly authorised it, before another network controller (Upper Hunter 2) had authorised and issued a SPA for the same section. This created a 32 minute overlap of authorities.
