**ATSB TRANSPORT SAFETY REPORT**  
Rail Occurrence Investigation  
RO-2009-008  
Final

**Signal Passed at Danger by Train ST24  
Junee, New South Wales  
9 September 2009**

At about 1411 on Wednesday 9 September 2009, scheduled XPT passenger train ST24, en route from Melbourne to Sydney, passed signal JE02 at Junee by about 33 m while that signal was displaying a Stop (red) indication. No injuries or damage resulted from the occurrence.

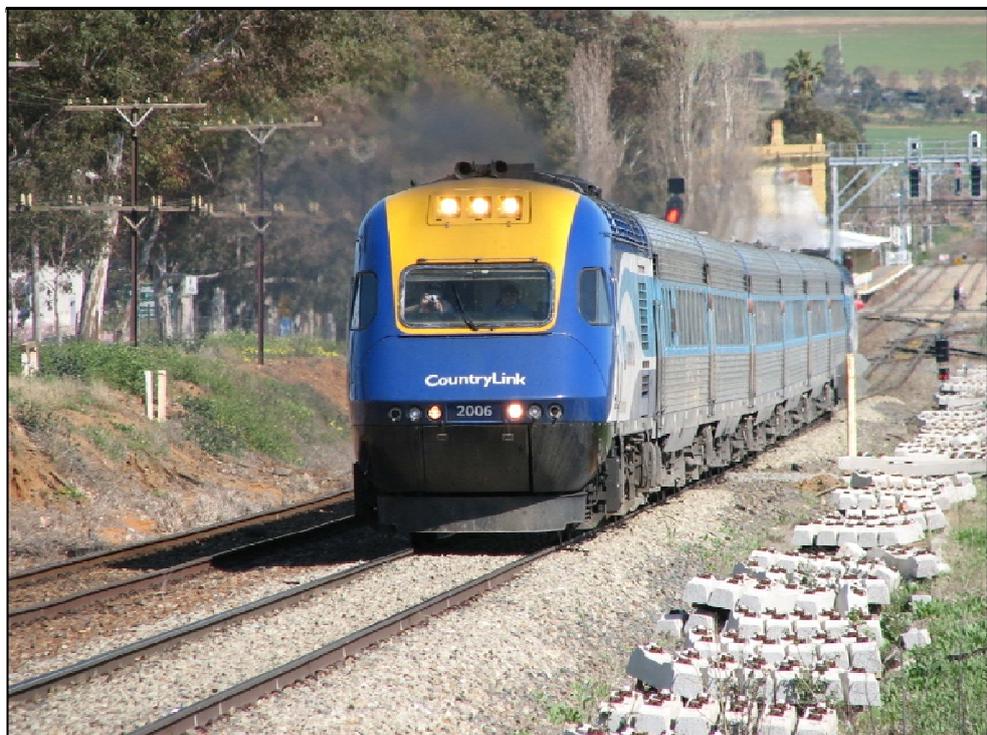
**Figure 2: CountryLink XPT approaching signal JE02 at Junee**

Signal JE02 was mounted on a pole to the left of the Up Main line. The signal was equipped with an older style incandescent globe. Unlike LED signals, the light output from incandescent lamps is critically dependent on voltage and the optical performance of the lamp also makes focusing a critical factor. Onsite observations noted that the performance of signal JE02 appeared inferior to that of other signals in the Junee Yard. The voltage at signal JE02 was tested by the ARTC and found to be below the requirements of the ARTC standard. When the voltage was raised to the appropriate value, the brightness of the signal indication improved appreciably.

While signal JE02 appeared to have exhibited degraded performance at the time of the SPAD, the train driver should have been aware of its indication based on the aspect displayed by the previous signal (in this case JE26) and driven the train accordingly. Consequently, the performance of signal JE02 was not considered to have directly contributed to the SPAD. However, it was still considered a safety issue that could increase the safety risk to train operations.

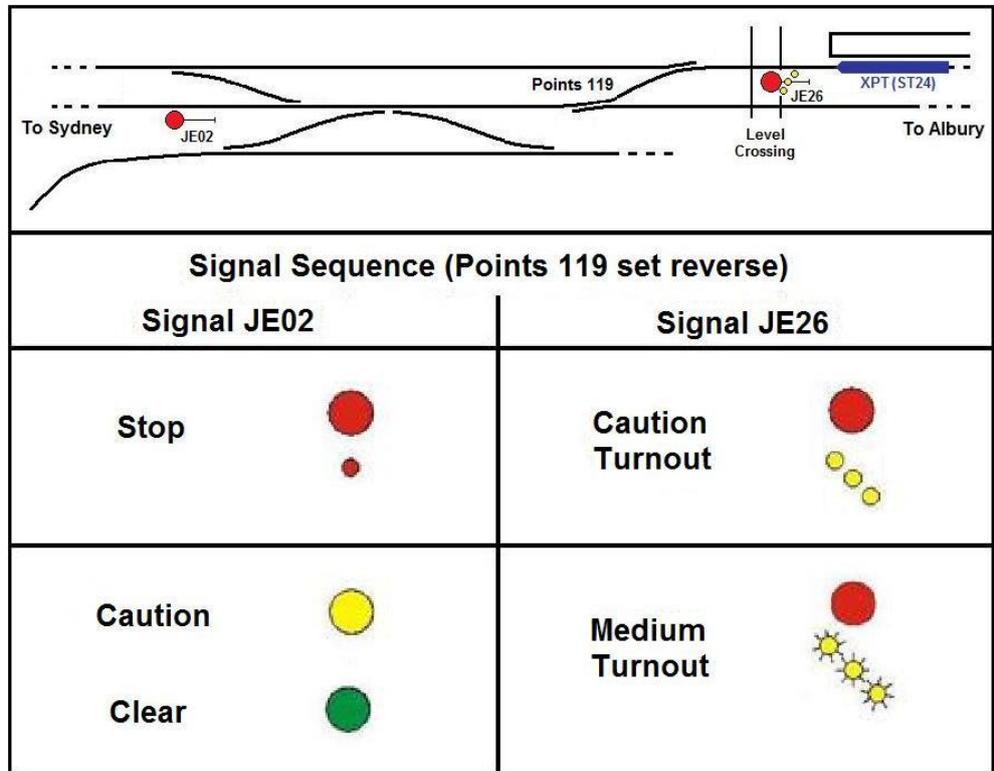
Figure 5: Signal sequence for signals JE26 and JE02

Signal JE02 was a colour light signal with a three light main head. The signal was located about 940 m beyond the northern end of the Junee Platform. Figure 5 shows the signal sequence displayed to a train driver travelling from signal JE26 (departing the Junee Down Platform) onto the Up Main via points 119 set reverse.

A Caution Turnout indication is displayed on signal JE26 when signal JE02 is at stop. When sighting a signal displaying a Caution Turnout indication, a driver should be prepared to stop at the next signal.

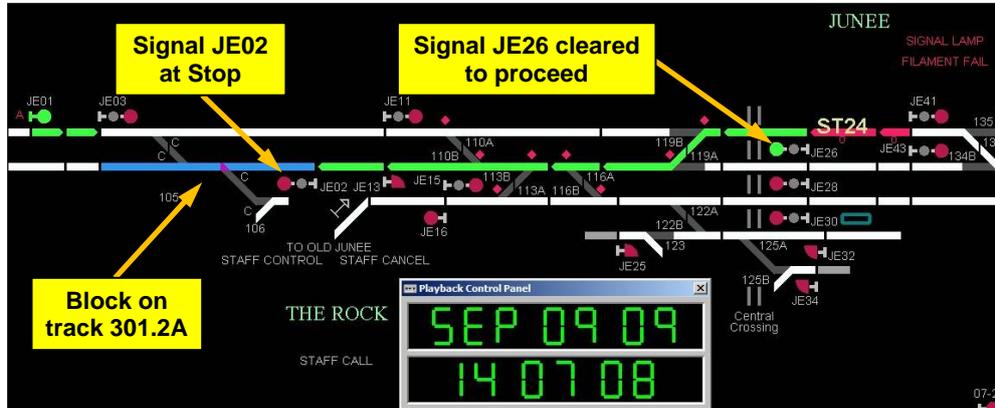
**Figure 8: Phoenix replay system – Event time 1407:08**

Figure 8 shows the Phoenix replay system displaying the signal data that was recorded at 1407:08. Signal JE26 has cleared to a Proceed aspect and the route up to signal JE02 is shown as available (green track indications). However, it is evident that signal JE02 has not been called, is displaying a red indication and track 301.2A is shown as blocked (blue track indication).

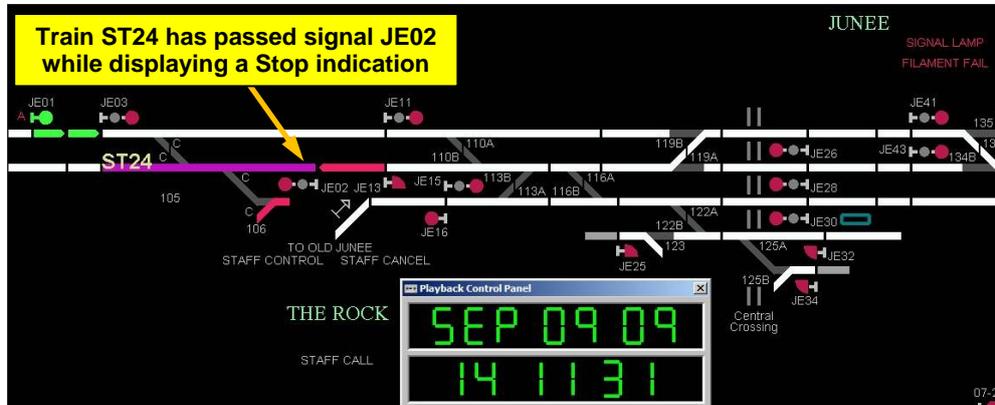
**Figure 9: Phoenix replay system – Event time 1411:31**

The recorded data indicated that train ST24 departed Junee station, travelled over the points and advanced through the block section towards signal JE02. At 1411:31, the data indicates that train ST24 passed signal JE02 while this signal was displaying a Stop indication (Figure 9).

The recorded data showed that for the entire sequence, from the time train ST24 was at the station through to the time of the SPAD, signal JE02 was displaying a red Stop indication and a block was applied to track 301.2A.
