ATSB TRANSPORT SAFETY REPORT
Rail Occurrence Investigation RO-2009-009
Final

Reported signal irregularity at Cootamundra NSW involving trains ST22 and 4MB7

12 November 2009

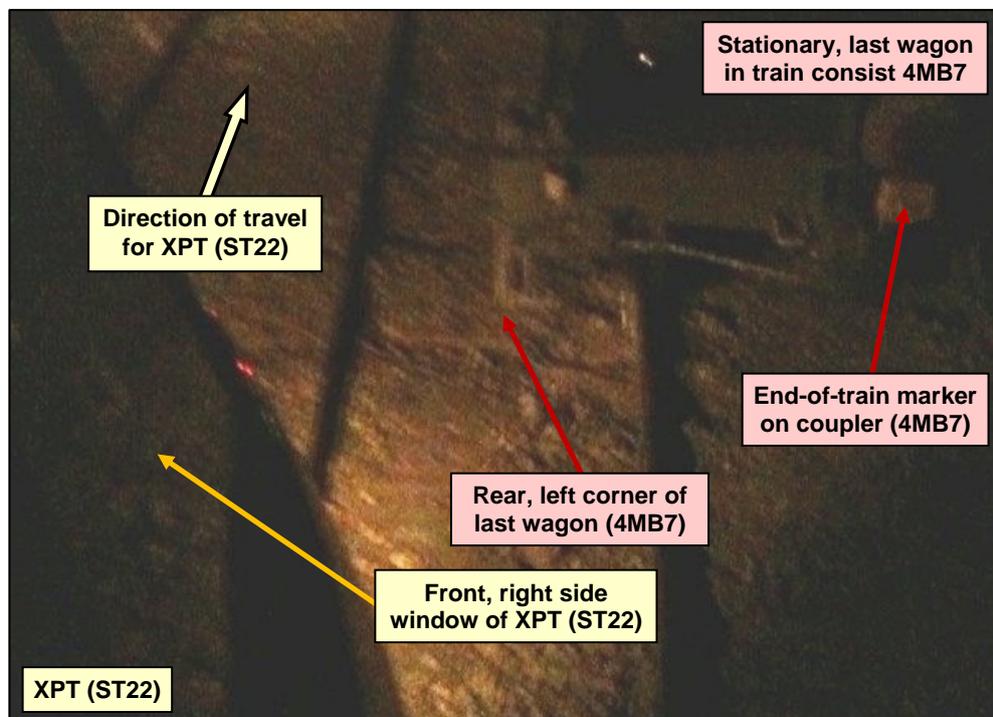
At about 0217¹ on Thursday 12 November 2009 train ST22, an XPT passenger service, was being routed into No.1 Platform Road at Cootamundra, New South Wales. The driver of the XPT received a Medium Turnout² indication on signal CA74 signifying that the route into No.1 Platform Road was set and unobstructed. Shortly after passing over the Gundagai Road level crossing and traversing 136 points set reverse³ the driver of the XPT observed the last wagon of freight train 4MB7, located on the Up Main line, was obstructing the path of his train. He applied the train brakes and stopped just short of train 4MB7 (Figure 1).

Figure 1: Photograph taken from driving cab of XPT, with last wagon of 4MB7 in upper right

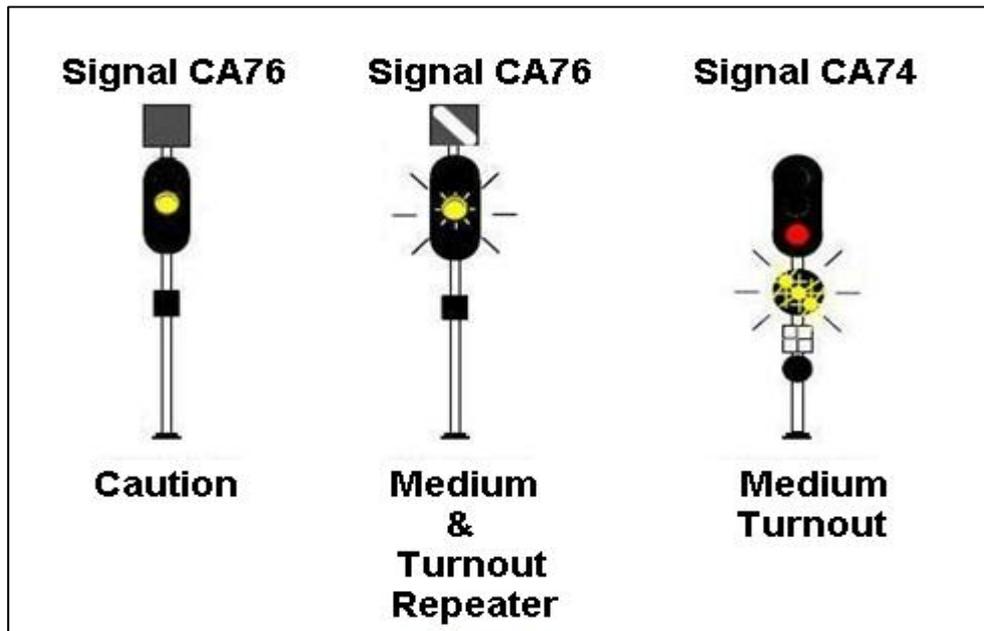
As the XPT approached Cootamundra the driver initially observed signal CA76, the signal before CA74, displaying a Caution indication (Figure 9). As the train neared signal CA76 it changed to a Medium (Figure 9) with the turnout repeater signifying that the train would be routed into No.1 Platform Road. At about this time the driver of train 4MB7, now stationary on the Up Main line, noticed that the adjacent Platform Road signal CA44 had cleared. This indicated to him that the following train, the XPT, had been given a through route to allow it to pass his train (Appendix B provides further information regarding the aspects that can be displayed by signals CA44, CA46, CA74 and CA76 at Cootamundra).

The XPT continued on its journey, as it rounded a left-hand curve the driver observed the next signal, CA74, displaying a Medium Turnout indication (Figure 9). He could simultaneously see signal CA46, located at the end of the Cootamundra platform, displaying a proceed indication. This indicated to him that the route through No.1 Platform Road was set but more importantly it should be unobstructed. As the driver of the XPT prepared to enter No.1 Platform Road he slowed the train to a speed of about 25 km/h to negotiate 136 points, set reverse. It was at about this time he observed the ‘End of Train Marker’ (flashing red light) fitted to the last wagon of freight train 4MB7. The XPT driver continued to slow the train as he approached train 4MB7. When the XPT was near the Gundagai Road level crossing (430.050 km) the driver could clearly see the last wagon of train 4MB7 illuminated by his train’s headlights. He continued to drive slowly towards train 4MB7. Shortly after passing over the Gundagai Road level crossing and traversing 136 points he became sure that train 4MB7 was ‘foul’ and would obstruct the passage of his train. He further slowed the XPT stopping it about 5 m short of train 4MB7.

Figure 9: Signal CA74 & CA76 – Signal indications

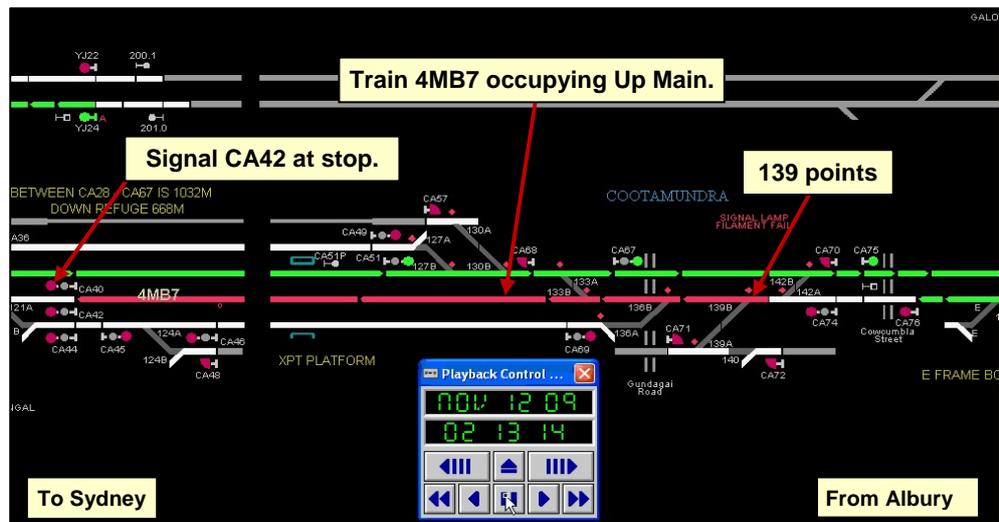
Figure 10: Cootamundra, Phoenix replay 0213:14

The Phoenix replay, Figure 10 (0213:14), shows train 4MB7 occupying the Up Main (signal CA42 at stop) with the end of train traversing 139 points set normal.

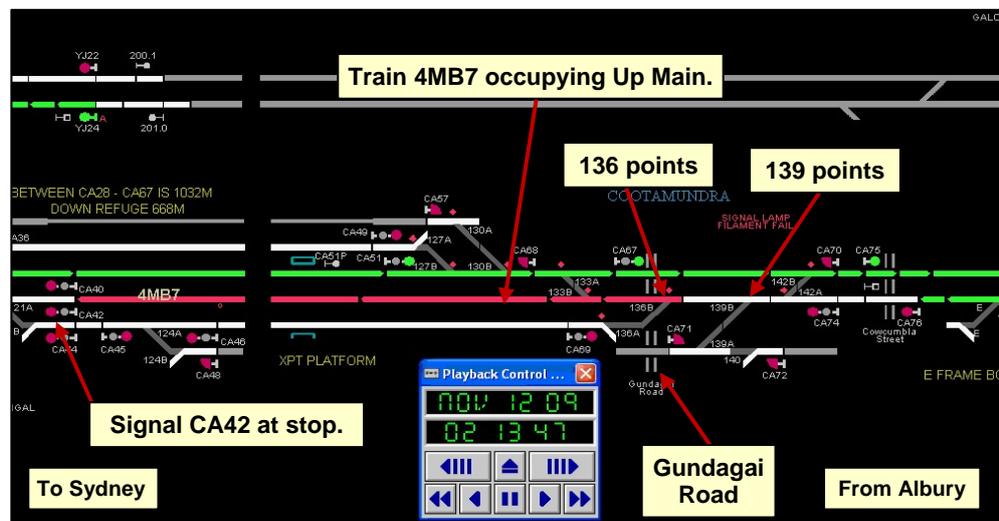
Figure 11: Cootamundra, Phoenix replay 0213:47

Figure 11 (0213:47) shows that train 4MB7 has cleared 139 points but is still traversing 136 points (set normal) and the Gundagai Road level crossing.

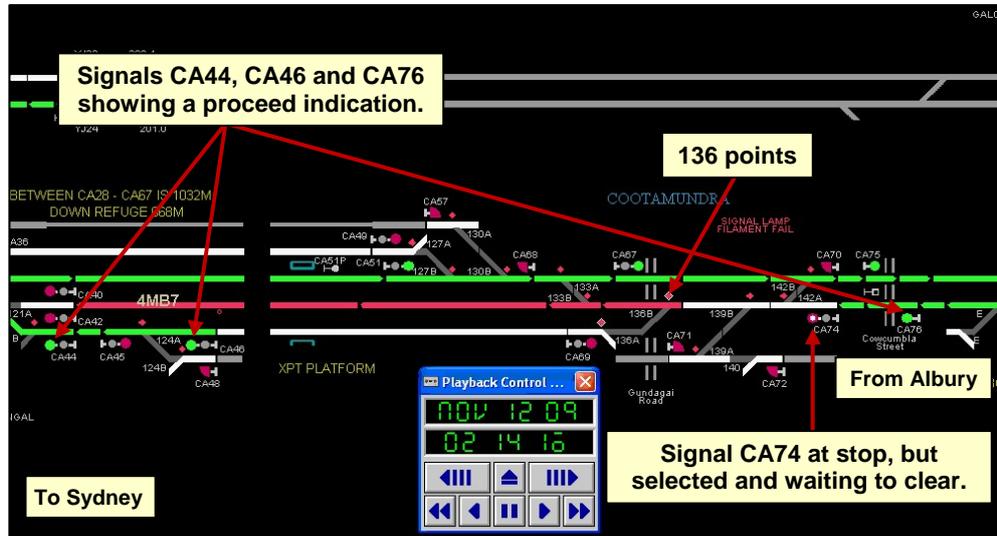
Figure 12: Cootamundra, Phoenix replay 0214:16

Figure 12 (0214:16) shows signals CA44, CA46 and CA76 have cleared and are displaying a proceed indication. Signal CA74 is still at stop, but has been selected and is waiting¹¹ for route availability before it can clear. An examination of events just after 0214:16 established that train 4MB7 was travelling slowly towards signal CA42 with the end of train traversing 136 points and the Gundagai Road level crossing. Signal CA44 clearing is corroborated by evidence given by the driver of train 4MB7, he stated that he noticed that the Platform Road signal CA44 had cleared for the passage of the XPT (ST22).

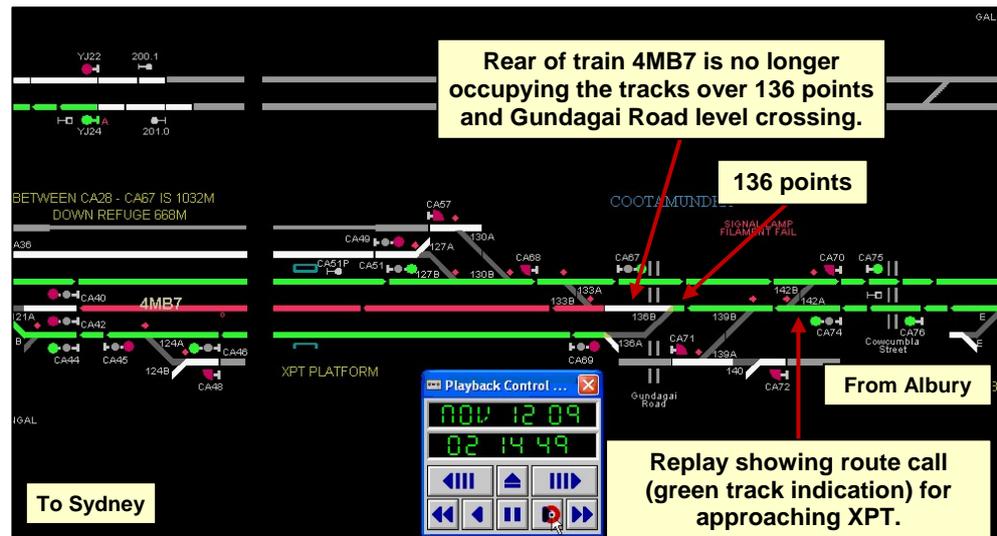
Figure 13: Cootamundra, Phoenix replay 0214:49

Figure 13 (0214:49) shows the rear of train 4MB7 having just cleared 136 points and the Gundagai Road level crossing. An examination of events at this time shows signal CA74 clearing when the rear of freight train 4MB7 had completely traversed 136 points and the Gundagai Road level crossing.

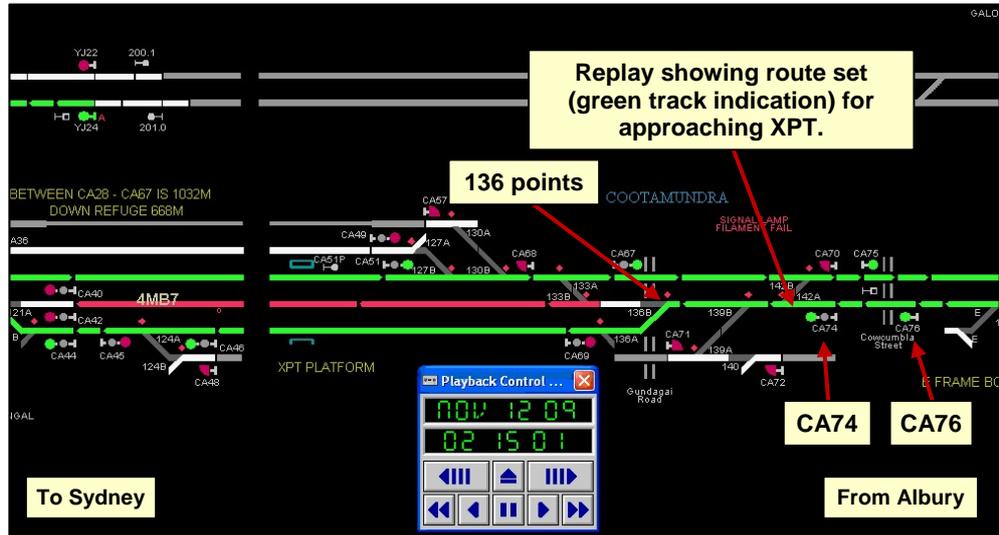
Figure 14: Phoenix replay 0215:01

Figure 14 (0215:01) shows train 4MB7 at stop¹² on the Up Main line and clear of 136 points and the Gundagai Road level crossing. Signals CA76 and CA74 are displaying a proceed indication for the XPT. The network controller and XPT driver would rightly expect that the route for the XPT into No.1 Platform Road was set and unobstructed.

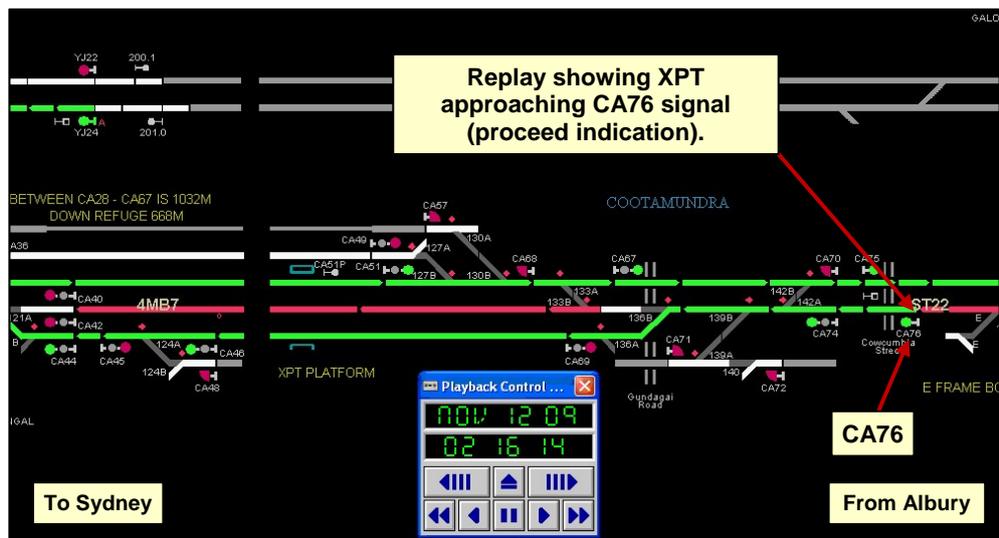
Figure 15: Phoenix replay 0216:14

Figure 15 (0216:14) shows the XPT occupying the track in advance of signal CA76 which is displaying a proceed indication. The train was travelling at a speed of about 77 km/h (XPT Hasler data log) as it passed signal CA76.

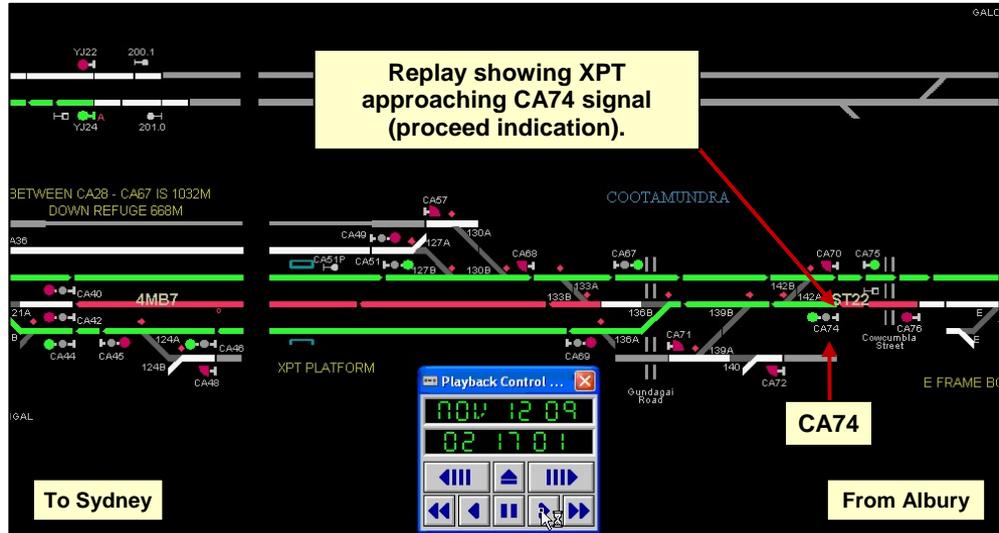
Figure 16: Phoenix replay 0217:01

Figure 16 (0217:01) shows the XPT occupying the track in advance of signal CA74. Signal CA74 is displaying a proceed indication. The train had slowed to about 50 km/h (XPT Hasler data log) as it passed signal CA74. To the driver of the XPT, signal CA74 displaying a Medium Turnout indication would mean the route ahead was correctly set and unobstructed.

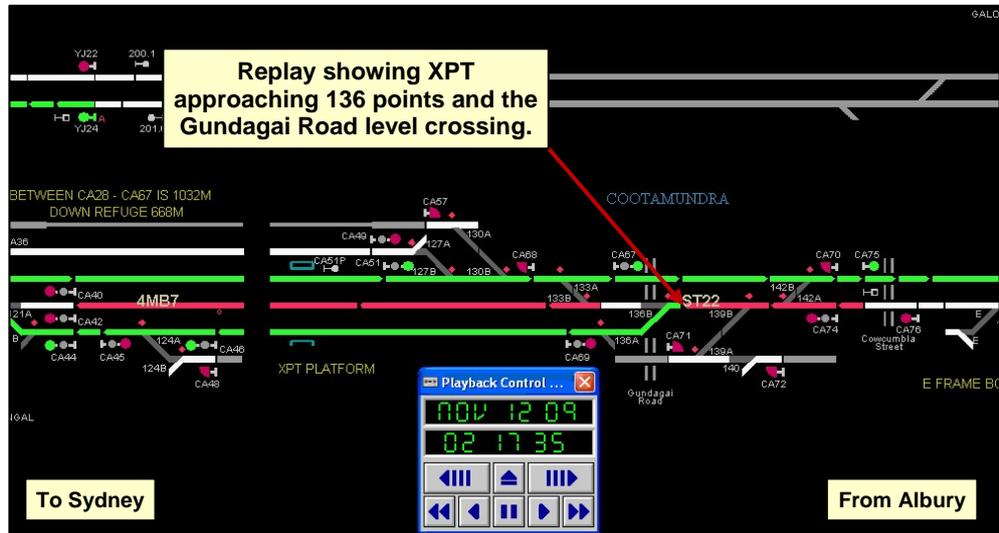
Figure 17: Phoenix replay 0217:35

Figure 17 (0217:35) shows the XPT occupying the track in advance of 136 points and the Gundagai Road level crossing. As the driver of the XPT prepared to enter No.1 Platform Road he had further slowed the train and was travelling at less than 20 km/h (XPT Hasler data log) before negotiating 136 points (set reverse). It was at

about this time he observed the ‘End of Train Marker’ (flashing red light) fitted to the last wagon of freight train 4MB7.

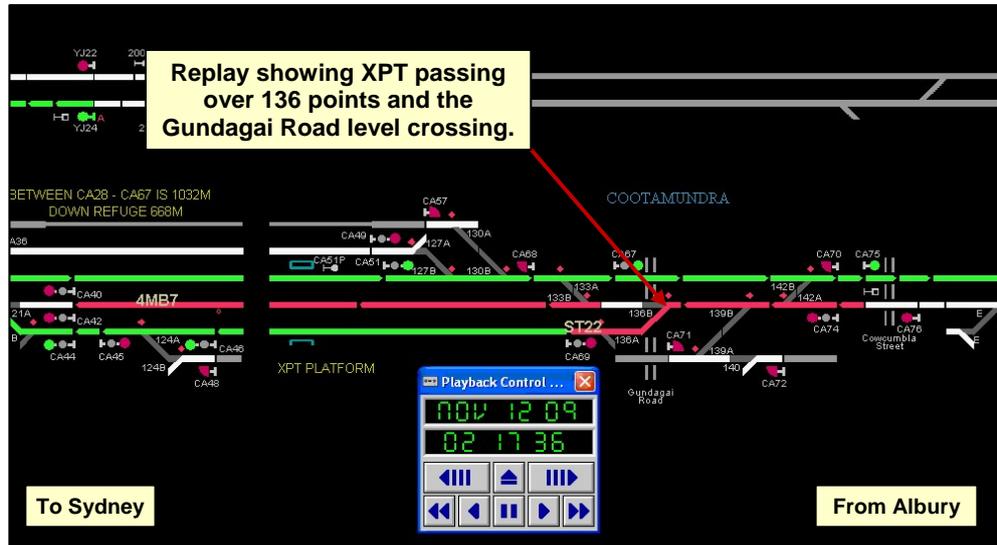
Figure 18: Phoenix replay 0217:36

Figure 18 (0217:36) shows the XPT occupying the tracks located over 136 points and the Gundagai Road level crossing. It was about this time that the driver of the XPT became sure that 4MB7 was standing ‘foul’ and would obstruct the passage of his train. He further slowed the train, stopping it about 5 m short of 4MB7 before alighting from the driver’s cab to take some photographs (Figure 19).

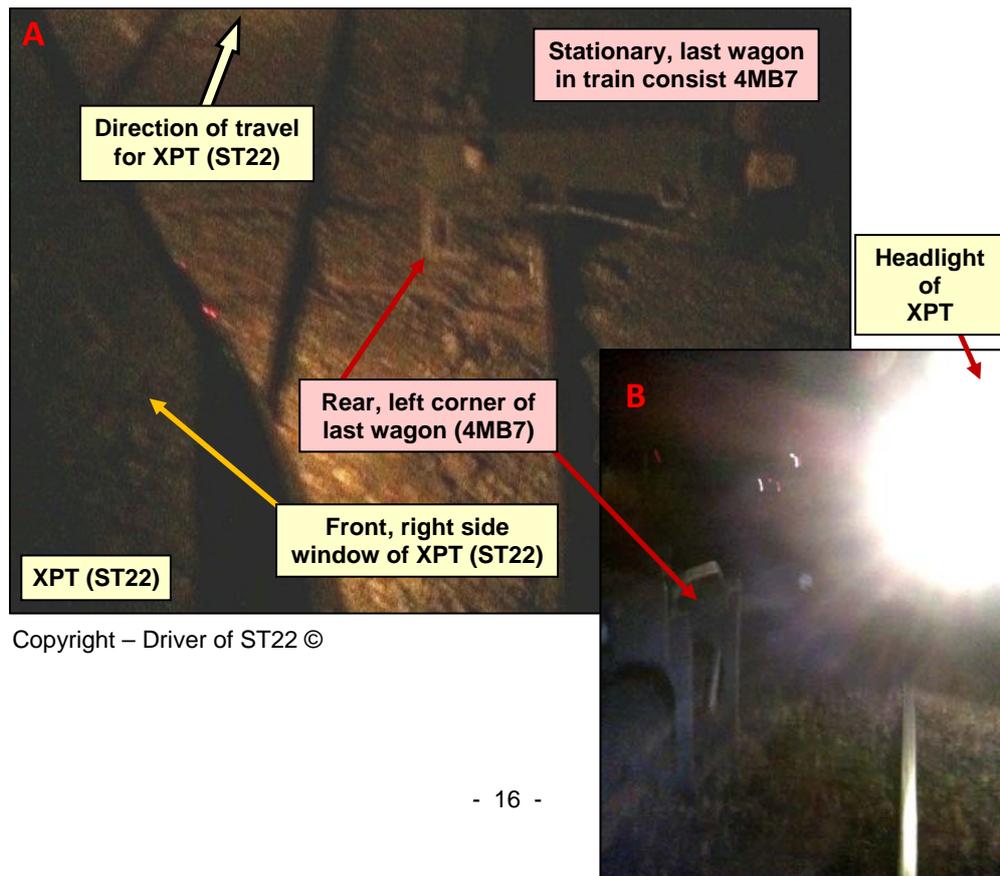
Figure 19: Photograph A – View from XPT drivers cab, looking towards the last wagon of 4MB7 seen in upper right.

Photograph B – XPT driver standing adjacent to step of last wagon of 4MB7, looking towards XPT, glare of headlight in background

The photographs at Figure 19 and schematic at Figure 20 illustrate the close clearances the XPT driver observed, why he brought his train to a stand and then requested that the matter be investigated.

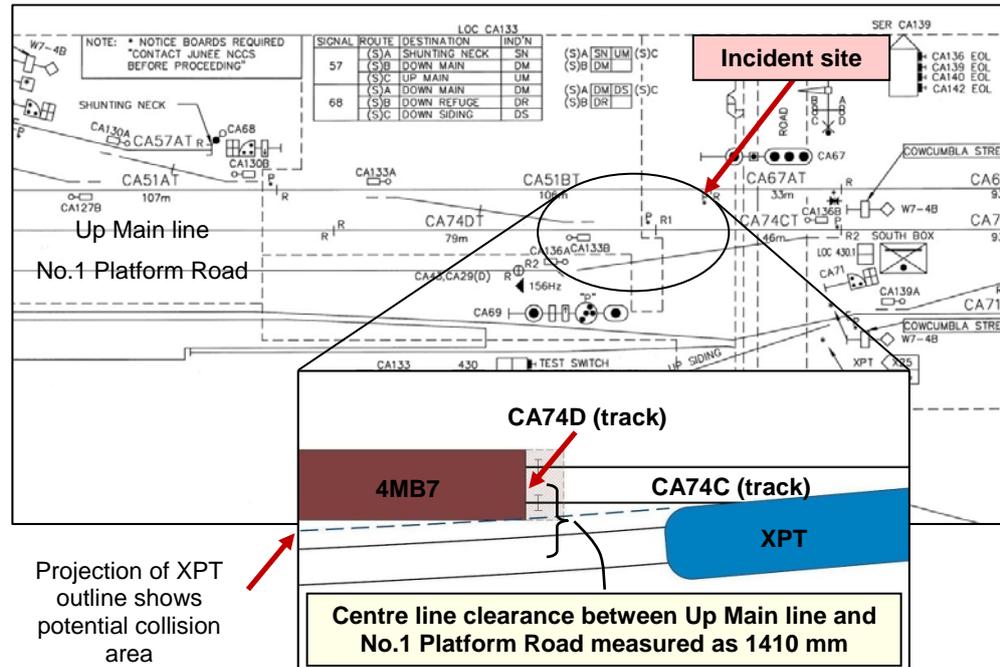
Figure 20: Schematic showing incident site and 4MB7 and XPT

On this occasion, train 4MB7 stopped such that the rear wagon was about 0.5 m past the clearance point. However, when considering the overhang of the last wagon past the rear wheels, it is possible that the wagon could have been about 2 to 3 m further back and not been detected by CA74C track. This meant that signal CA74 would have shown a proceed aspect even if the rear of train 4MB7 was 2 to 3 m further fouling of the path of the XPT.

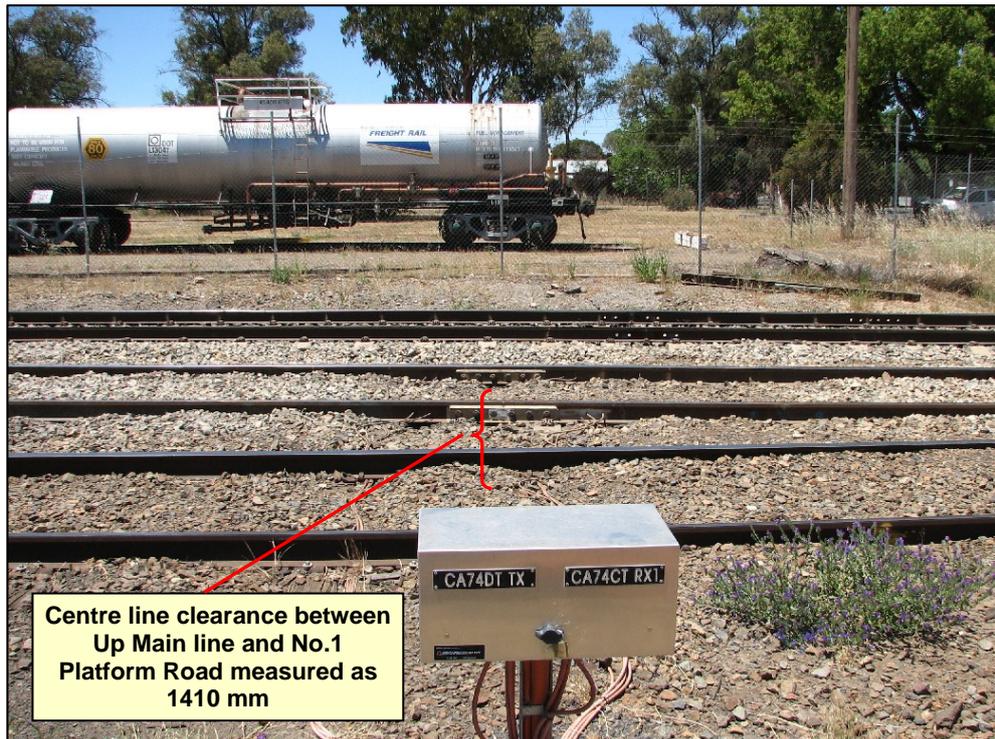
An onsite examination of the track by the ARTC signal engineers established that the centre line clearance between the Up Main line and No.1 Platform Road at the interface between CA74D and CA74C track was 1410 mm. The ARTC subsequently advised that the minimum distance to prevent fouling between the two tracks at this location should have been 2016 mm.

Figure 21: Photograph adjacent CA74D and CA74C tracks

It was therefore concluded that the observations by the driver of the XPT were correct, in that the rear of 4MB7 was obstructing the path of the XPT even though signal CA74 was showing a proceed indication.

¹⁵ The centre-line distance between the Up Main line and No.1 Platform Road at this location had not been checked and as part of the investigation was found to be 1410 mm and therefore foul.
