**ATSB TRANSPORT SAFETY REPORT**  
Rail Occurrence Investigation  
RO-2010-002  
Final

**Safeworking irregularity involving a  
freight train and an empty passenger train  
at Manildra, NSW  
10 February 2010**

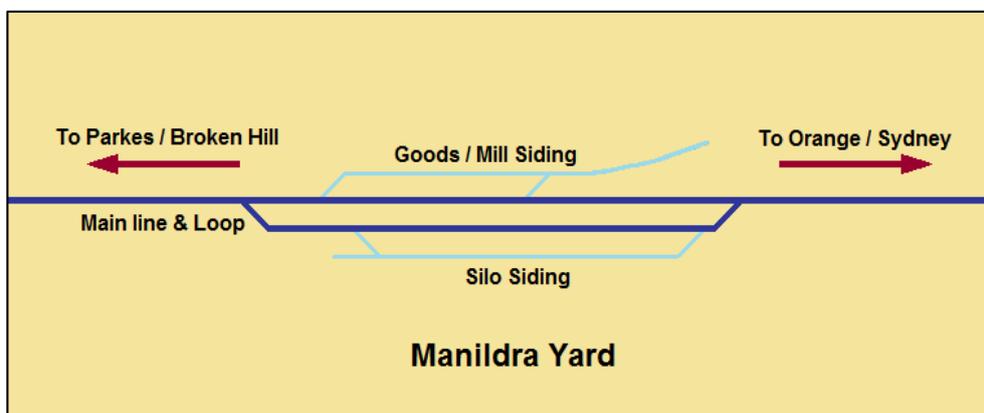
**Figure 2: Manildra yard layout**

The track, managed by the Australian Rail Track Corporation (ARTC), is bi-directional single line with crossing loops (short sections of double track) provided at regular intervals to allow trains to cross (travelling in opposing directions) or pass (travelling in the same direction) each other. At the time of the occurrence, Manildra Yard consisted of a crossing loop with a siding off the main line accessing a flour mill and a siding off the loop accessing grain silos (Figure 2).

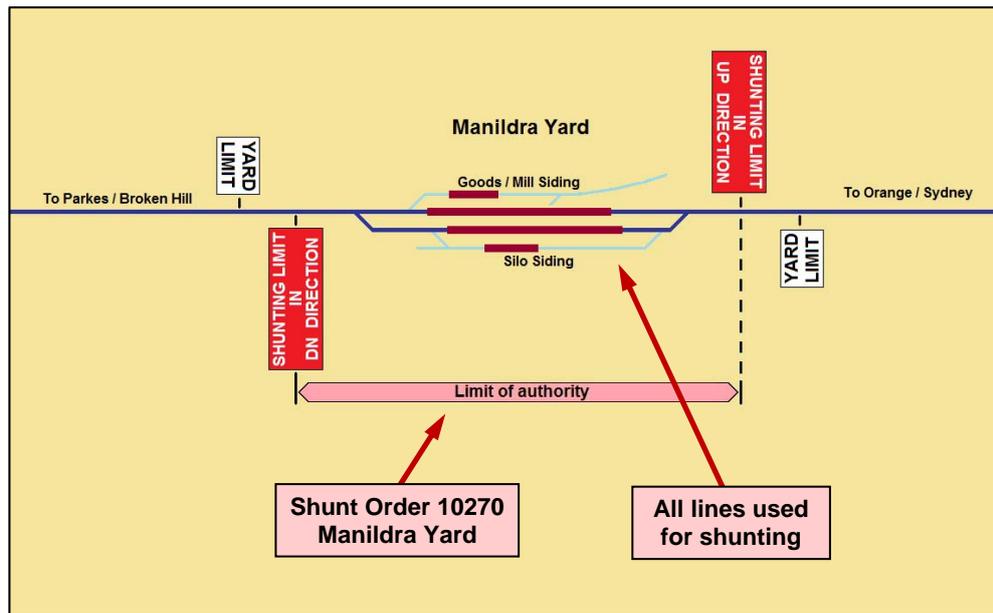
**Figure 5: Manildra yard shunting (Train MRA1)**

At 1333, the Manildra Mill shunter received shunt order 10270 authorising shunt operations to be carried out between the Manildra Yard shunt limits. For the purpose of this shunt order, the train was designated as train number MRA1 and the locomotive was number MMO1 (the Manildra Mill shunt locomotive). The Manildra Mill shunter proceeded to manage shunt operations within the yard, including directing the crew of train 9837 to undertake shunting when required. Figure 5 illustrates the limits of authority given for shunting within the Manildra Yard.

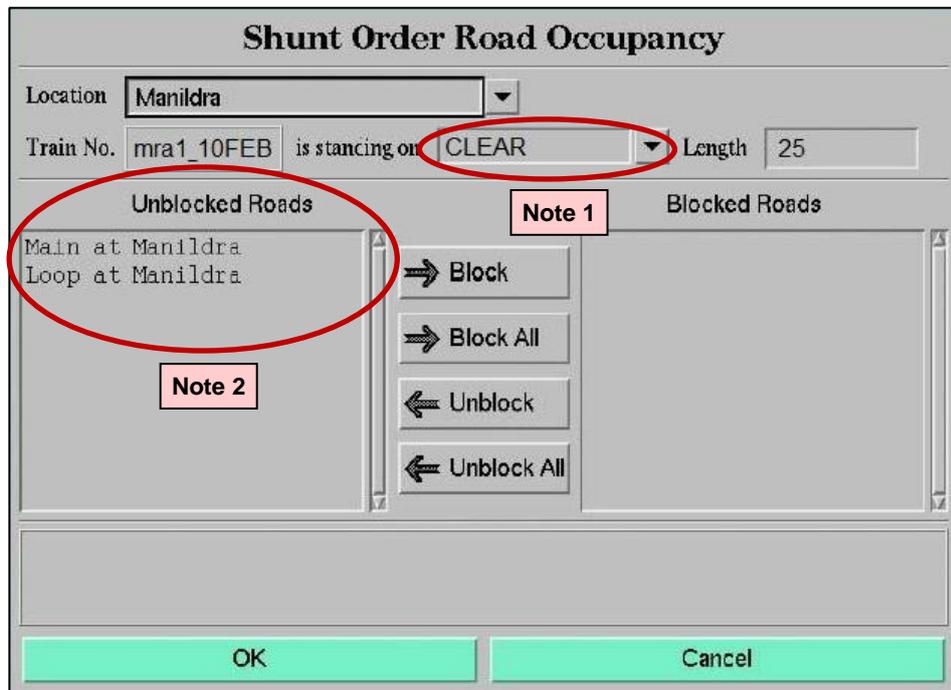
**Figure 7: TMCS - Shunt Order Road Occupancy**

When fulfilling shunt order 10270, the network controller entered the correct security code and entered train MRA1 at the 385 km point. Since train order 10270 was a shunt order, the TMCS required that the controller complete the road occupancy dialog. In this case, the controller entered train MRA1 as standing clear of train order territory, but did not apply a 'road occupancy' block to either the main line or loop, even though both lines were occupied (illustrated in Figure 7). The network controller then logged train MRA1 off the TMCS.

Note 1: MRA1 set as 'standing on CLEAR'

Note 2: The loop and main lines set as 'Unblocked Roads'

The error that set the conditions allowing an order to be issued over an occupied track occurred when fulfilling shunt order 10270. That is, the road occupancy window was not used to apply blocking facilities to the main line and loop, even though this condition was communicated to the network controller. However, the controller made a second data entry error (about 3 hours earlier) when he fulfilled train order 10258. The network controller incorrectly entered train 9837 as standing clear of train order territory, even though the train was standing on the loop. While this error did not directly impact on the incident being investigated, it too highlights a condition whereby a running line was incorrectly recorded as clear.

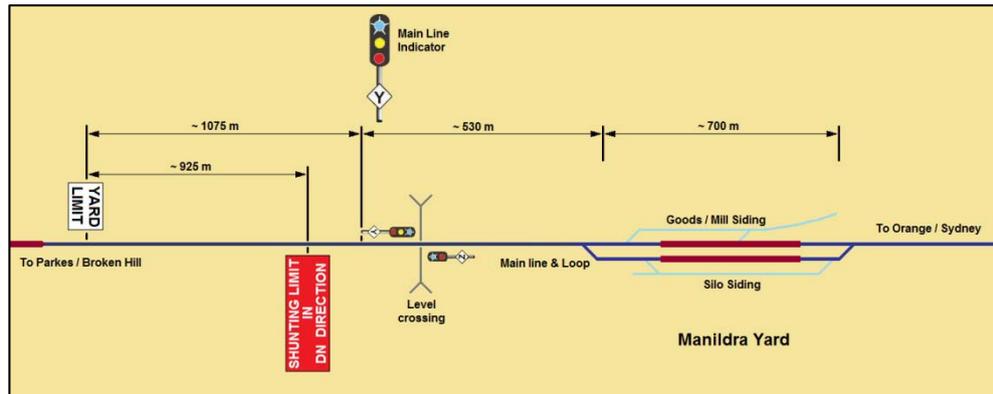
**Figure 8: Manildra Yard main line indicators and signs**

A train approaching Manildra from Parkes will pass the yard limit board about 1075 m before reaching a main line indicator (Y MLI) located immediately before the Kiewa Street level crossing (Figure 9). This main line indicator will only display a proceed indication if the level crossing warning equipment is operating correctly, the Manildra Yard points are set for the main line and the main line is clear of rail traffic. The ARTC document ANSG-610 *Passing indicators at STOP* (dated September 2004) states that rail traffic must not pass main line indicators at stop unless the level crossing warning equipment is operating correctly and the points are set for the correct route.

Since the main line was occupied by the freight train, the main line indicator (Y MLI) would have been displaying a red stop aspect, regardless of the condition of the points or level crossing equipment. A train driver is able to sight the main line indicator from about 670 m away, about the same point that the level crossing warning equipment would begin to operate. While drivers may expect the indicator to change to a proceed aspect as they approach, they must also consider the possibility that the indicator remains at red and stop accordingly. Even if a train was unable to stop before passing the main line indicator, there is at least a further 530 m before the train would pass over the points and onto the track where the freight train was sitting. It is very unlikely that a collision would have occurred under the conditions that were present in this incident, even if a warning had not been communicated by radio.
