Safeworking incident Junee, NSW 4 August 2010

Abstract

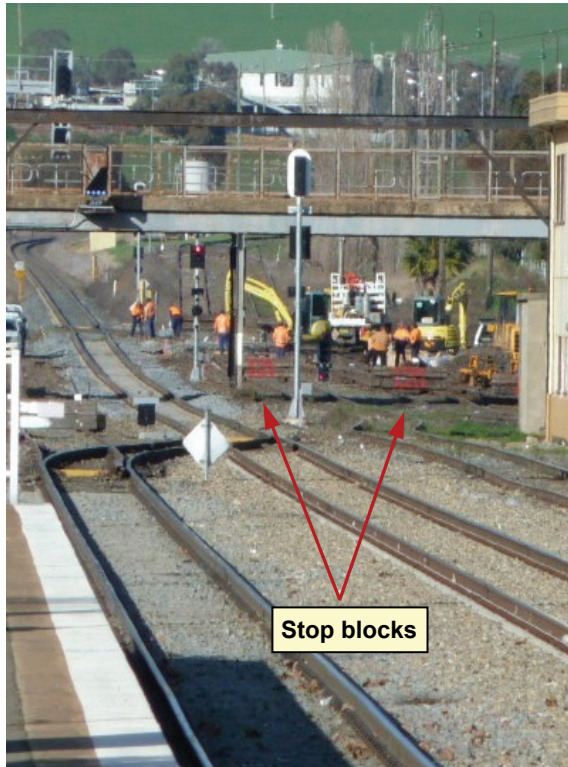
In order to prevent unauthorised rail traffic from gaining access to the damaged infrastructure, temporary stop blocks (painted red), consisting of a number of sleepers strapped together and resting on the track, had been erected. The photograph in Figure 1 was taken from Junee station platform looking south and shows two of the three temporary stop blocks on the southern side of the Kemp Street 'road over rail' bridge.

Figure 1: Worksite (looking south from Junee station platform) showing temporary stop blocks

To prevent access by rail traffic, stop blocks were installed on the Up platform road, the back platform road and number one road. In addition, points 143 were clipped and locked in the normal position so that rail traffic from the south could not be routed directly into the track repair worksite.

While the stop blocks provided a barrier between rail traffic and the worksite, there did not appear to be any systems in place to protect rail traffic approaching the barriers. For example, access to the barriers was available from the back platform road and roads 1 to 9. Also, similar access was available via the Up platform road, which was a signalled running line.

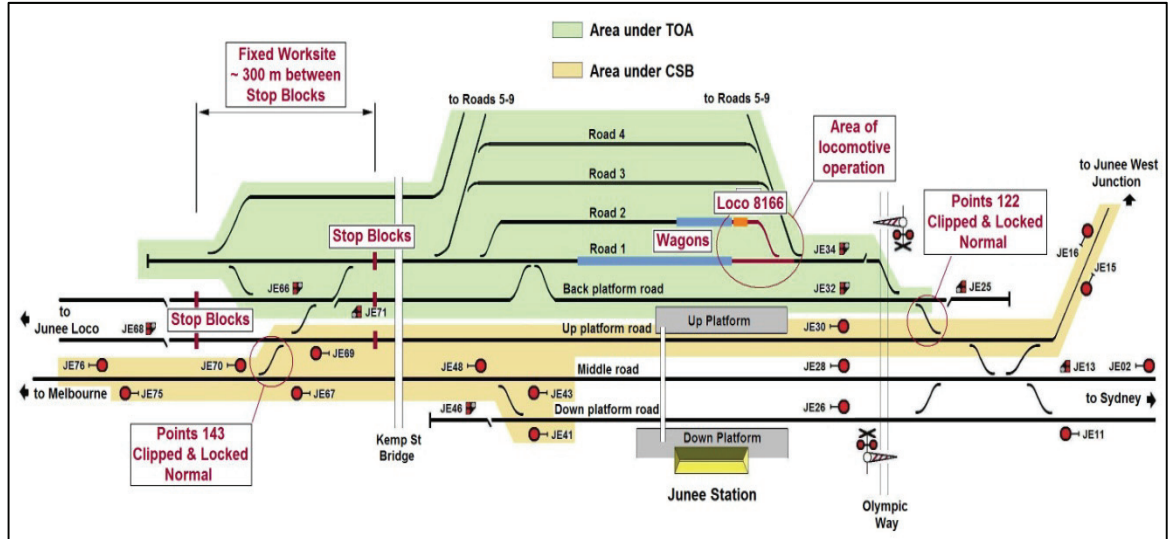
Figure 2: Junee station yard

At 0840 locomotive 8166 was moved from number two road to number one road and, at 0905, the same locomotive was moved from number one road back to number two road in the Junee station yard. Both movements were in conjunction with the brake test method decided upon and involved travelling about 90 m in one direction before traversing a set of hand operated points and travelling a similar distance in the reverse direction. No electrically operated points or colour light signals were encountered and, as such, the network controller was unaware of the movement when it occurred. The extent of the train movement is illustrated in Figure 2.

In this case, the track work was conducted within a fixed worksite that was bounded by stop blocks. On the day of the safeworking incident (4 August 2010), the limits of the TOA extended to cover all siding roads, as illustrated by green shading in Figure 2.

In this case, the PO arranged for CSB protection to be applied, as illustrated by yellow shading in Figure 2. While most routes appeared to be protected under CSB, the route from the Sydney down line crossing to the Junee Up platform road did not appear to be included.

In short, scenarios existed whereby rail vehicles could obtain unprotected access to within 500 m of the fixed worksite which is contrary to the intent of rule ANWT 304.
