# Safe working irregularity involving freight train 2CM3 at Bomen, New South Wales

6 September 2010

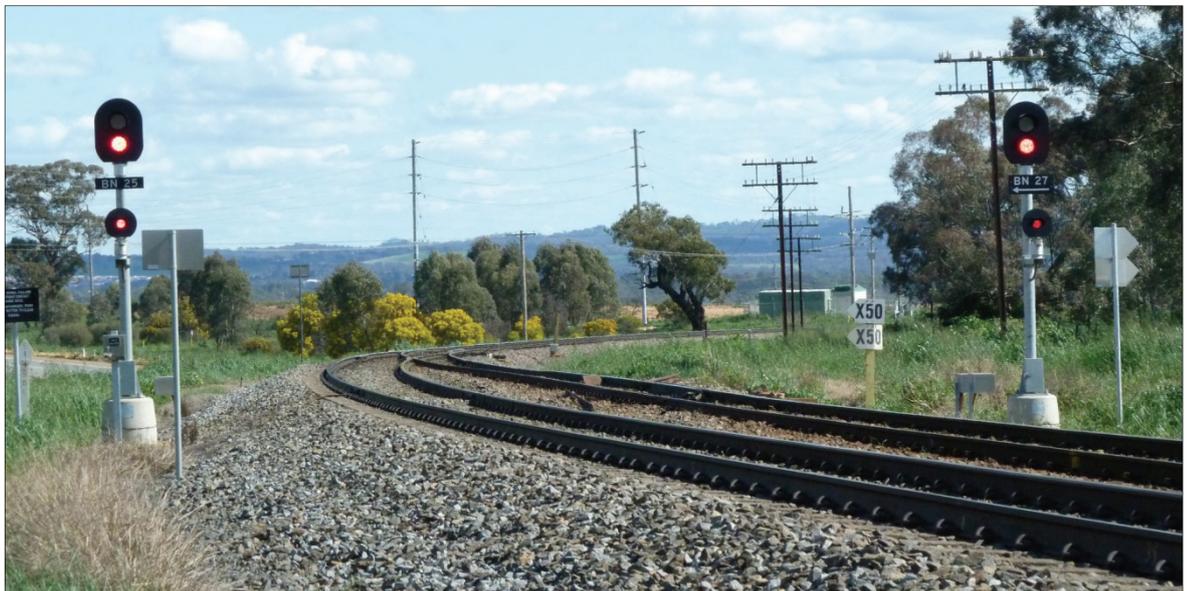
Figure 1: Signal BN27 (right of track) looking in the direction of travel for train 2CM3

The network controller attempted to set the route for freight train 2CM3 to depart Bomen Yard and proceed onto the mainline towards Melbourne. The network controller was unable to change absolute signal BN27 from a stop (red) aspect to a proceed aspect (green), so he gave verbal authorisation to the driver of train 2CM3 to depart Bomen and pass signal BN27 while it was displaying a stop indication. However, issuing a verbal authorisation was not in compliance with the safeworking rules in this case. The network

controller should have issued a written Special Proceed Authority (SPA) to authorise train 2CM3 to pass signal BN27 at stop.

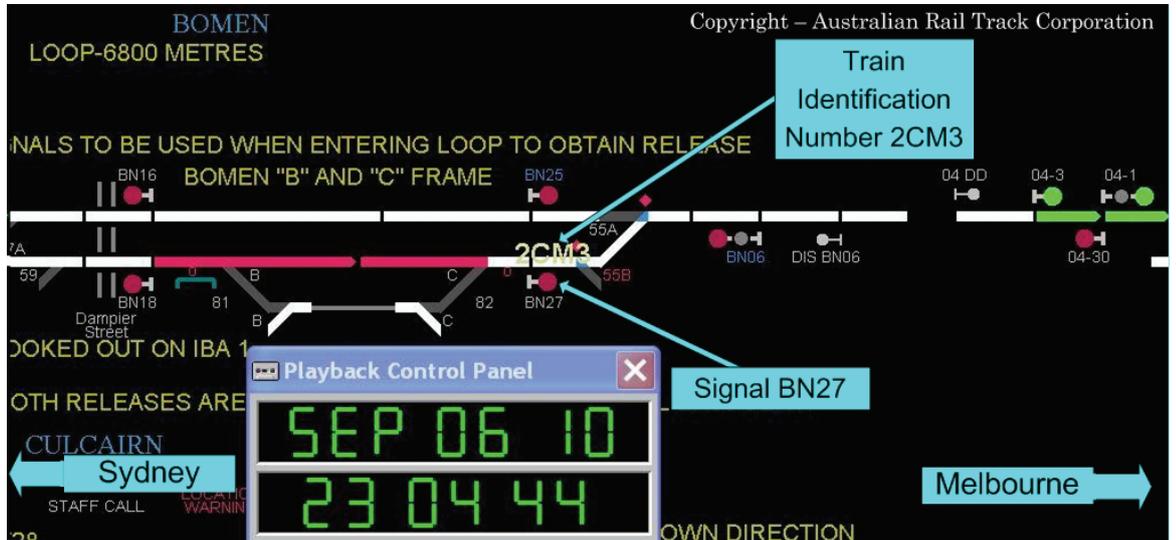
At 2304, the replay system indicated that the network controller attempted unsuccessfully to clear signal BN27. It was evident that, after signal BN27 was cleared at 2203 and the shunt movement was completed, a condition remained

An examination of the interlocking control tables implied that the system should have allowed clearing of signal BN27, even though the previous movement past the signal may have been incomplete. However, it is evident that the Phoenix Control System retained a train identification number (2CM3) over the unoccupied switch track immediately after signal BN27 (Figure 3) when normally the identification number would show over the track occupied by the head of the train, in this case the loop track before signal BN27. It is apparent this condition is a limitation of the Phoenix Control System, however it is recognised that this is a 'non-vital' system and the condition that existed did not affect the safe operation of the signalling system.

Based on the information available, it is likely that the Phoenix Control System prevented a command being issued to the field based interlocking, even though the interlocking would normally have accepted the command and cleared signal BN27. It is possible that an alternative method of conducting the shunt at Bomen may have avoided the condition that prevented signal BN27 from clearing. For example, the train drivers said that on previous occasions, they had received a verbal order to conduct a similar shunt movement past signal BN27 (within yard limits).

Figure 3: Phoenix replay of Bomen passing loop showing the 2CM3 train identification number that was retained and positioned over unoccupied track beyond signal BN27
