Signal passed at danger by XPT ST24

Henty, New South Wales
5 February 2011

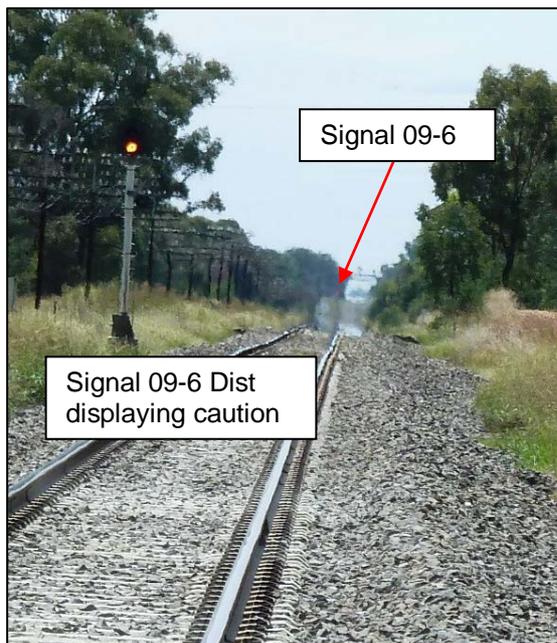
Figure 2: Up distant signal (09-6 Dist) at Henty

As train ST24 approached Henty it was raining heavily. Although visibility was reduced, the driver had no problem seeing the yellow aspect (Caution) displayed by the Henty Up distant signal 09-6 Dist. Upon sighting the distant signal he applied the brake lightly and felt some retardation. At about this time he saw a road vehicle driving very fast along a flooded road not far from the rail line. The vehicle was travelling at such a speed that water was being sprayed out to the side in large quantities.

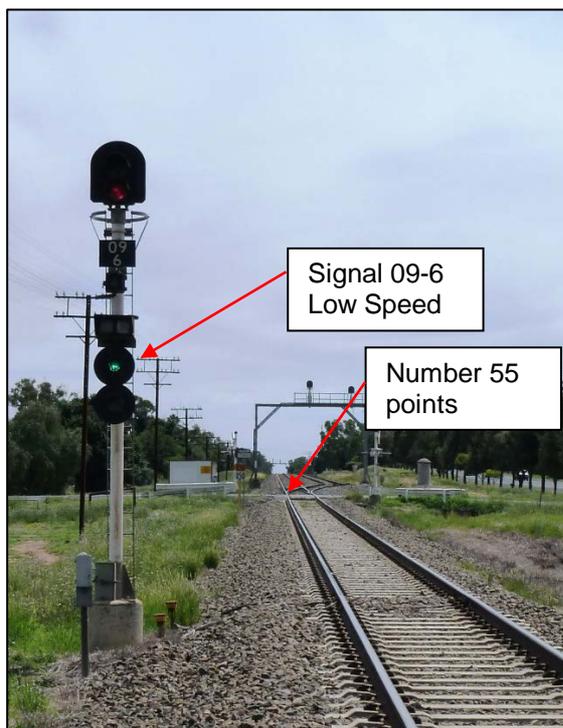
Figure 3: Up home signal (09-6) at Henty

In his statement, the driver indicated that if the brakes were operating correctly he would have brought the train to a stand at or before signal 09-6.

The Low Speed aspect on signal 09-6 is located below the main aspect and is physically smaller in size than the main signal aspect. Drivers must therefore 'close up' on the Low Speed indication before it can be seen, thereby slowing the train as if they were approaching a signal at stop.

In this instance, the driver was distracted by a vehicle travelling at high speed on the adjacent road. It is therefore probable that in his mind, signal 09-6 was displaying a Low Speed indication and therefore he did not initially perceive the indication displayed by signal 09-6 as at Stop.

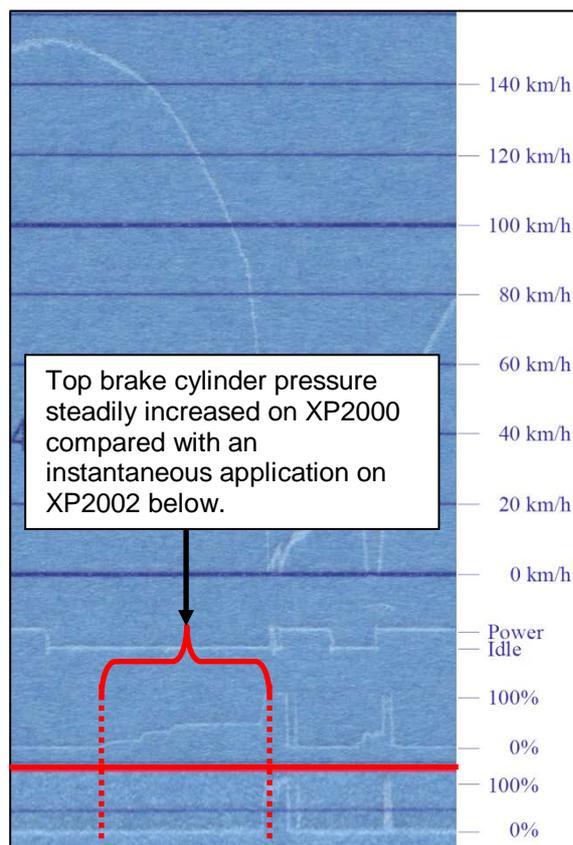
Figure 4: Hasler comparison

An extract from the Hasler recorder(s) from both power cars (Figure 4) supports the driver's account of his handling of the train on the approach to the Up home signal (09-6) at Henty. The extract clearly shows a difference in brake cylinder pressure between the two power cars, in that the leading power car XP2002 did not record brake cylinder pressure until making a full

service application towards the end of the SPAD sequence, while XP2000 recorded gradual increases in brake cylinder pressure before the full service application. The data validates the driver's

observation that the brakes on the leading power car were not applying until a full service application of the brakes was made.

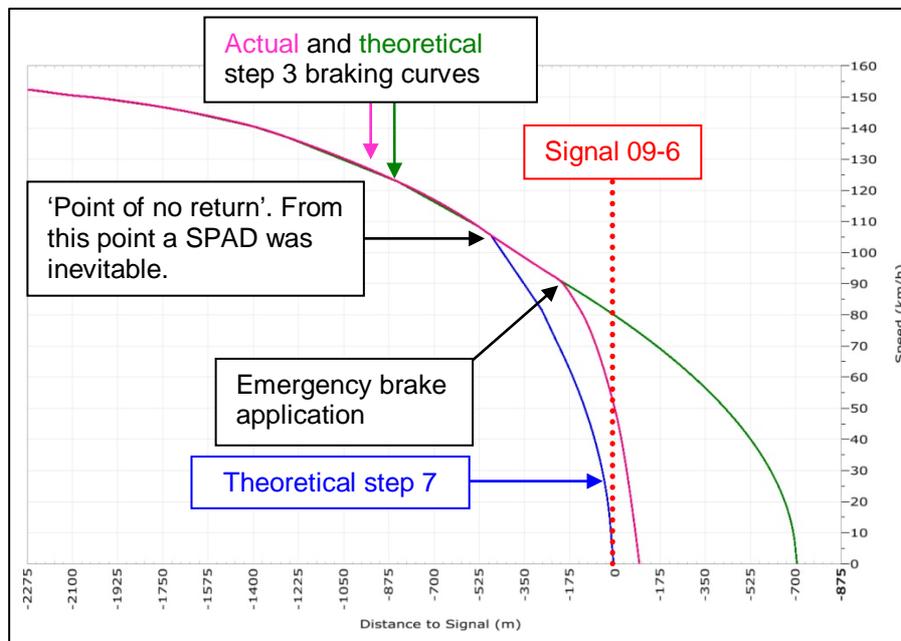
Figure 5: Braking curve

Examination of the Hasler data shows that the driver selected step 3 braking 1406 m in advance of Up home signal 09-6. The train was travelling at a speed of about 141 km/h. Based on the achieved and the theoretical braking rates (Table 1), the driver could have remained in step 3 until the train was about 480 m from signal 09-6. At this

'point of no return' (Figure 5) the driver needed to make a step 7 or emergency brake application to stop short of signal 09-6. In this instance, the driver remained in step 3 braking until about 223 m from signal 09-6, when he initiated an emergency brake application. A SPAD of signal 09-6 was inevitable from this point.

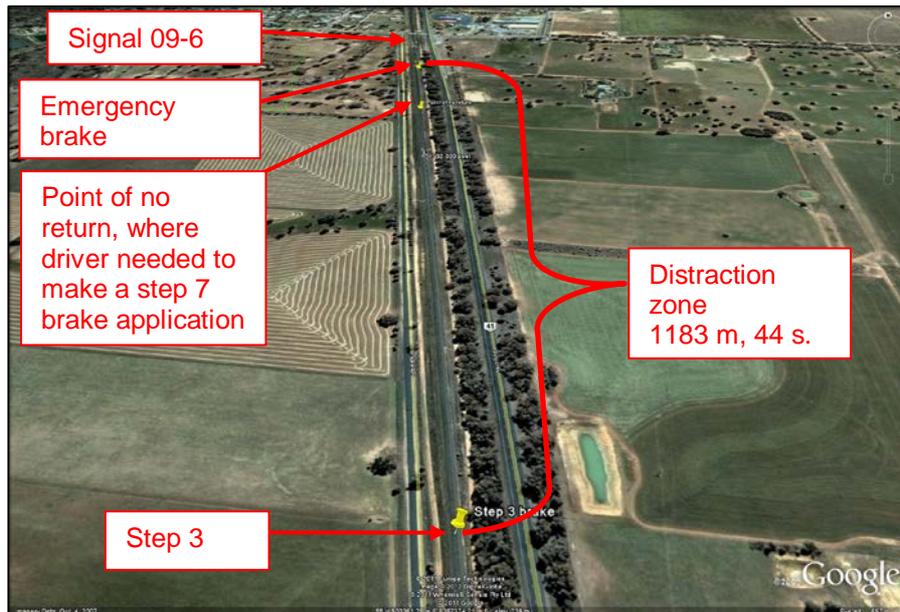
Figure 6: Distraction zone diagram

In this instance train ST24 was nearly 1 hour late at the time of the SPAD; the driver nevertheless indicated that he felt no pressure from either network control or management to make up this lost time. However, he was distracted by events external to the rail corridor; a vehicle being driven at speed on an adjacent flooded road. He said that as he was watching the vehicle he applied the brakes 'automatically', but did not monitor the train's progress by scanning the gauges at his control console, nor did he look in the direction of travel.

An examination of the Hasler data log shows that between the time the driver made the step 3 brake application and the emergency application, about 44 seconds elapsed and the train travelled about 1183 m (Figure 6). This positioned the train past the calculated 'point of no return' by about 10 seconds, or 223 m from the Henty Up home signal (09-6), from which point the train could not stop before passing the signal.
