Safeworking breach – Track machine BC7

Bogan Gate, New South Wales | 15 August 2011

ATSB Transport Safety Report
Rail Occurrence Investigation
RO-2011-013
Final

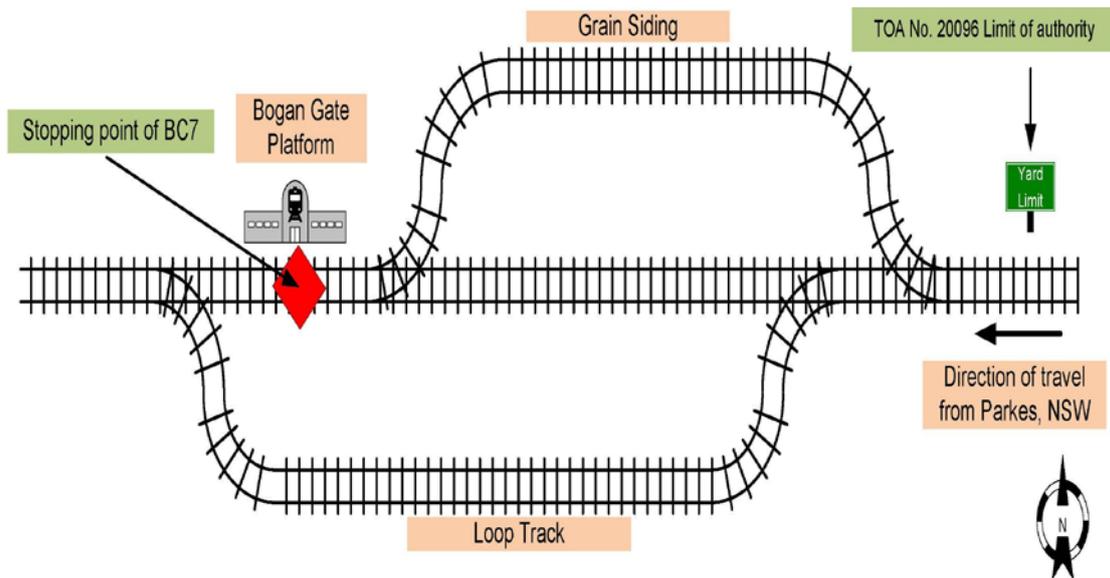
Figure 1: Diagram of train order crossing location at Bogan Gate showing limit of authority and the stopping point of BC7

The NCO then realised that in proceeding past the yard limit board and stopping at the platform, the Traffic Officer had travelled beyond the limit of his authority under TOA No.20096. The NCO then instructed the Traffic Officer to remain at the platform with the track machine and operator.
