# Proceed authority exceeded by train 2AD1

Tarcoola, South Australia | 21 August 2012

**ATSB Transport Safety Report**  
Rail Occurrence Investigation  
RO-2012-009  
Final – 28 May 2014

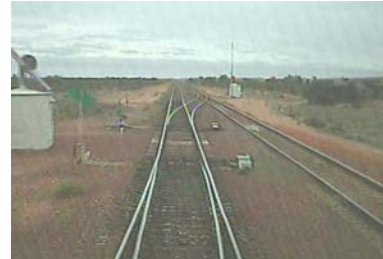
View from 2AD1 departing Tarcoola Yard

The train authority authorised the crew to travel to Northgate, which is located on the railway line branching to the north from Tarcoola. However, the crew did not take the line to Northgate and the train continued through Tarcoola, travelling west for about 2.6 km toward Perth before stopping.

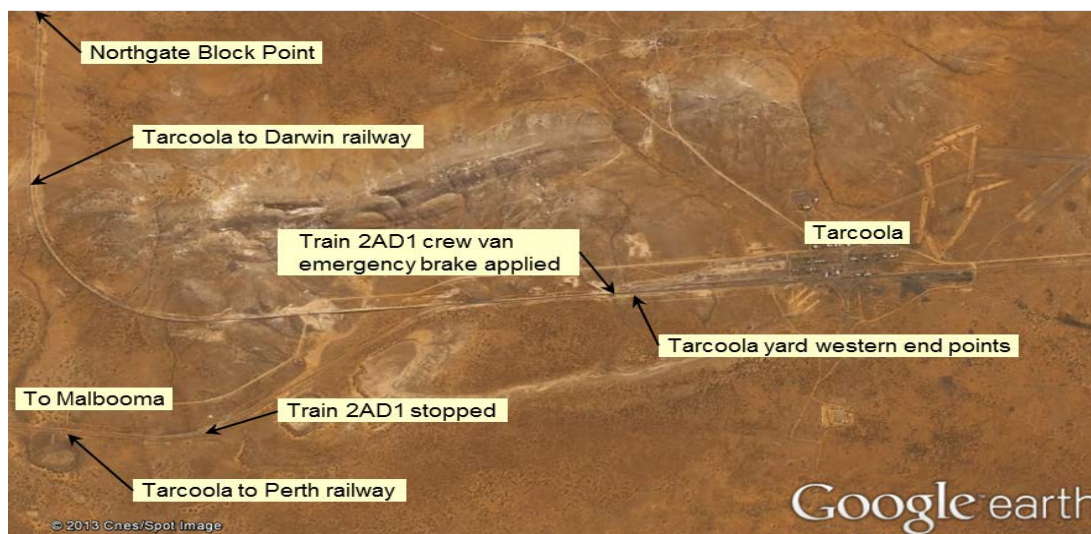
**Figure 2: Tarcoola Yard and path of train 2AD1**

Train 2AD1 came to a stop shortly after passing the Location Ahead sign<sup>4</sup> situated about 2.5 km from the Tarcoola Yard limit, in the Tarcoola to Malbooma section (Figure 2).

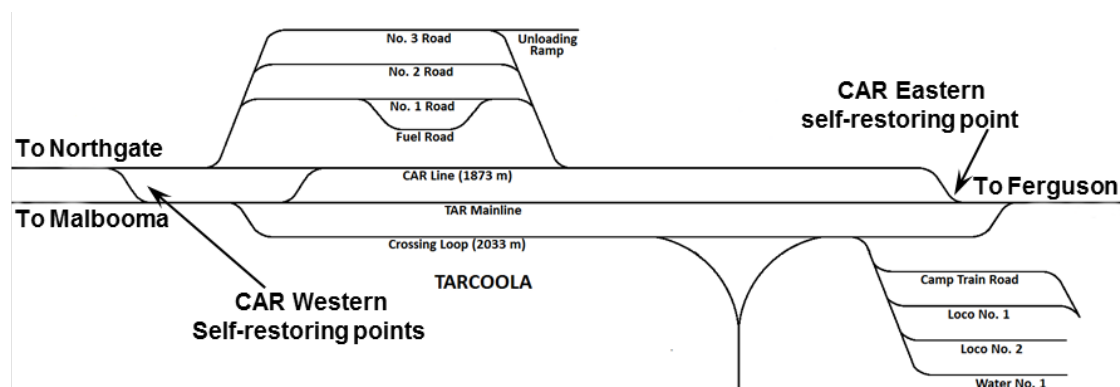
**Figure 5: Layout of Tarcoola Yard**

Points located at either end of the Tarcoola Yard provided access from the TAR main line to the CAR. These points were also equipped with self-restoring electric point machines, which would normally be set for trains to travel on the TAR main line. To access the CAR, crews were required to stop the train and operate pushbutton controls located on a hut adjacent to the point machines to set the points for the required direction (Figure 5).
