Proceed authority exceeded by train 9104

Tarcoola, South Australia | 26 November 2012

ATSB Transport Safety Report
Rail Occurrence Investigation
RO-2012-011
Final – 22 June 2015

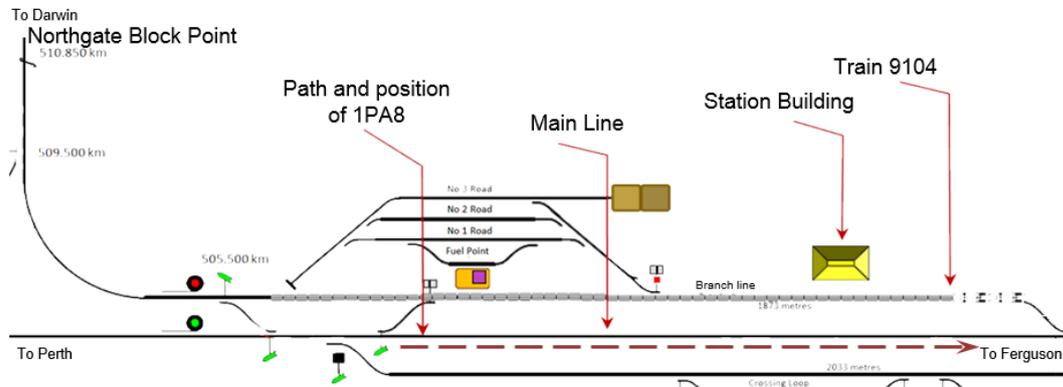
Figure 2: Tarcoola yard showing location of 9104 and path of 1PA8

Train 9104 proceeded to Tarcoola, stopping on the Branch Line at about 1935, adjacent to the Tarcoola Station building (Figure 2).
