# Safeworking breaches involving Absolute Signal Blocking

Blackheath, NSW, 13 June 2013  
Newcastle, NSW, 13 July 2013  
Wollstonecraft, NSW, 17 July 2013

**ATSB Transport Safety Report**  
Rail Occurrence Investigation  
RO-2013-018  
Final – 2 March 2015

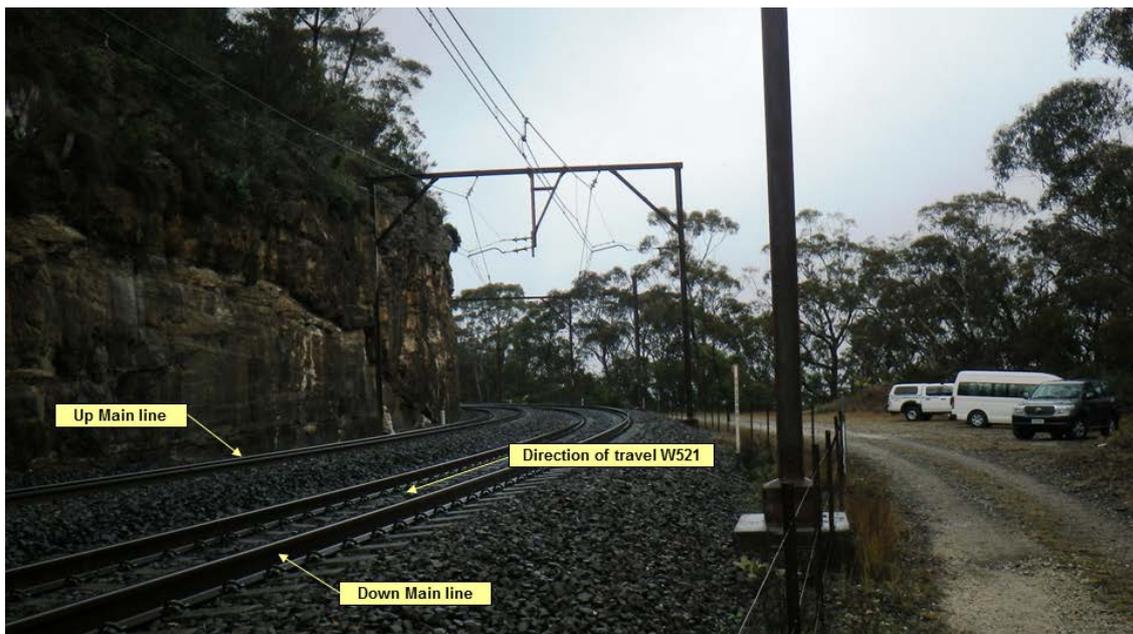
**Figure 2: Worksite at Blackheath**

The worksite was located at the 123.456 km point on a 280 metre right hand curve with a gradient of 1:80.

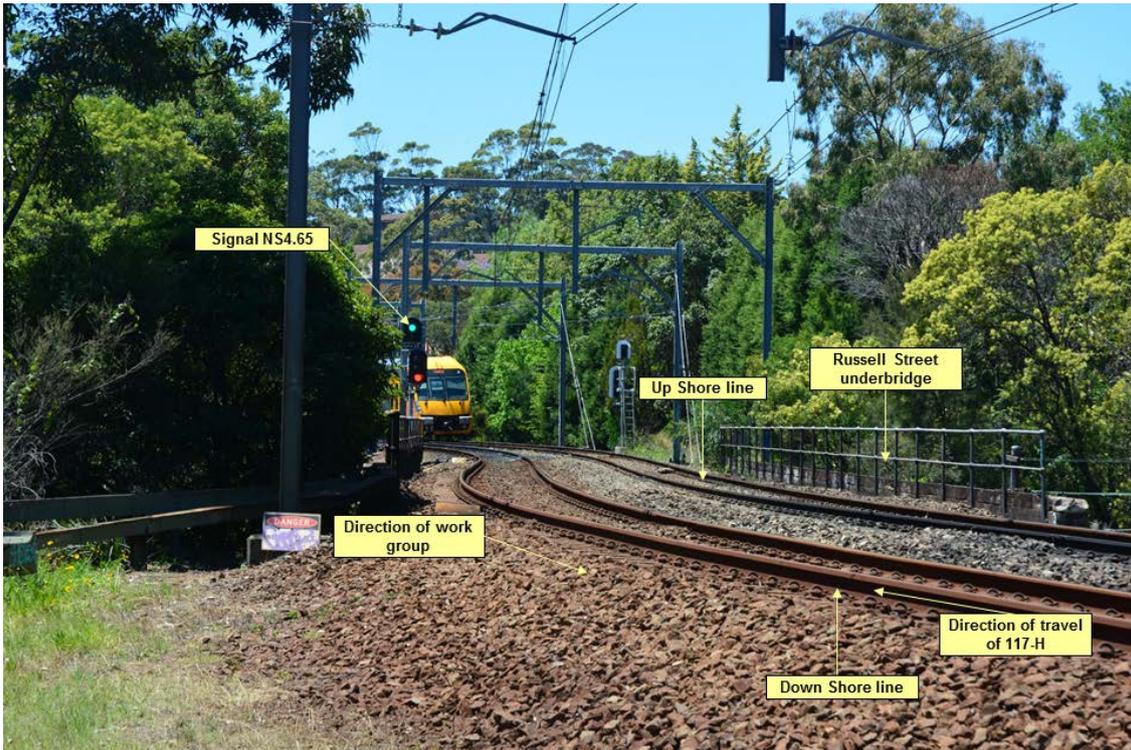
Figure 4: Worksite at Wollstonecraft

The workgroup cleared the track to signal NS4.65 which is located about 20 metres past the northern (St Leonards) end of the bridge at the 7.519 km point.

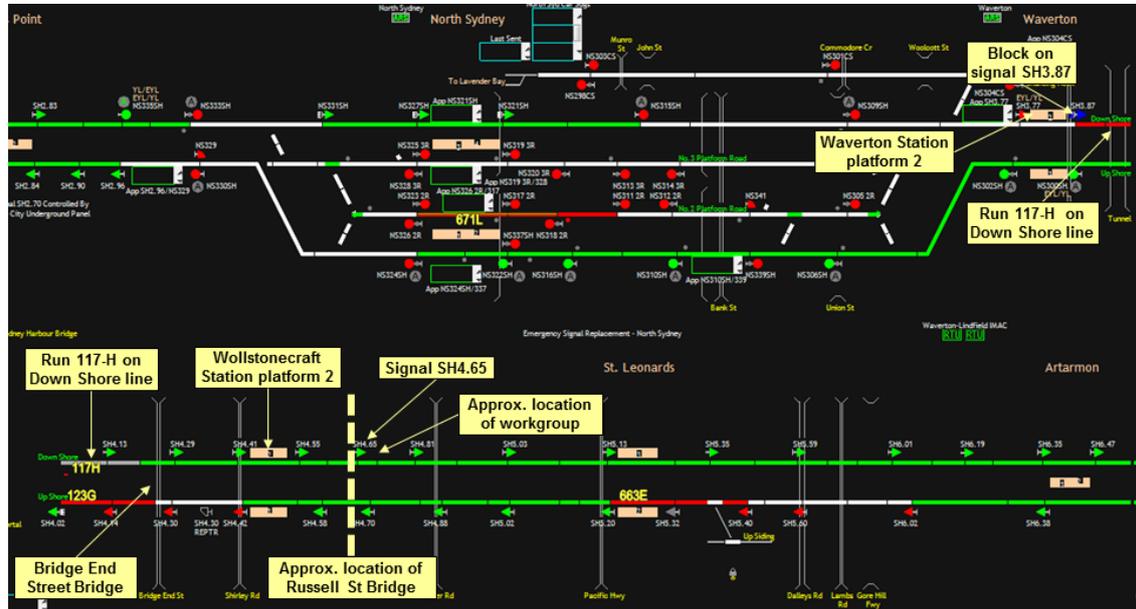
**Figure 8: ATRICS replay at 1256 depicting status of trains and signals at Wollstonecraft**

granted to the PO (Figure 8). He granted the ASB on the assumption that the workgroup was intending to cross the bridge at Bridge End Street (6.822 km point) near Waverton. Observing that this was the first bridge marked on the ATRICS screen after Signal SH3.87 he assumed that the train would have completely passed the workgroup and the bridge by the time the ASB was granted.

While four road overbridges and the Waverton Tunnel are marked on the ATRICS screen, the Russell Street road underbridge is not. At interview the Area Controller stated that he was unaware of the existence of the Russell Street bridge or the workgroup’s intention to cross it. He also stated that he was unaware of any other infrastructure in the section other than that marked on the screen as he had not undergone any familiarisation in the field.
