Safety Investigation Report

Incident with a signal displaying
a less restrictive aspect than expected
Comblain-la-Tour - 6 September 2018

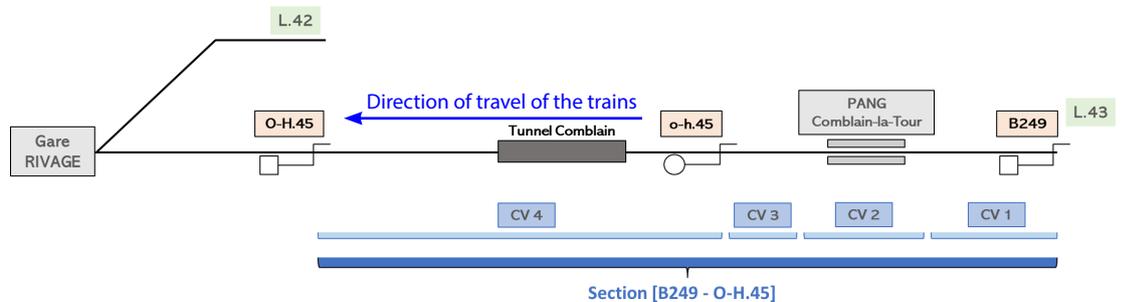
The incident took place in the section between the main automatic stop signal B249 and the main operated stop signal O-H.45 standing at the entry into the Rivage station on line 43. The Liège TGV signal box (block 45) manages the zone where the incident took place.

The signal B249 is an automatic signal: it is not controlled by a signal box operator but by the train detection system consisting of track circuits.

The section between signals B249 and O-H.45 is covered by 4 track circuits.

If at least one of the track circuits in the section is occupied, then:

- the entire section is to be considered as occupied;
- the section access signal (signal B249) must display a Red aspect (at danger).
