Summary Safety report

COLLISION BETWEEN 2 FREIGHT TRAINS
REMERSDAAL - 1 OCTOBER 2013

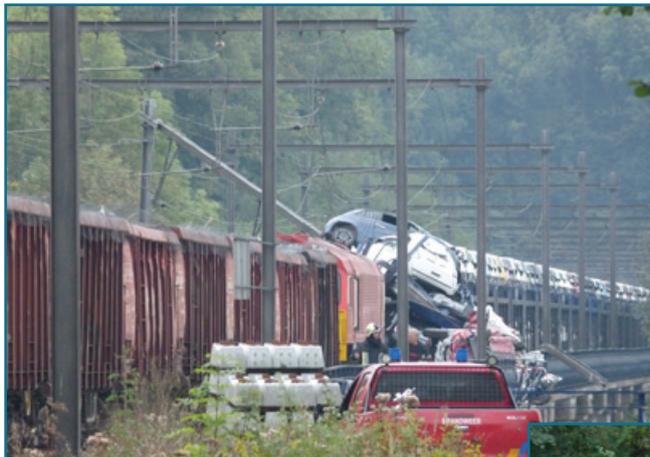
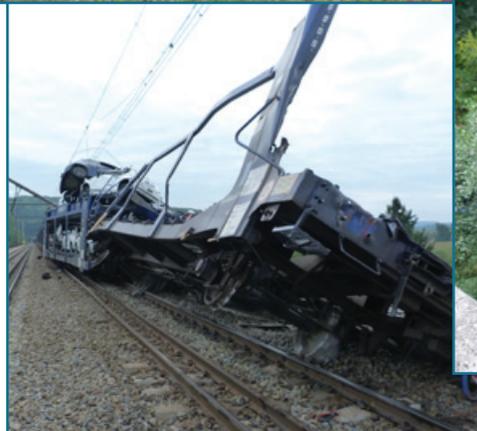
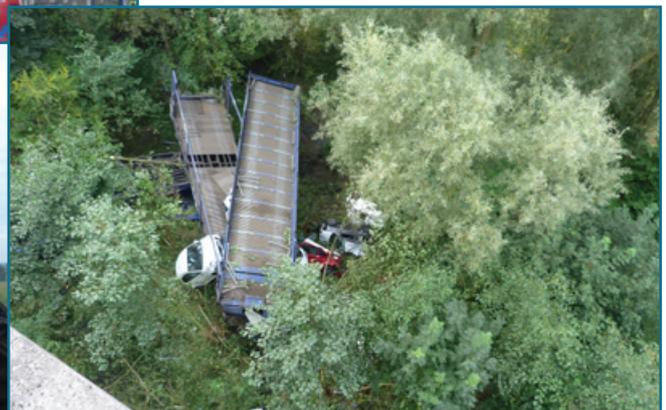
The accident caused major damage to the infrastructure and to the rolling stock but no one was injured.

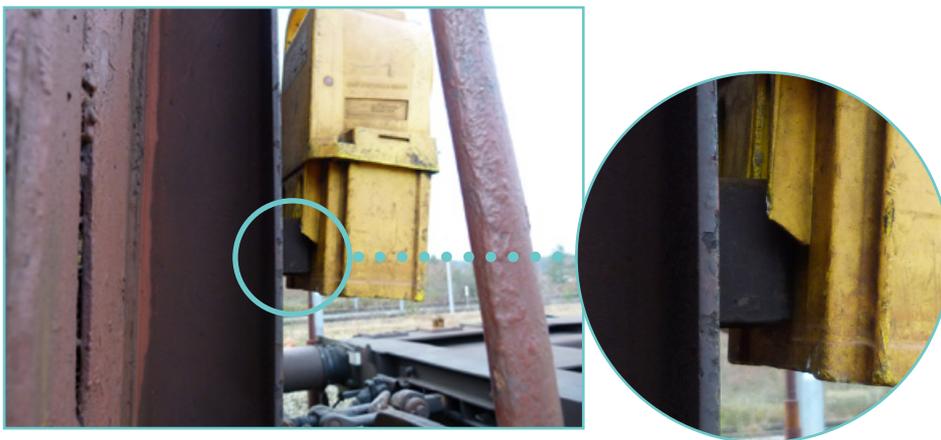
The first train was equipped with a tail lamp but, as it was seized by the police, it was not tested immediately: the investigation could not determine if it was working at the time of the accident. What is more, following contradictory comments on the draft of its investigation report, the IB decided to organise a reconstruction. The IB has thus found compatibility problems between the lamps and the lamp brackets present on certain types of wagons. These incompatibilities could result in, amongst others, the lamp failing to illuminate. The rear wagon on the first train was concerned by this issue.

Other recommendations concern measures to be taken to mitigate the identified risks of a lamp battery failure and the inadequacy of tail lamps and lamp brackets on wagons.
