Summary - Safety Investigation

Collision between 2 SNCB/NMBS passenger trains

Binche - 13 January 2016

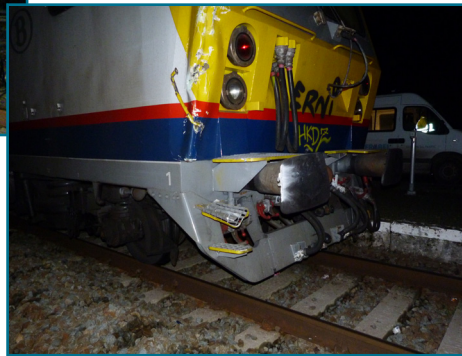
On Wednesday 13 January 2016 at around 20:53, the SNCB/NMBS empty passenger train ME3421 struck the rear of the SNCB/NMBS train E3440 when entering Binche station. There were no victims in the collision and the damage, which was only to the rolling stock, was relatively limited.

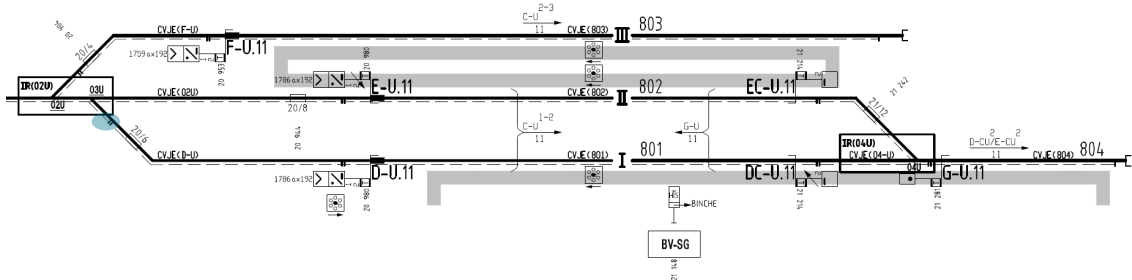
The collision between the two passenger trains was made possible due to the position of an insulated connection on a track circuit ensuring the detection of trains: while the train E3440 had released one part of its route by passing this connection, the train was still in the track gauge of the adjacent track II.

The track circuit being released, the movement of the train ME3421 onto track II was authorised: the front of the train ME3421 collided with the rear of the train E3440.
