Summary Safety Investigation Report

Drifting of 2 empty railcars followed by a lateral collision with a technical train between the Brussels-North and Schaerbeek stations 24 April 2018

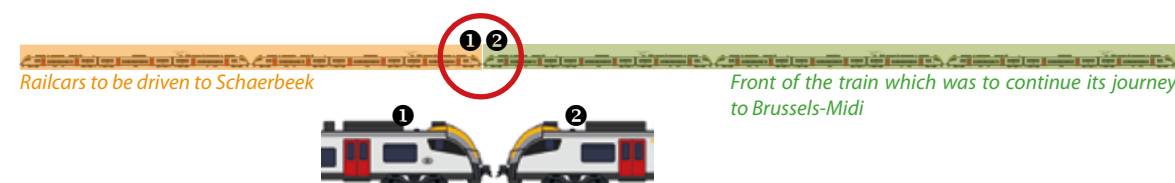
When the driver started the decoupling from the driver's cab ②, the railcars that were to be driven to Schaerbeek came loose and drifted in the Brussels-North set of tracks towards Schaerbeek.

The fact that the parking brake was not engaged on these two railcars was the direct cause of the uncoupling and drifting.

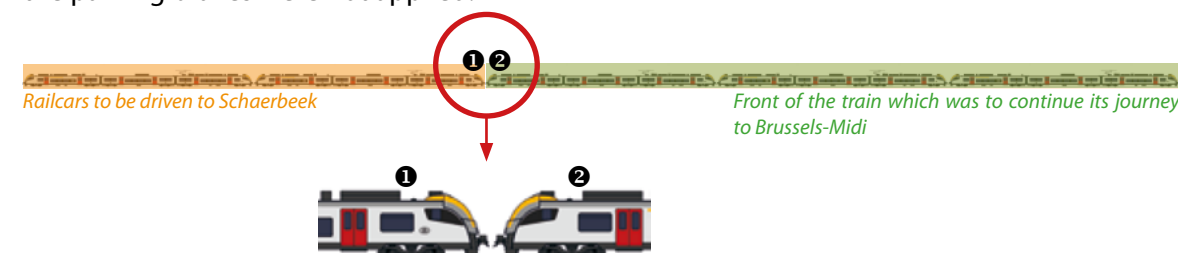
To perform the decoupling, the driver sent to Brussels-North tried to board the first of the towed railcars (❶): he pressed the door button, but as there was no power supply on these railcars, the doors did not open.

He did not notice either that the parking brake indicators on the side of the railcar were green: the parking brakes were not applied.

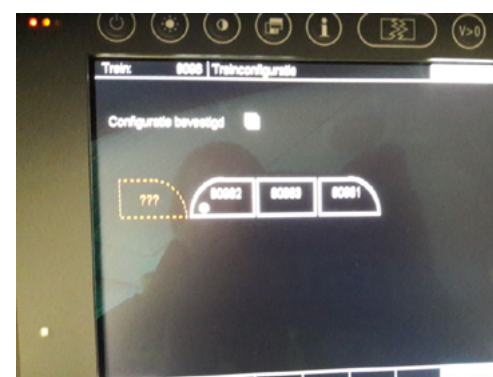
Image from a reconstruction.

- the white area represents the railcar in which the driver is located (❷ on the previous diagram);
- the dotted lines indicate that one or more railcars are coupled in "vehicle" mode.

This characteristic display did not sufficiently draw the driver's attention to the fact that the 2 towed railcars were in "vehicle" mode.

On the control panel, a parking brake indicator light was on, but as there were no electrical connections between the towing railcars and the towed railcars, this indicator only provided information on the status of the parking brakes of the 3 towing railcars (❷ on the diagram and shown in white on the TDD screen).

This last element did not help the driver realise that the railcars that were to be brought to Schaerbeek did not have their brakes on.
