**RAILWAY INVESTIGATION REPORT  
R11W0247**

**MOVEMENT EXCEEDS LIMITS OF AUTHORITY**

**VIA RAIL CANADA INC.  
PASSENGER TRAIN 692  
MILE 32.73, TOGO SUBDIVISION  
MEHARRY, MANITOBA  
29 OCTOBER 2011**

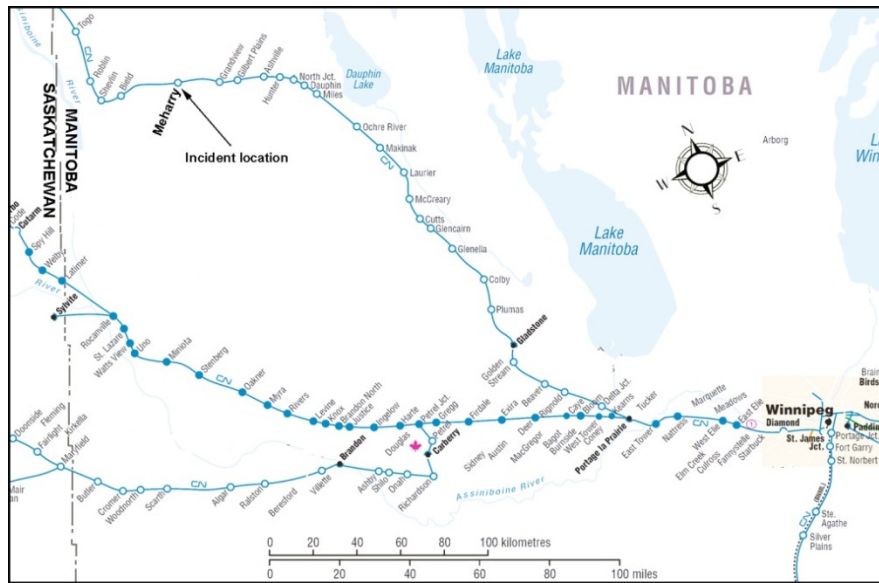
At approximately 1215, the crew of CN freight train 853 saw the headlight of the oncoming VIA train. The CN crew members contacted VIA 692 by radio and began to stop their train, which was travelling westward at 25 mph. Upon hearing the radio call from CN 853, the crew members of VIA 692 realized that they had travelled beyond the limits of their authority and immediately brought the train to a stop. VIA 692 stopped with the head-end locomotive at Mile 32.7, approximately 4.3 miles past its authorized limit.

The 2 opposing trains came to a stop approximately 1500 feet apart. Without requesting authority from the RTC, VIA 692 then began a reverse movement on the main track and backed into the siding at Meharry. CN 853 proceeded westward to Meharry and came to a stop at the east switch (Figure 1).

Figure 1. Incident location (source: Railway Association of Canada, *Canadian Railway Atlas*)

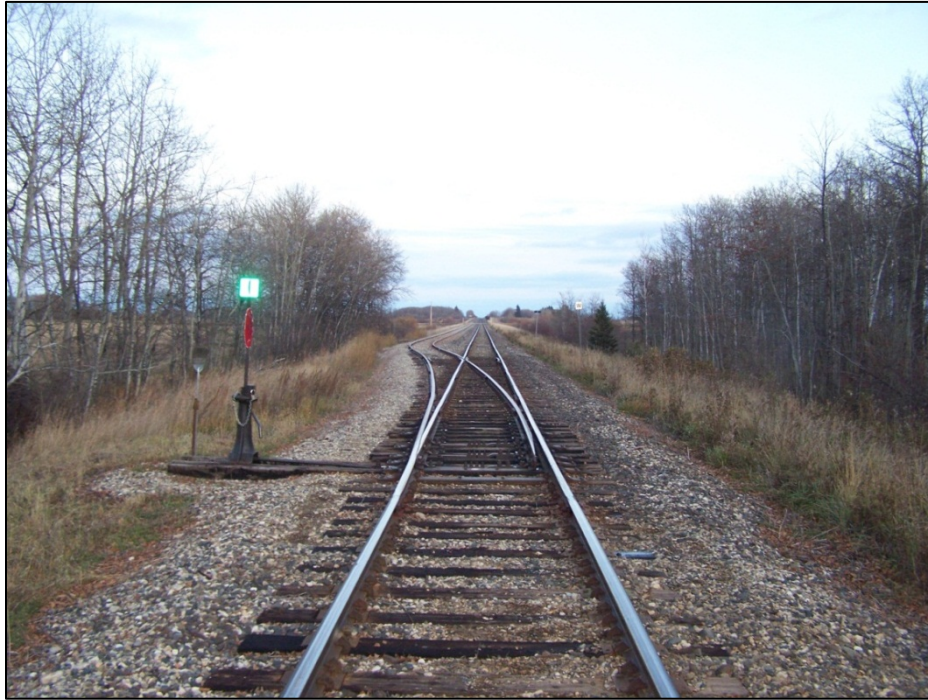
In this incident, Meharry was the seventh station encountered by VIA 692 on the Togo Subdivision. Approaching the west switch at Meharry Siding (Photo 1), there were several visual cues indicating the siding, including:

- the 1 mile to station sign;
- the west siding switch and the switch target located north of the main track;
- the whistle post sign located south of the main track;
- a back track that contained a gondola car situated south of the main track;
- the Meharry station sign located north of the main track;
- the mile post 37 sign located north of the main track;
- the 6727-foot siding track situated north of and adjacent to the main track;
- 2 public road crossings (at each end of Meharry crossing); and
- the east siding switch and the switch target.

**Photo 1.** West switch at Meharry Siding looking eastward

The Meharry signs on the railway right-of-way provide visual indications of the station. In addition, there were other visual cues present, including the siding track, a gondola car stored on the side-track, the manual switches at each end of Meharry Siding, the mile post markers, and the whistle post. However, neither these visual cues nor the written clearance triggered a recall of the RTC instructions or alerted the train crew members that they were proceeding down the main track rather than entering the siding to stop and wait for CN 853.
