## RAILWAY OCCURRENCE REPORT

### COLLISION

CANADIAN NATIONAL  
FREIGHT TRAINS NOS. 272, 308 AND 223  
MILE 4.2, STRATHROY SUBDIVISION  
LONDON, ONTARIO  
16 FEBRUARY 1995

REPORT NUMBER R95S0021

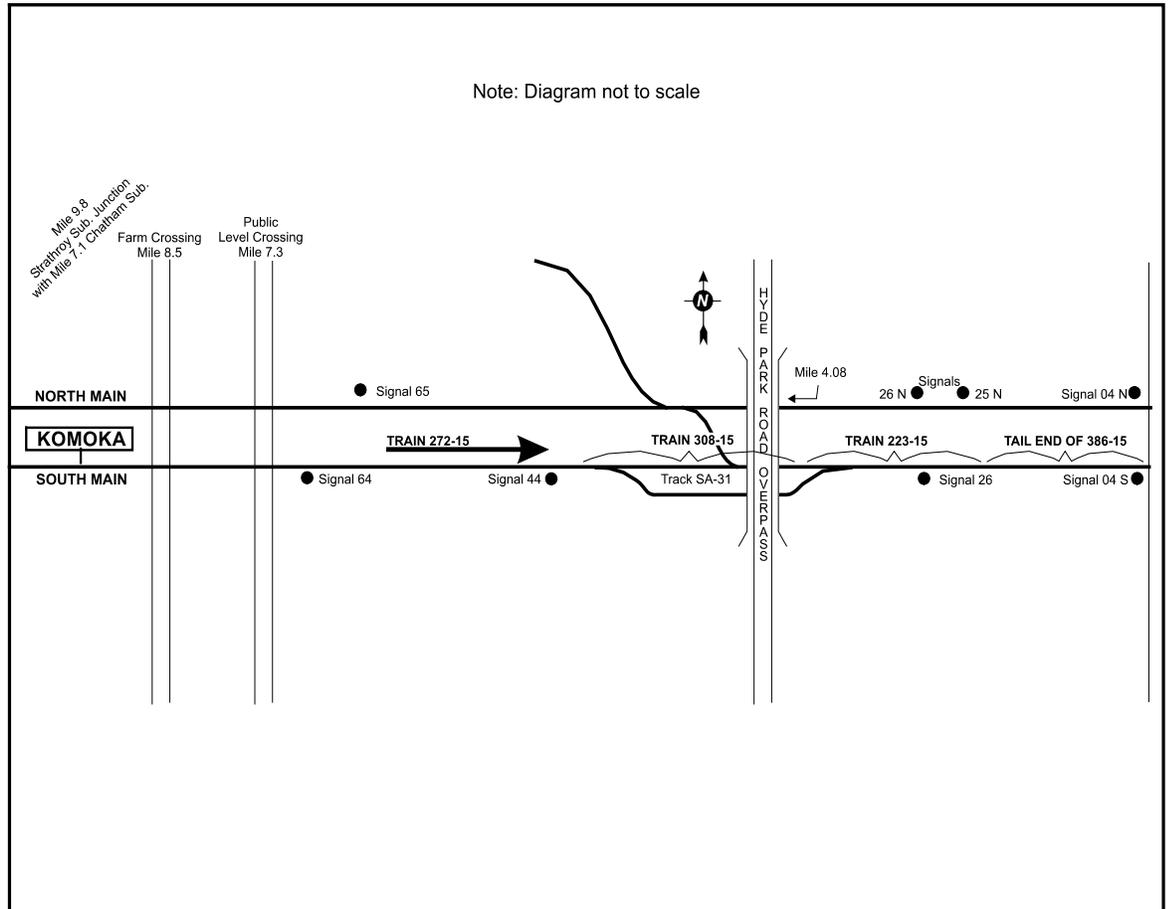
# Appendix A - Relative Position of the Trains Before Impact

When Canadian National (CN) freight train No. 386-15 (train 386), en route eastward from Windsor, Ontario, to Toronto, Ontario, arrived at London, Ontario, Mile 0.0 of the Strathroy Subdivision, it was necessary for the crew members to perform switching on the front of the train. To avoid blocking public crossings within London, the train was positioned on the south main track with the last car in the vicinity of Signal 04S (Mile 0.4) (see Appendix A).

CN freight train No. 223-15 (train 223), also travelling eastward from Windsor to Toronto, following signal indications, was stopped behind train 386. The rear of train 223 was approximately 2,000 feet west of Signal 26 (Mile 2.6).

Eastward CN freight train No. 308-15 (train 308), travelling from Sarnia, Ontario, to Toronto, also following signal indications, was stopped behind train 223. The last car of train 308 was about 1,100 feet east of Signal 44 (Mile 4.4).

Eastward CN freight train No. 272-15 (train 272), travelling from Pontiac, Michigan, to Toronto, left Komoka, Ontario (Mile 9.01), at approximately 0337 after having obtained authority to operate, without restrictions, on the south main track, between Komoka and Ridout (Mile 0.4). At approximately 0349, after passing Signals 64 (Mile 6.4) and 44 and while travelling at about 29 mph, train 272 collided with the last car of train 308. The force of the collision pushed train 308 into the last car of train 223. Train 223 did not derail.
