RAILWAY INVESTIGATION REPORT

R02C0022

MAIN-TRACK COLLISION AND DERAILMENT

**CANADIAN PACIFIC RAILWAY
TRAIN 671-038 AND TRAIN 177-24
MILE 26.9, MOUNTAIN SUBDIVISION
GLENOGLE, BRITISH COLUMBIA
24 MARCH 2002**

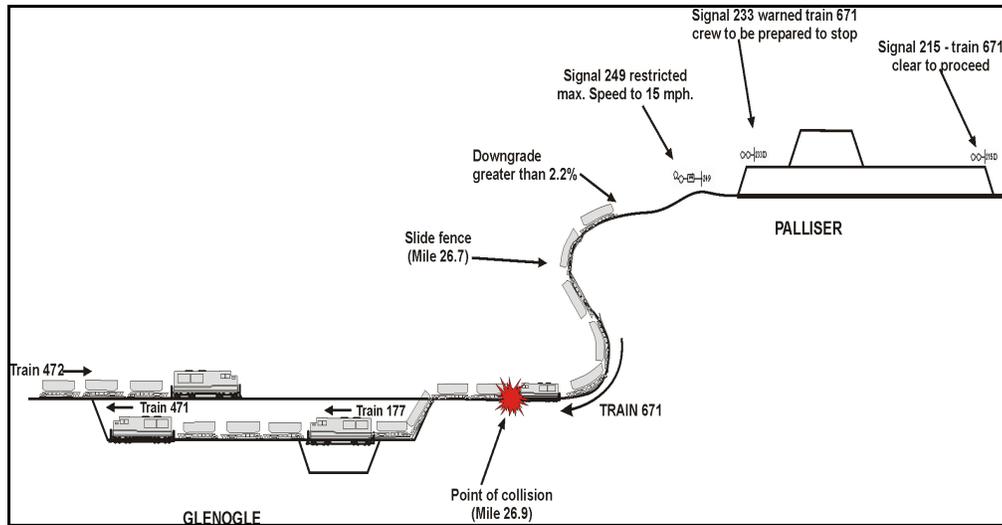
Figure 1. Sketch showing position of trains and signals

Train 177 consisted of 2 locomotives, 42 loads, weighed 4130 tons and was 6286 feet in length. Train 177 was stationary with its head end portion in the siding at Glenogle and the rear portion extending onto the main track to Mile 26.9.

Train 471 consisted of 2 locomotives, 6 loads, 65 empties, weighed 2250 tons and was 4854 feet in length. Train 471 was stationary with its head end at the west end of the Glenogle siding and the rear portion extending to the middle of the siding.

The RTC had informed trains 471 and 177 that there would be a meet at Glenogle. However, train 671 was not informed that trains 471 and 177 were waiting to meet train 472 at Glenogle. There is no requirement for RTCs to communicate to train crews where train meets are to take place, as train movements are controlled by signal indication. However, it is a common practice for RTCs to inform train crews of intended meets. CROR Rule 90, "Communication Between Crew Members," establishes communication requirements between crew members when there is a crew member located in other than the cab of the lead locomotive. Canadian Pacific Railway (CPR) System Special Instruction 2 makes it a requirement for CPR train crews to announce the requirements of CROR Rule 90 over the standby radio channel when all crew members are located in the cab of the lead locomotive. Train crews are not required to, and might not always, communicate with other trains when they are stopped or delayed, unless they are stopped due to an emergency or an abnormal condition. Furthermore, due to the volume of radio traffic on the standby channel, radio announcements made as per CROR Rule 90 are often inaudible.
