**RAILWAY INVESTIGATION REPORT  
R13C0049**

**MAIN-TRACK TRAIN COLLISION  
CANADIAN PACIFIC RAILWAY  
FREIGHT TRAINS 351-424 AND 100-17  
MILE 138.7, MAPLE CREEK SUBDIVISION  
DUNMORE, ALBERTA  
18 MAY 2013**

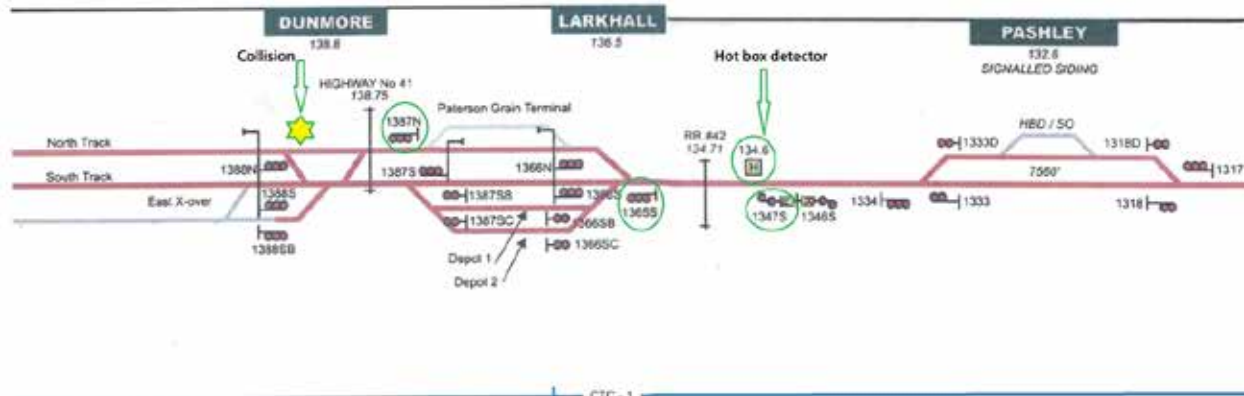
The next signal encountered was signal 1365S (Figure 2) at Larkhall, Alberta, (Mile 136.5) which is the beginning of the two main tracks that extend westward to Bellcote, Alberta, (Mile 141.9). At signal 1365S, the continuation of the single main track becomes the south main track, and train 351 was lined to diverge onto the north main track.

Figure 2. Signal layout (Source: Canadian Pacific Railway Timetable, with annotations by the TSB)

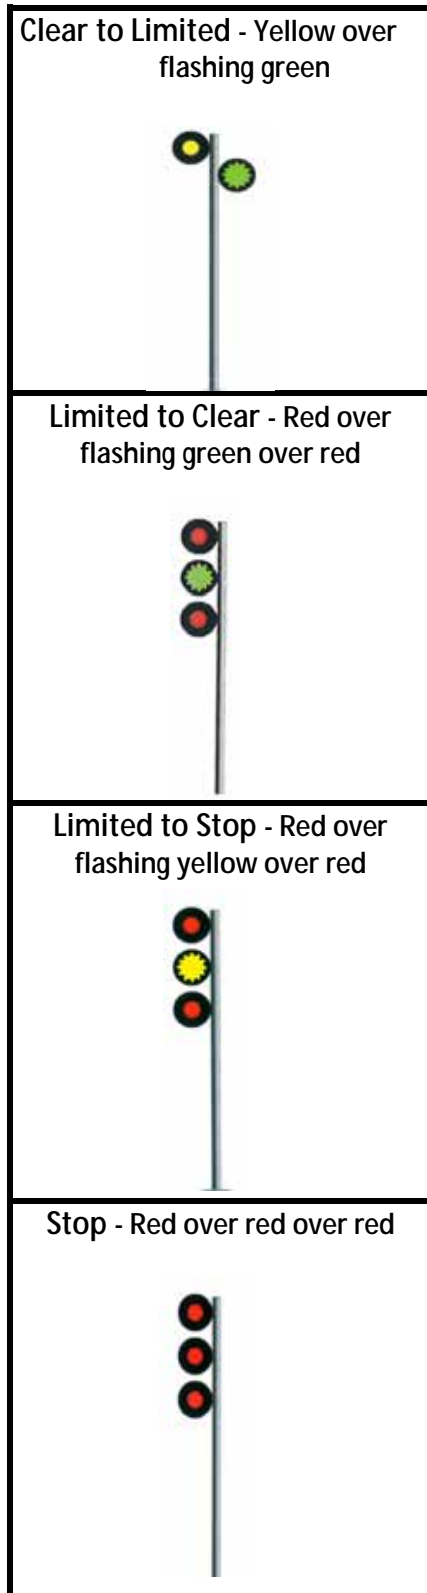
In the cab, signal 1365S was identified and communicated by the locomotive engineer (LE) as a Limited to Clear indication (Figure 3). The LE believed that the conductor had repeated Limited to Clear in response. However, the conductor believed that he had identified the signal as a Limited to Stop indication, and had called Limited to Stop to the LE. Neither crew member noted any discrepancy with the indication vocalized by the other. The indication that was entered on the conductor's CTC Signal Record form for signal 1365S was Limited to Stop.

Figure 3. Signal aspects

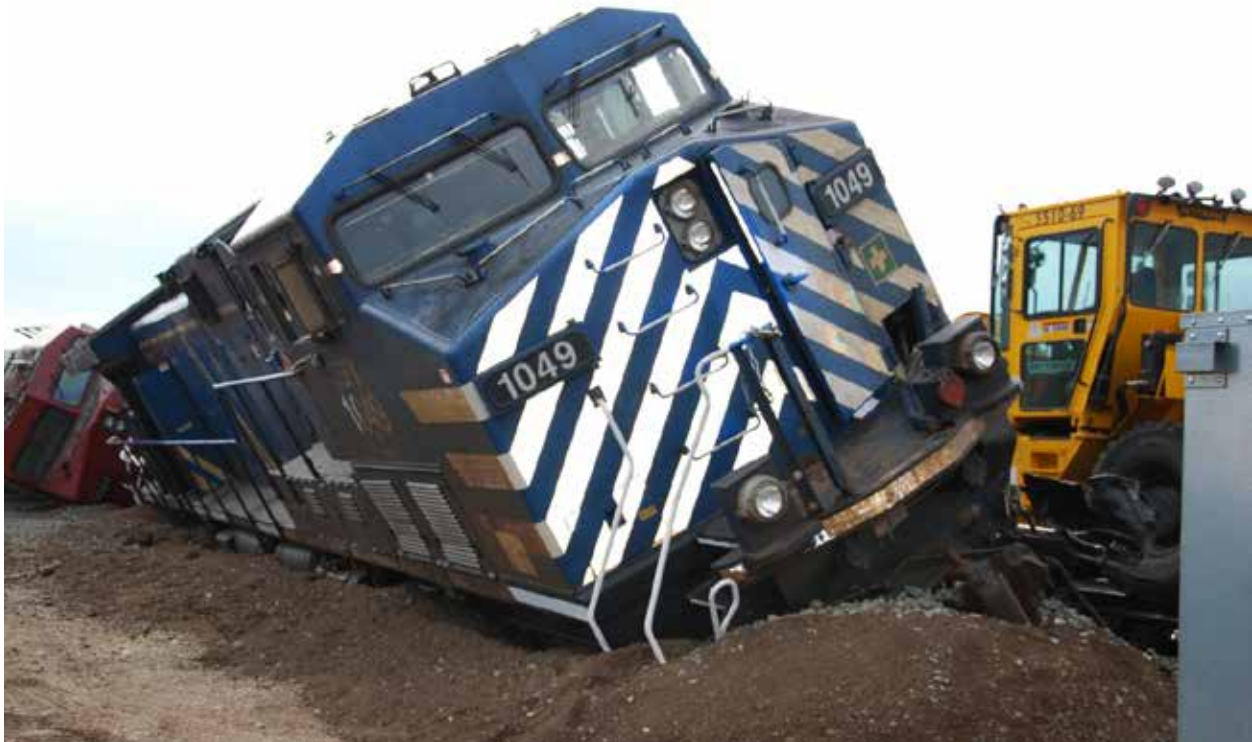
Photo 1. Orientation of derailed locomotives on train 351

Train 351 travelled approximately 1100 feet past the Stop signal and collided with the 39th car of train 100. At the time of the collision, train 351 was travelling at 20.2 mph. The lead locomotives of train 351 (CEFX 1049, CP 9804) derailed to the north and came to rest leaning at about 20 degrees and 70 degrees respectively (Photo 1).

Approximately 80 litres of diesel fuel was lost when the fuel tanks punctured. A small fire started post-accident due to engine oil igniting. The fire was extinguished by emergency

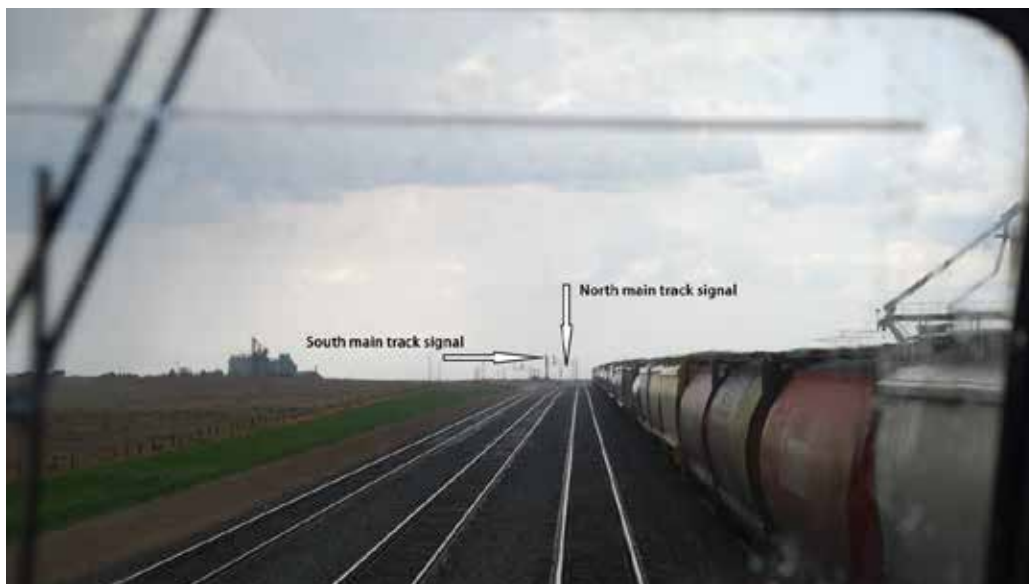
Photo 2. Positioning of signal 1387S and signal 1387N at Dunmore

The north main track signal is positioned in this manner to accommodate the western access to the grain terminals. When approaching this signal, because of the track curvature and the fact that there are multiple tracks to the north and south of the main track, it may be difficult to observe signal 1387N when there are railcars on these tracks.

On the day of the occurrence, due to a train on the adjacent south main track, the signals were in view from about 1200 feet, and the clear but overcast skies provided good contrast for signal visibility.
