RAILWAY INVESTIGATION REPORT R13Q0001

COLLISION AND DERAILMENT QUEBEC NORTH SHORE AND LABRADOR RAILWAY FREIGHT TRAIN FCN-05 AND IRON ORE TRAIN BNL-005 AT MILE 124.2, WACOUNA SUBDIVISION, NEAR MAI, QUEBEC 11 JANUARY 2013

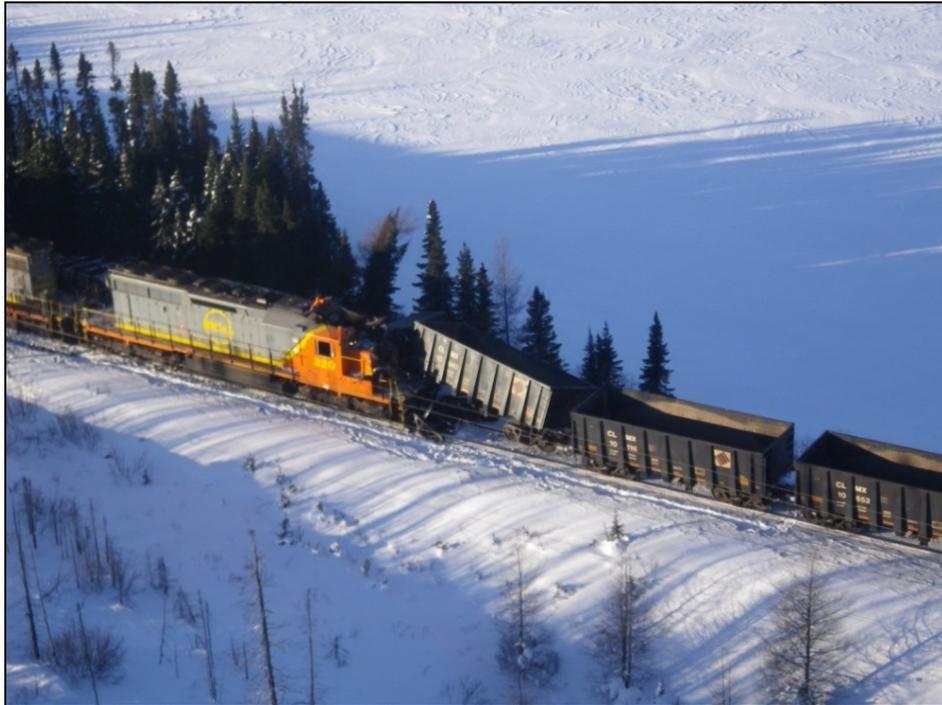
Photo 1. Train FCN-05 in collision with the tail end of train BNL-005 (source: QNS&L)

The crew members of train FCN-05 sustained minor injuries. Just prior to the collision, the engineer instructor got up from his seat and moved next to the engineer trainee. The engineer instructor braced himself behind the engineer trainee's seat, while the latter bent forward in his seat awaiting the impending collision. The cabin of the lead locomotive on train FCN (locomotive 320) was destroyed by the impact. The second locomotive on train FCN (locomotive 318) and 8 cars from train BNL derailed and sustained varying degrees of damage. Approximately 40 feet of track was damaged.

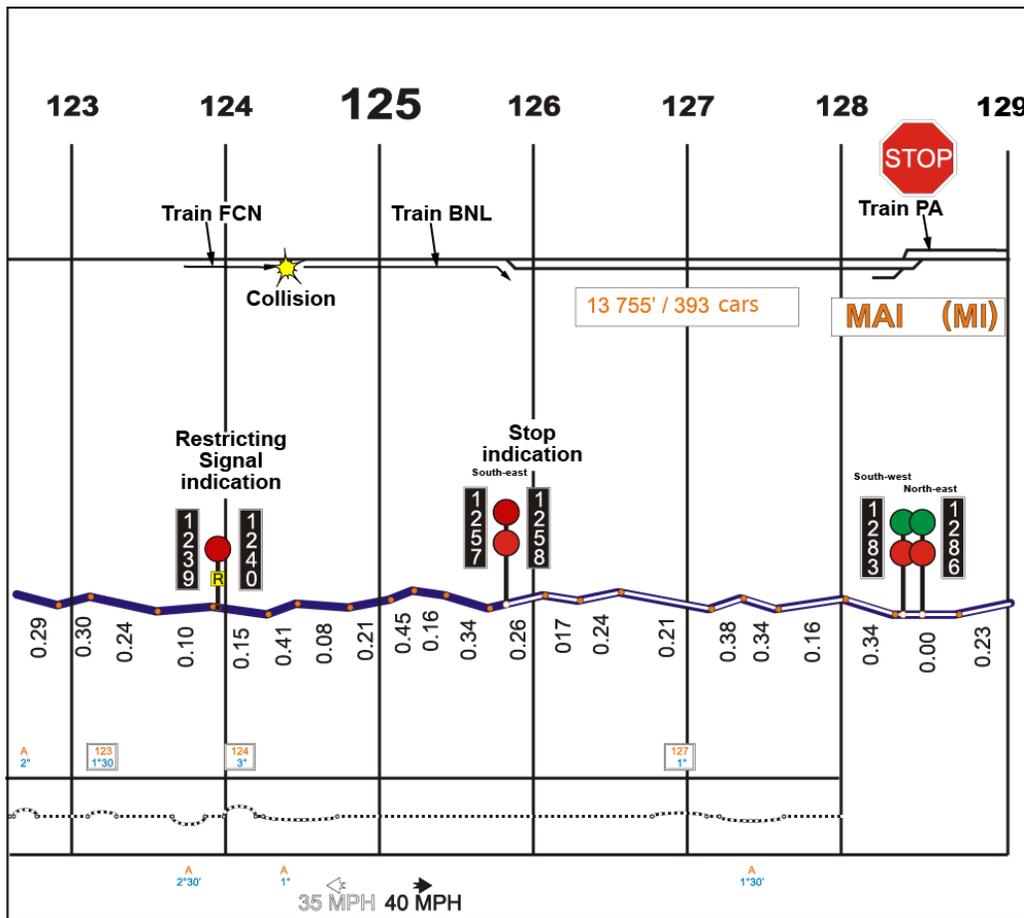
The first locomotive on train FCN came to rest at Mile 124.2, at the exit of a 3° left-hand curve. This curve, located right after signal 1239, is preceded by a 2°30' right-hand curve. The cabin on this locomotive was destroyed. Two truck side frames from derailed cars on train BNL were projected into the cabin. The rear truck on the second locomotive of train FCN derailed.

Figure 2. Track profile, signal layout and trains in the vicinity of Mai

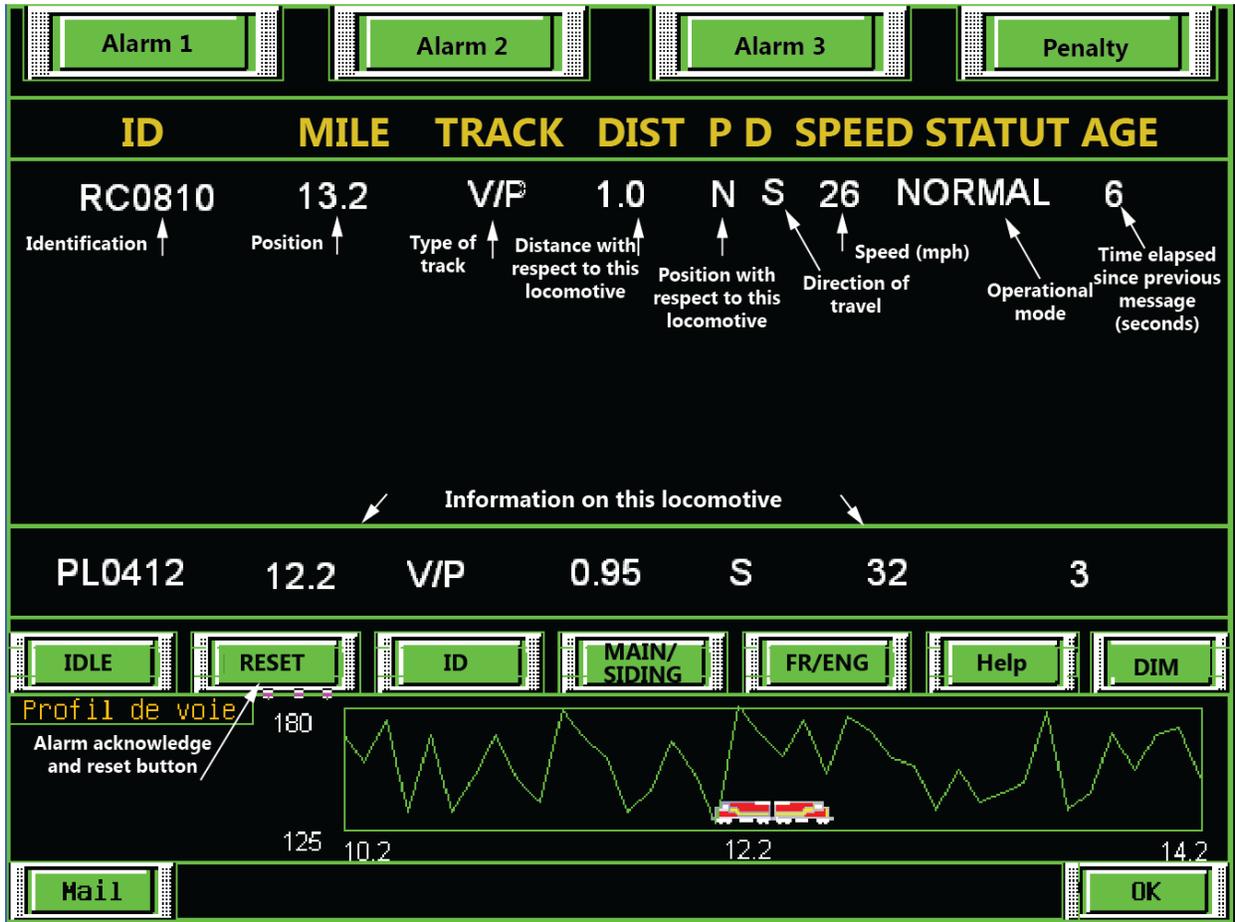
Figure 3. Standard screen for a proximity detection device (source: QNS&L)

The PDD displays the distance between rail vehicles along with the other positions received. This distance calculation does not take into account the length of a train and only provides the distance between vehicles that have an onboard PDD. The distance must be interpreted by the engineer. When the separation between locomotives is less than 8, 5 or 3 miles, a visual warning indicating the alarm level (1, 2 or 3) is displayed on the screen and an audible warning is sounded (identical for all 3 alarm levels). To acknowledge receipt of type 1 and 2 alarms, the engineer must press the button on the crew alertness device located near the PDD screen or click on the "REARMER" button on the PDD screen itself. For type 3 alarms, the engineer must first press the button on the crew alertness device within 10 seconds of the alarm, and then click on the "REARMER" button in the next 5 seconds. If an engineer fails to acknowledge receipt of a type 2 or 3 alarm within 10 seconds, the system triggers automatic braking of the rail vehicle.

The audible warnings sounded by the PDD force the operator to refocus his visual concentration on the screen. The operator acknowledges each alarm by clicking on the "REARMER" button located at the bottom left of the screen. However, this does not prompt the operator to take note of such critical parameters such as separation distance, and the speed and location of the nearest rail vehicle. A visual warning signal associated to these parameters would draw the operator's attention to this critical information. Moreover, the distance given for a train preceding another train in the same direction indicates the distance between the 2 locomotives and not the actual separation distance between the 2 trains. The operator must extrapolate the distance from the identification code of the trains to determine the actual distance. Therefore, when the type 3 alarm sounded, the actual separation between the 2 trains was approximately 1 mile whereas the screen indicated 3 miles. Given that the PDD screen does not show the actual separation distance between 2 trains moving in the same direction, the operator did not fully realize that a collision was imminent.
