RAILWAY OCCURRENCE REPORT

R98D0184

SIGNAL PROBLEM

CANADIAN NATIONAL  
MILE 8.9, MONTREAL SUBDIVISION  
BALLANTYNE, QUEBEC  
15 DECEMBER 1998

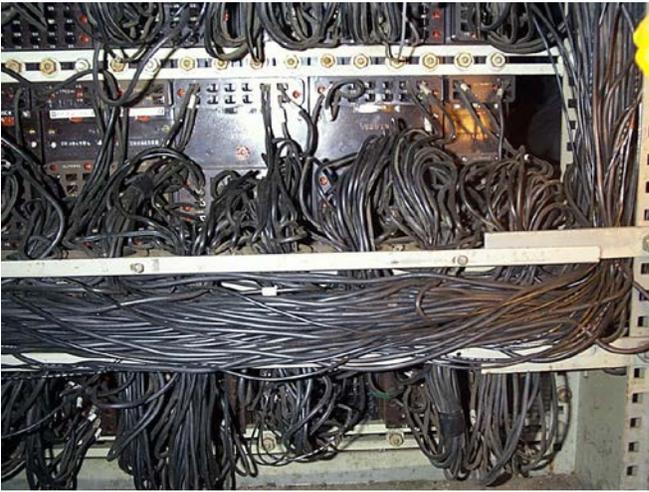
27RWCR was on the bottom row of the rack, and a bundle of wires obstructed the metal identification plaque. The relays are arranged in rows with very little spacing (see Figure 1).

Given that employees have to lie on the ground and try to read a small metal plaque with the engraved relay number through a bundle of wires to install a wire to relay 27RWCR and that some relays are not identified, it is difficult to be sure that the installation has been correctly done. The identification of the two relays in this case differed by only one letter (27NWCR and 27RWCR), which increases the potential for error. The S&C installation coordinator and his apprentice did not use standard terminology when installing the wire ("second left" instead of "relay 27RWCR"), and the S&C installation coordinator stood on one side of the rack while the apprentice worked on the other, making it difficult to check the work done.

5. Because of the location of the relays, their proximity to one another and their identification in the Ballantyne main bungalow, the potential for error in installation was increased.

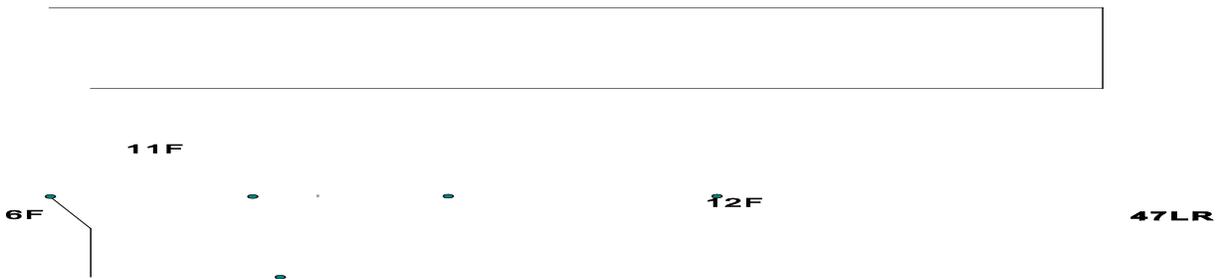
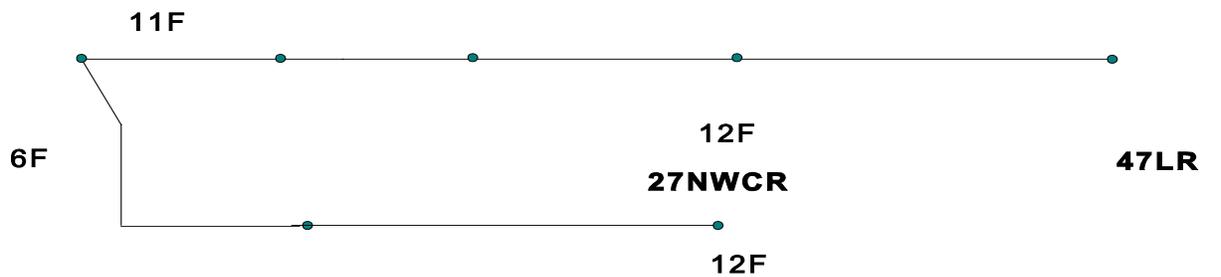
S&C employees went to the Ballantyne main bungalow and found that a power wire was connected to the wrong relay, allowing the system to give less restrictive signals than it should have. They reported that only signal 24R was affected by this wiring error.

During the installation, the S&C installation coordinator had given instructions to the apprentice concerning the location of the wire, but he could not remember whether he had identified the relay by name or by its position on the rack. The apprentice had made the connection at the back of the rack and had connected the wire to terminal 12F on relay 27NWCR, the one right next to 27RWCR, to which it should have been connected (see

1. A wire was connected to the wrong relay in the Ballantyne main bungalow, so that signal 24R at Ballantyne could display a permissive signal while a train was still in the next block; this created a risk of collision since one train could have followed another (which could have been stationary) at a speed of up to 95 mph.
2. Because of the lack of procedures for RTCs to follow when they suspect a signal system malfunction, RTCs must rely on their own judgment and experience in making decisions to ensure system safety.
