RAILWAY ACCIDENT INVESTIGATION UNIT IRELAND

INVESTIGATION REPORT

Investigation into SPADs on IÉ Network, from January 2012 to June 2015

RAIU Report No: R2016 – R001

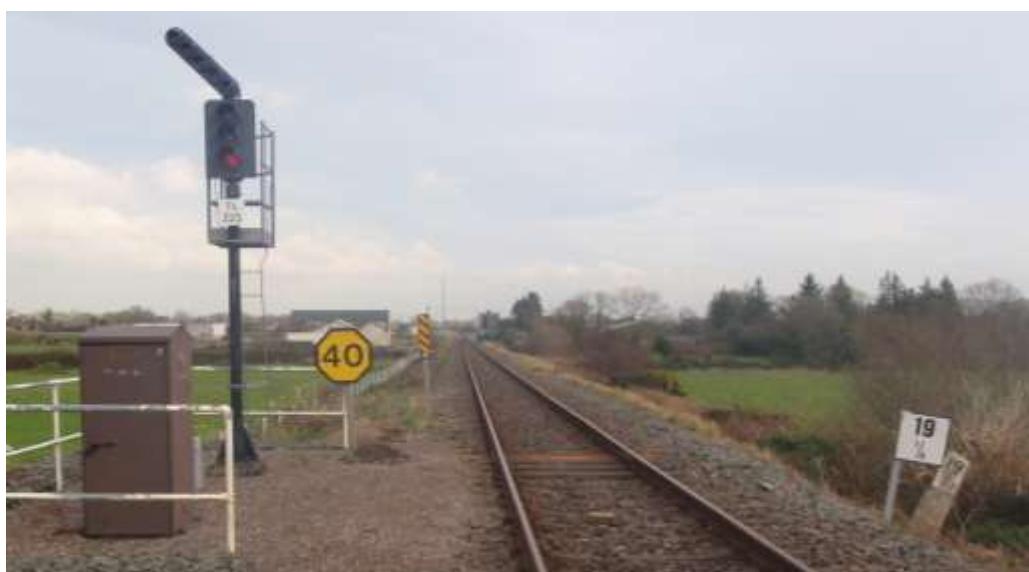
Figure 22 – Signal TL223 with route indicator and adjacent speed board

190 Signal TL223 is a three aspect signal mounted on a standard height pole situated on the left hand side of the track close to 19 ¼ MP. It is capable of displaying single yellow, green and red aspects; and has a *route indicator*, see Figure 22. TL223 clears to a green aspect on request from the CTC Signalman after the barriers of Level Crossing XT061 are lowered; the level crossing is not *approach released*. There is a 40 mph (64 km/h) speed board located behind the signal.

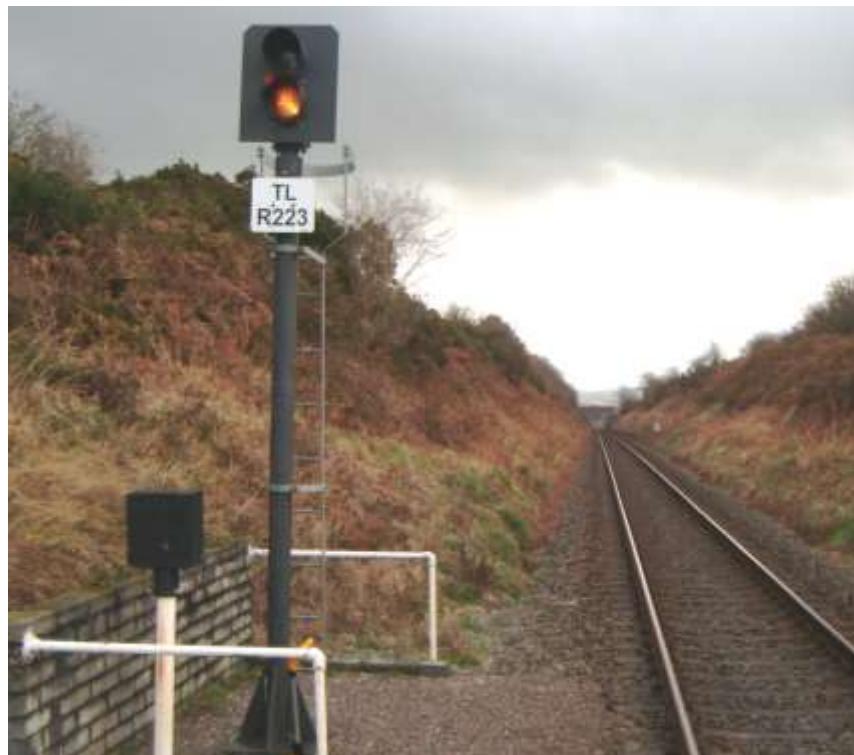
Figure 24 – Signal TLR223

192 Signal TLR223 is the *repeater signal* for Signal TL223. It is a two aspect signal mounted on a standard height pole situated on the left hand side of the track, see Figure 24. It is capable of displaying single yellow and green aspects. It is located 2,016 m before Signal TL223. It has a recorded sighting distance of greater than 1000 m as it is located on a straight section of track; therefore this signal also meets the requirement of 286 m sighting distance set out in I-SIG-2043.

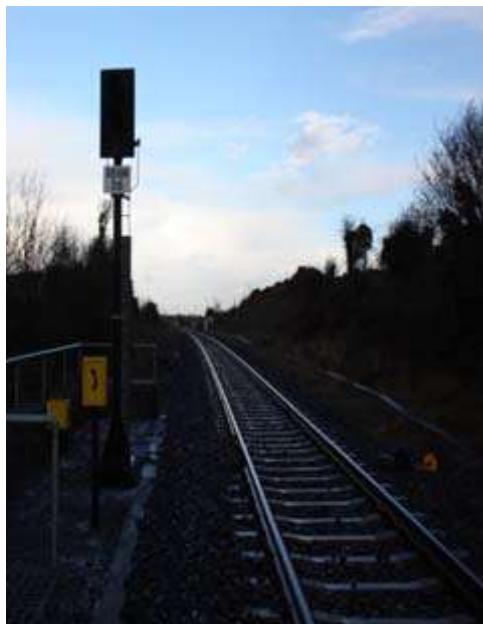
Figure 45 – Distant Signal XE098DS

350 Distant signal XE098DS, the signal that was passed at danger, is a two aspect signal mounted on a standard height pole situated on the left hand side of the track close to the 36 MP. It is capable of displaying single green and red aspects. It is not approach released and normally clears to a green aspect on request from the LCCO at Mallow after the barriers at Level Crossing XE098 are lowered and the crossing is observed to be clear by the LCCO, see Figure 45.

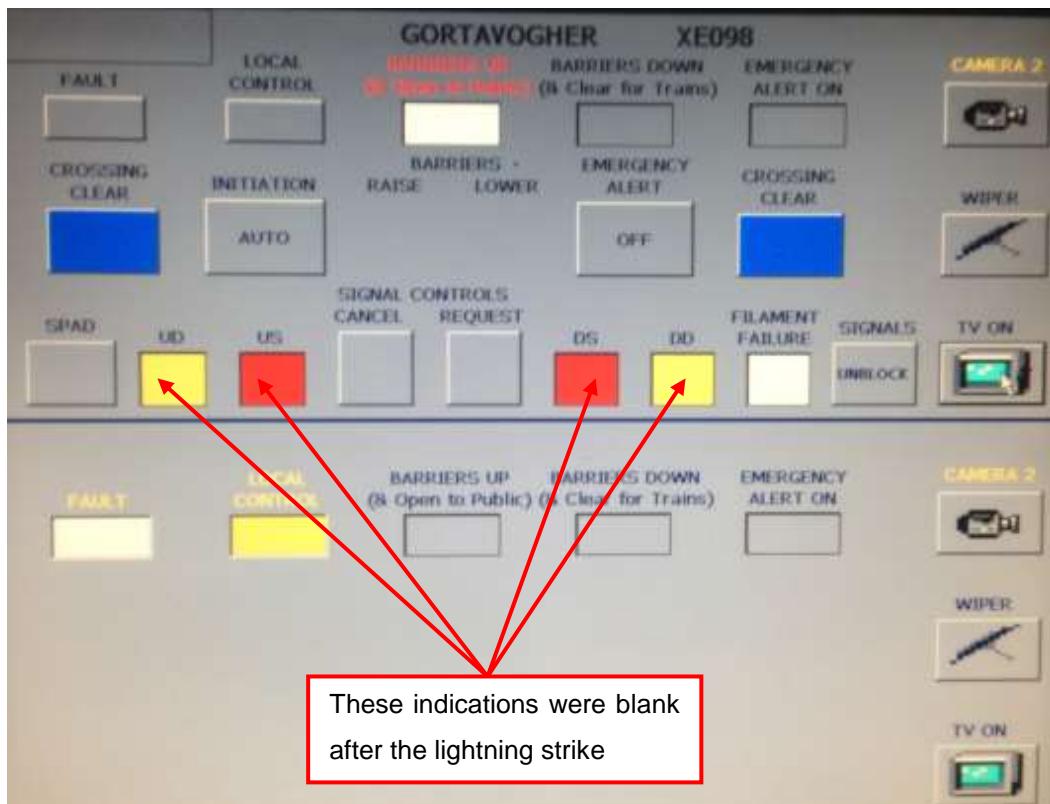
Figure 50 – The signal information was blank after the lightning strike

361 However, the specific fault of a failure of controls and indications on the touch screen was not referred to in the table, this is the fault which occurred on the day of the incident, where the UD, US, DS and DD information was blank, see Figure 50.

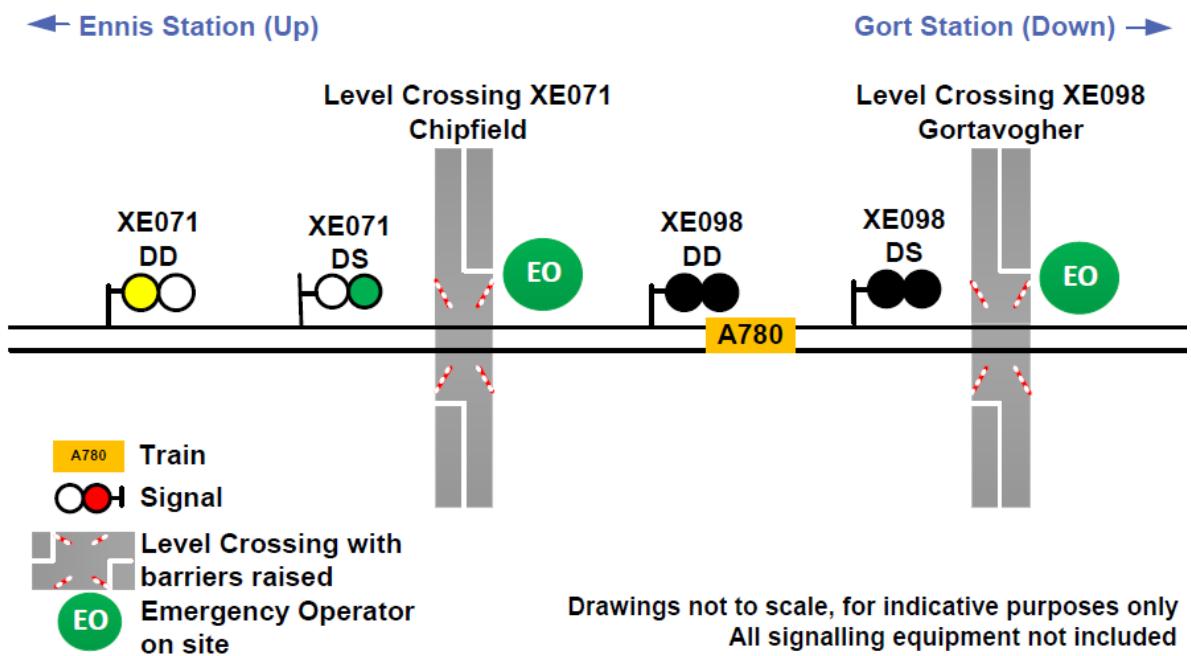
Figure 55 – Train A780 travels past Signal XE098DD (which is not showing any aspect) without authority

399 As Train A780 approached Level Crossing XE098, Distant Signal XE098DD was not displaying any aspect. Due to the poor weather Driver A780 did not see the signal and as a result did not slow down; and continued past the signal 'at Danger', see Figure 55.

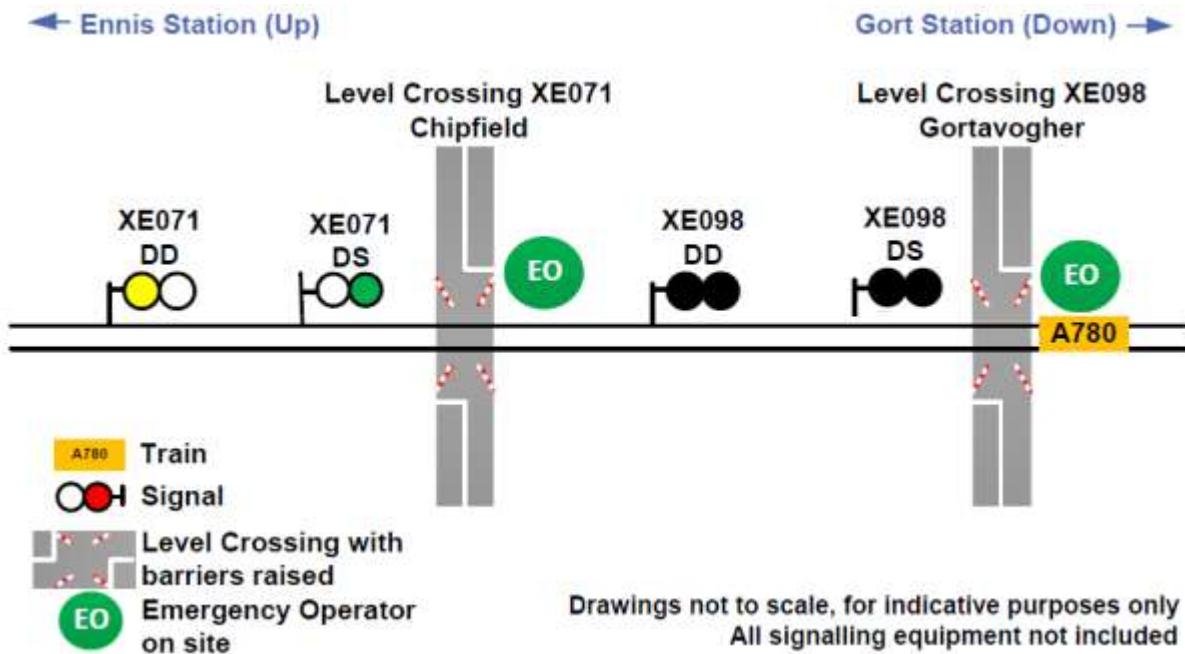
Figure 56 – Train A780 passes Signal XE098 DS without authority and through Level Crossing XE098 with the barriers raised to road traffic.

402 Train A780 travels past Signal XE098DS without authority and through Level Crossing XE098 with the barriers raised to road traffic. There is no road traffic using the crossing at the time of the incident. Train A780 is travelling at 58 mph (98 km/h), see Figure 56.

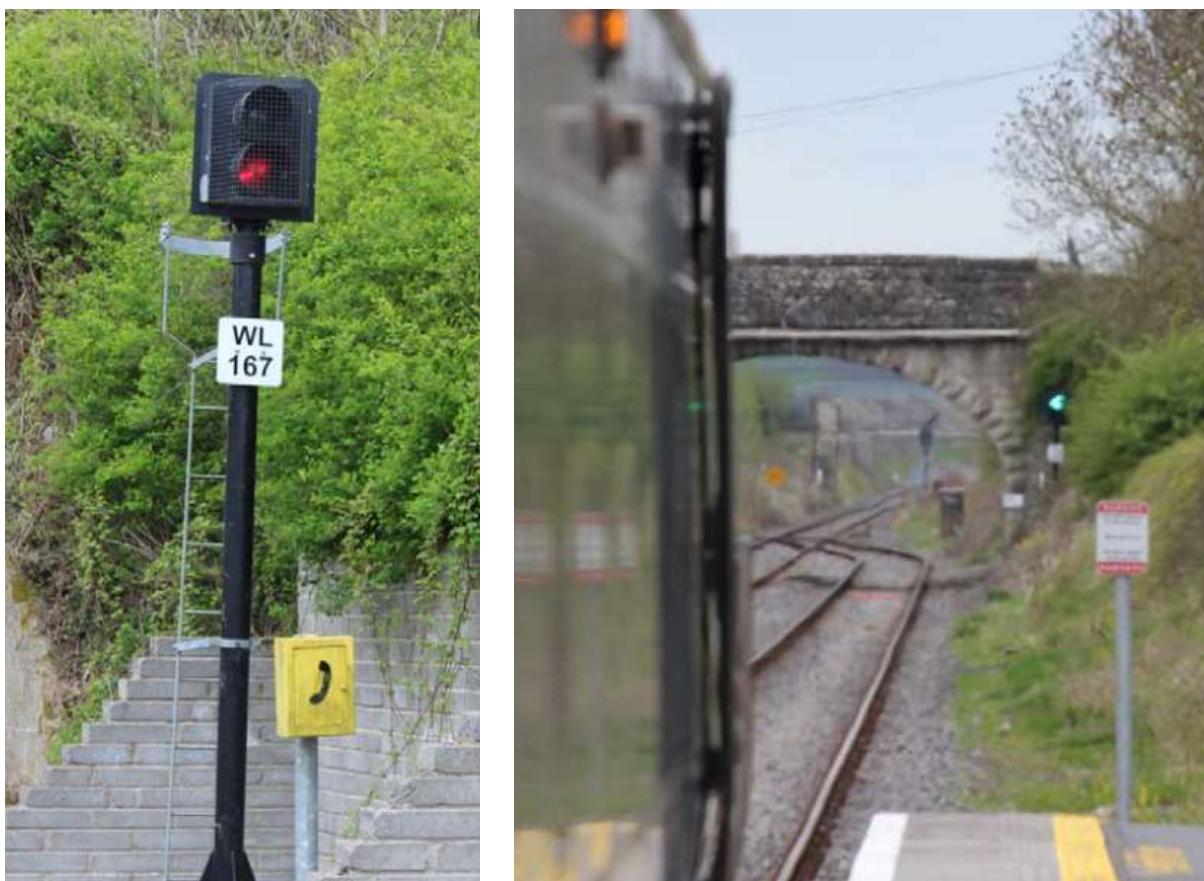
Figure 59 – Signal WL167 & sighting from cab of Signal WL167

452 Signal WL167 is located approximately 215 m off the platform on the right hand side exiting Muine Bheag Station. It is a two aspect signal mounted on a standard height pole that can display a red or green aspect, see Figure 59. Signal WL167 is the starting signal for the Muine Bheag to Kilkenny section. The sighting meets the requirements set out in I-SIG-2043.

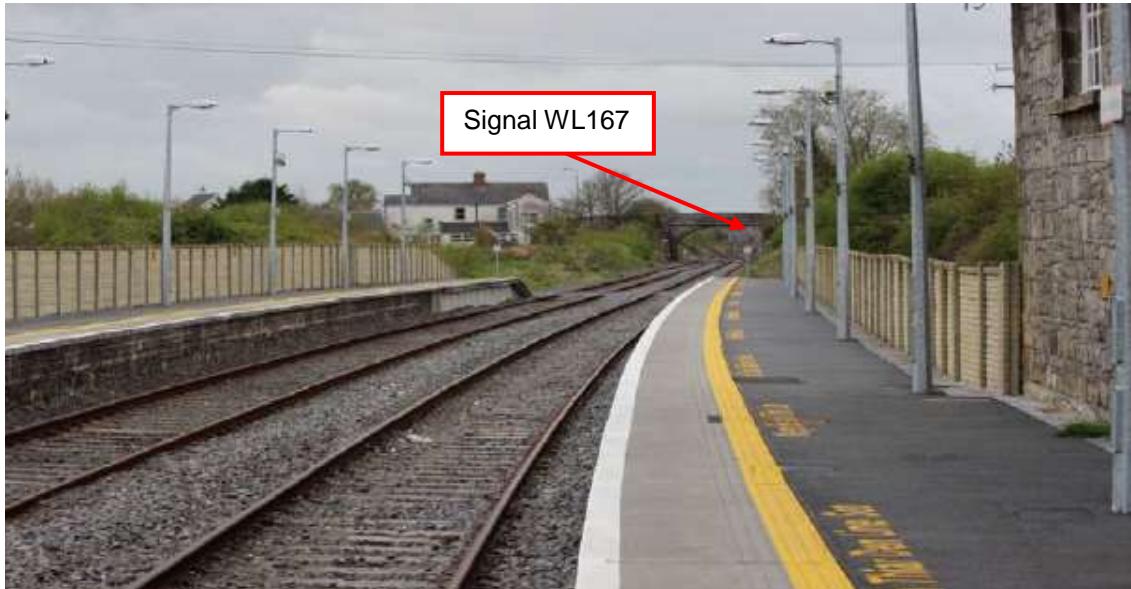
Figure 60 – PIC's view from platform of Signal WL167

453 Muine Bheag Station Platform is a curved platform, see Figure 61. As a result the PIC has to be in a position where he/she can see Signal WL167 (Figure 60), and the driver, prior to giving the 'Ready to Start' indication.
