REPORT

JB 2011/03

REPORT ON RAILWAY ACCIDENT WITH FREIGHT CAR SET THAT ROLLED UNCONTROLLEDLY FROM ALNABRU TO SYDHAVNA ON 24 MARCH 2010

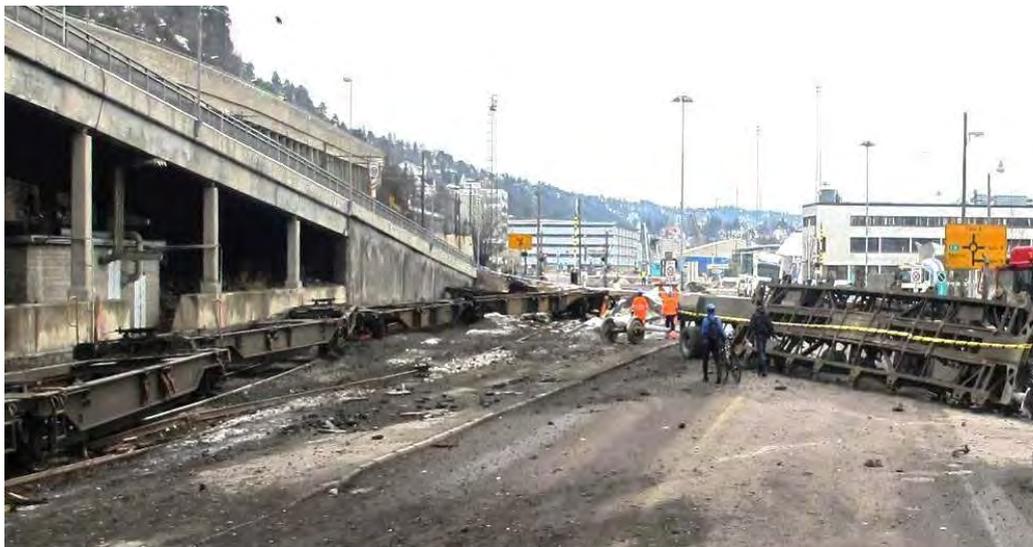
At Kongshavn at 13:13:15, one of the two-axled container wagons (freight car no. 8) in the freight car set derailed at a set of points. It pulled the freight cars behind it along so that these also derailed, overturned and came to a stop. This caused a great deal of damage to the track, to a building close to the track and to motor vehicles along the road.

Figure 2: Photo of Kongshavn where freight car 8 and the freight cars behind it derailed.

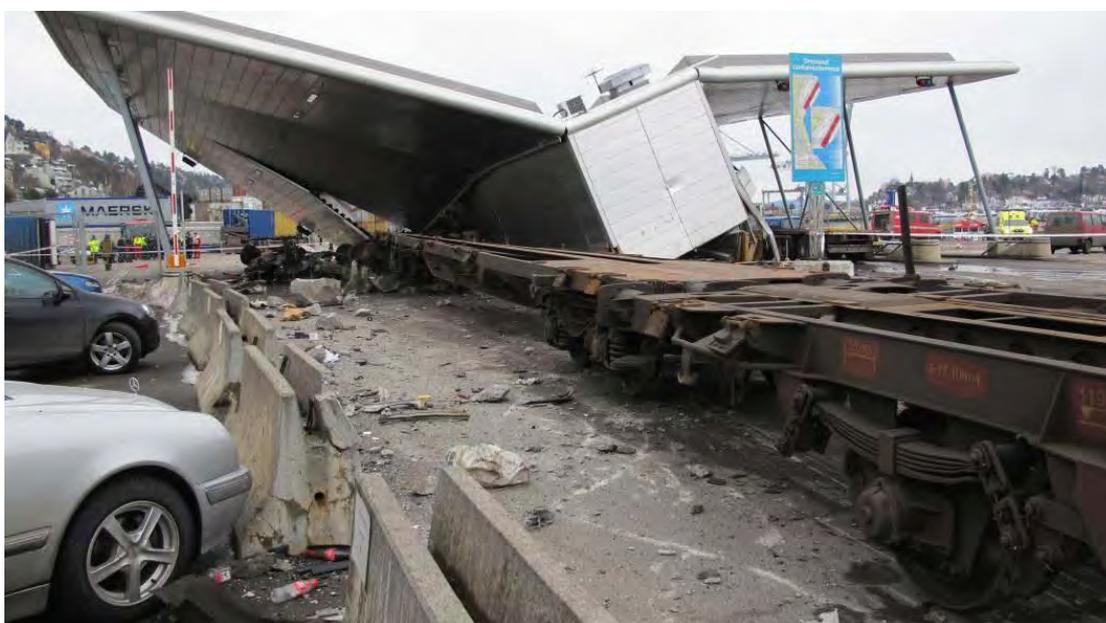
The freight cars continued through a buffer stop at the end of the track, across a parking area, through the access gate to the container terminal and into the gate building¹. This occurred at approximately 13:15:25. Freight cars 2 and 3 went over the edge of the quayside, across a tug boat and ended up in the harbour basin, while the rest of the freight cars stopped on the quayside. Two people inside the building died, and four others were injured. The freight cars damaged the gate building so badly that it collapsed, and they also caused extensive damage to motor vehicles and infrastructure.

Figure 3: Photo of container terminal at Bekkelagskaia.

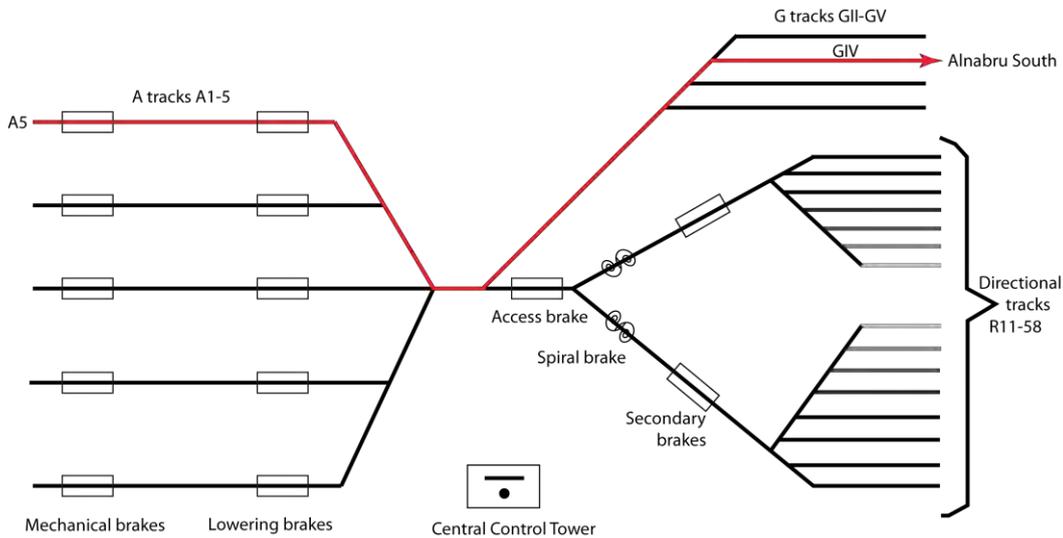
Figure 7: Plan showing the locations of the various brake systems at Alnabru S. The red line shows the freight cars' exit route from track A5.

When the brake systems were inspected after the accident, they were found to be in good working order.

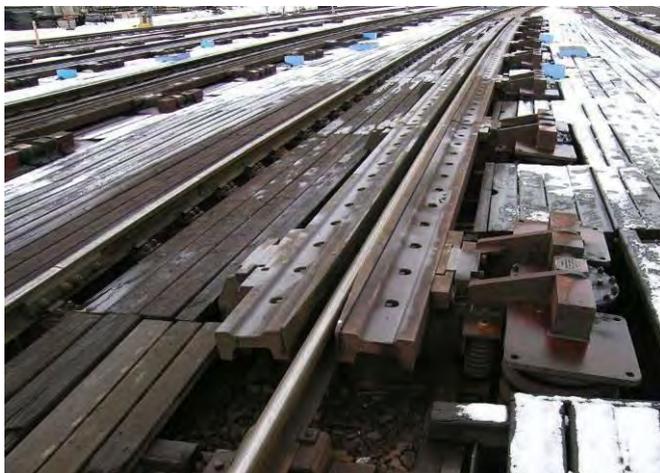
Figure 8: The mechanical brake is a beam brake that pinches against the freight car wheels.

The AIBN and representatives from the police inspected the mechanical brake and lowering brake on track A5 at Alnabru S on 24 March 2010. Following the inspection and documentation of their condition, a simple function test was performed by engaging and releasing the brakes. These inspections did not uncover anything to suggest technical failure in the brakes. Nor were there any marks indicating that the freight cars had 'climbed' out of the lowering brake.

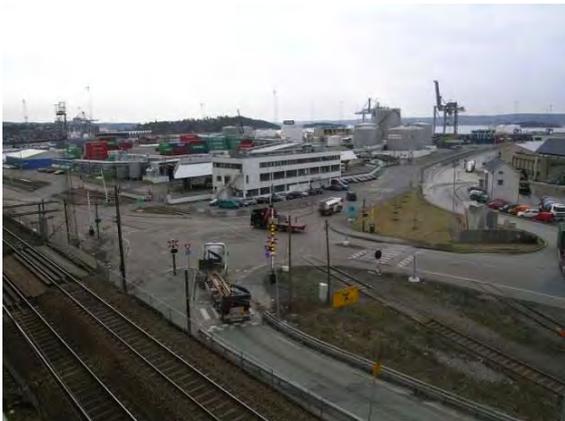
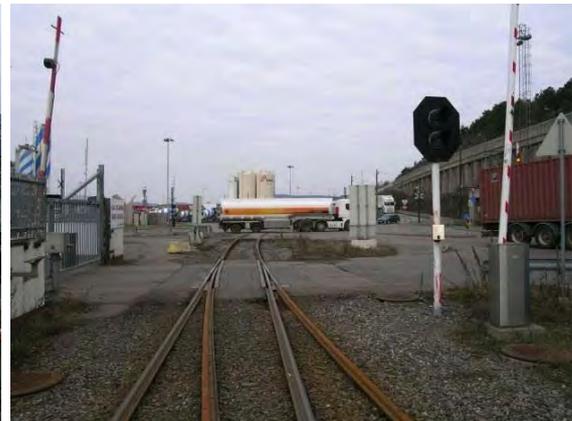
The photos show the roundabout at the Sjursøya junction which the freight car set went right through, on its way down towards Bekkelagskaia. There is a great deal of road traffic to and from the freight facilities in the area.

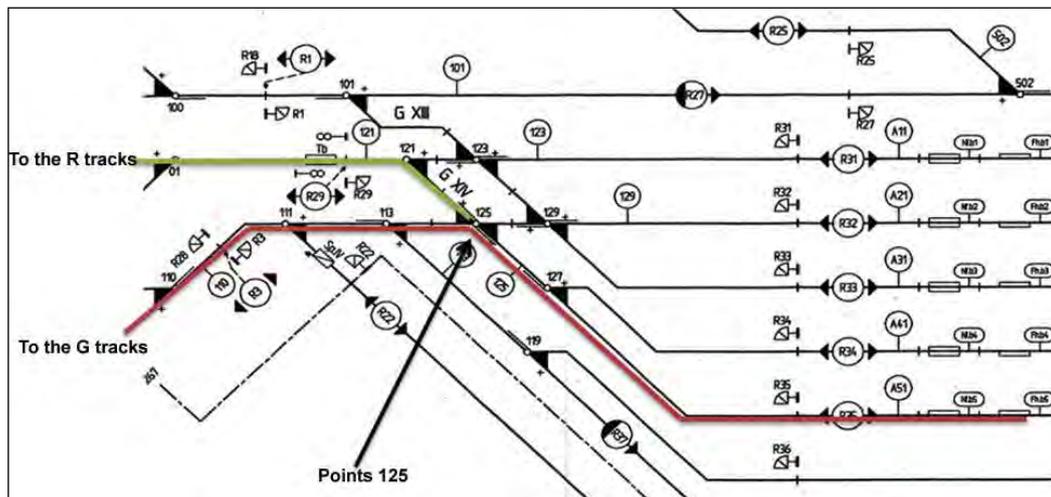
At the exit from track A5, points 125 can be set to one of two routes: a) freight cars can be directed towards the access brake, or b) freight cars can be directed around the access brakes towards tracks G2–G5. Points 125 are controlled via the interlocking system and are normally set towards the access brakes unless a train route is set through these points towards the G tracks. In the latter situation, any runaway freight cars would roll onto the directional tracks, collide with any freight cars standing in their way and finally be caught by the end buffers (T1 / T2) at the southern end of the shunting yard. The normal setting of the points to the south is that they are pulsed towards secure tracks T1/T2.

Figure 12: Section of schematic track plan. Possible train routes from track A5 through points 125. The red line shows the route that was taken by the freight cars.

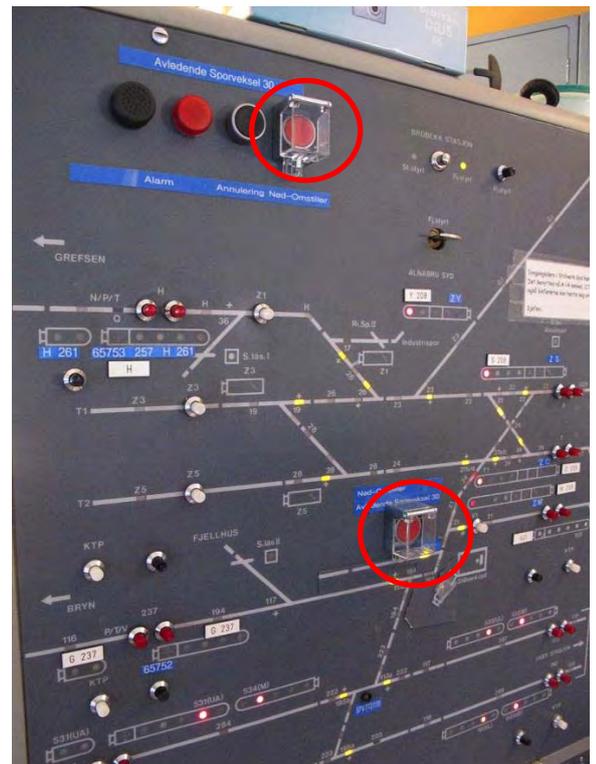
The emergency release push buttons (encircled in red) are secured with plastic covers to prevent pushing them accidentally.

Figure 27: Push buttons on the main control panel that must be operated in order to switch the points at Alnabru South.
