# REPORT

JB 2008/08

## REPORT ON SERIOUS INCIDENT HOVEDBANEN STRØMMEN 07.03.2008 TRAIN 41941

Date issued: 09.12.2008  
JB Report: 2008/08

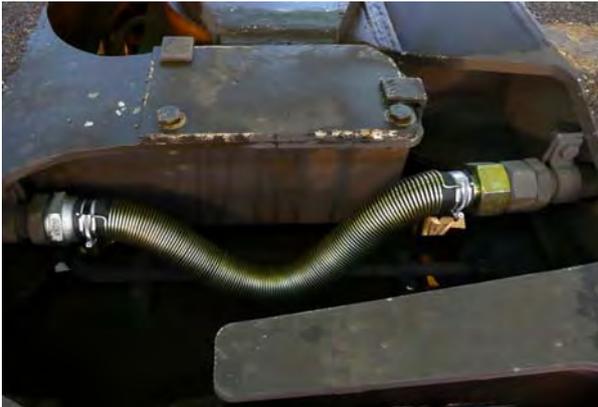
Figure 1: Brake hose above the middle bogie fitted without twisting.

The brake hose above the middle bogie on this wagon type consists of a standard brake hose encircled by a steel coil, cf. figs. 1 and 2. The connection part at one end has fixed nuts, while the other end has freely rotating nuts. On wagon 33684955117-9 it appeared that the brake hose had twisted during fitting. On moving the steel spring to the side, it was discovered that the brake hose had been damaged causing it to become partly compressed, cf. figures 3 and 4. The hose was dismantled and replaced with a new one. The wagon's brakes were then found to be functioning normally.

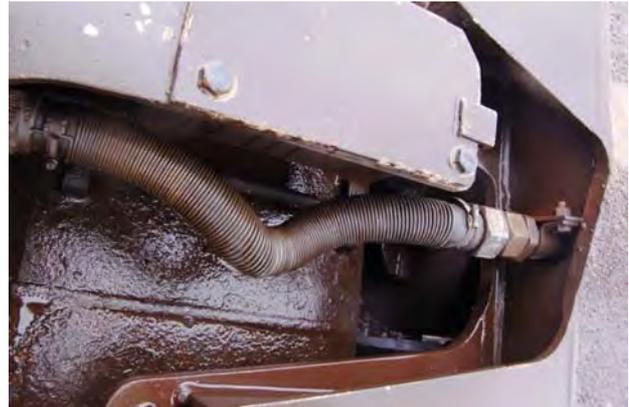
locomotive was attached and brake testing was initiated. The first tightness test gave a pressure drop of 0.8 bar over one minute, i.e. not approved. When the wagons were checked, a whistling noise could be heard from the brake hose above the middle bogie on wagon no. 33684955117-9. On closer inspection of the hose, it was discovered that it had twisted during fitting.

Figure 2: The brake hose on wagon 33684955117-9 was fitted with twisting.

CargoNet AS has brought up this incident with SweMaint AB as a matter for complaint. In its complaint investigation, SweMaint AB assumes that the twisting in the hose which occurred during refitting was caused by the freely rotating nut turning the hose with it at the end of the tightening torque, and this was not discovered by the fitter or during the final check out from the workshop.

It is AIBN's opinion that the physical cause of the problems during brake testing of train 41941 at Alnabru and the brake failure in the same train on the approach to Strømmen station was the twisted brake hose above the middle bogie on wagon no. 33684955117-9. AIBN considers it likely that the brake hose was twisted while being refitted after maintenance work at SweMaint AB in Gothenburg.

CargoNet AS has informed affected personnel of this incident by means of C Circular 08/2008, which gives instructions on how to identify this type of fault and what to do if such a fault is discovered. In addition, CargoNet AS has checked the brake hose above the middle bogie on all 6-axle wagons operated by CargoNet.

SweMaint AB has reported that all affected personnel have been informed and that the final control has been extended to include visual checking of the hoses with particular emphasis on deformation.

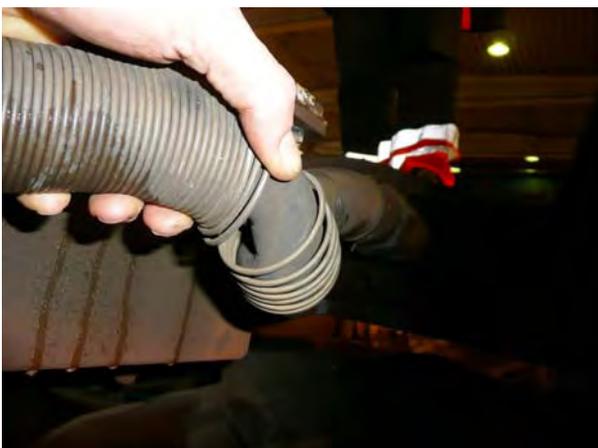
Figure 3: The twist in the brake hose resulted in a narrowing of the hose.

The "leakage problems" which were thought to exist during brake testing of train 41941 at Alnabru were probably in fact air which was being squeezed past the narrowed brake hose and trying to fill up the brake system on the wagons behind the narrowed area. The narrowing must have been so tight by now that it appeared to the locomotive driver as if the brake system was filled up and pressure stabilised.

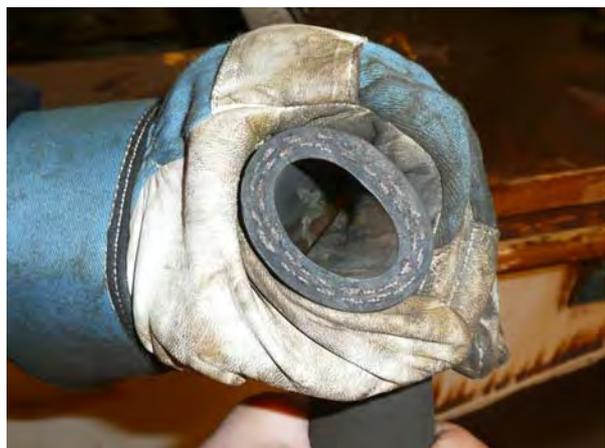
Figure 4: The cut brake hose could easily be squeezed together.
