**Report 00-102**  
**express freight Train 228**  
**passed signal at Stop**  
**Plimmerton**  
**23 February 2000**

**Abstract**

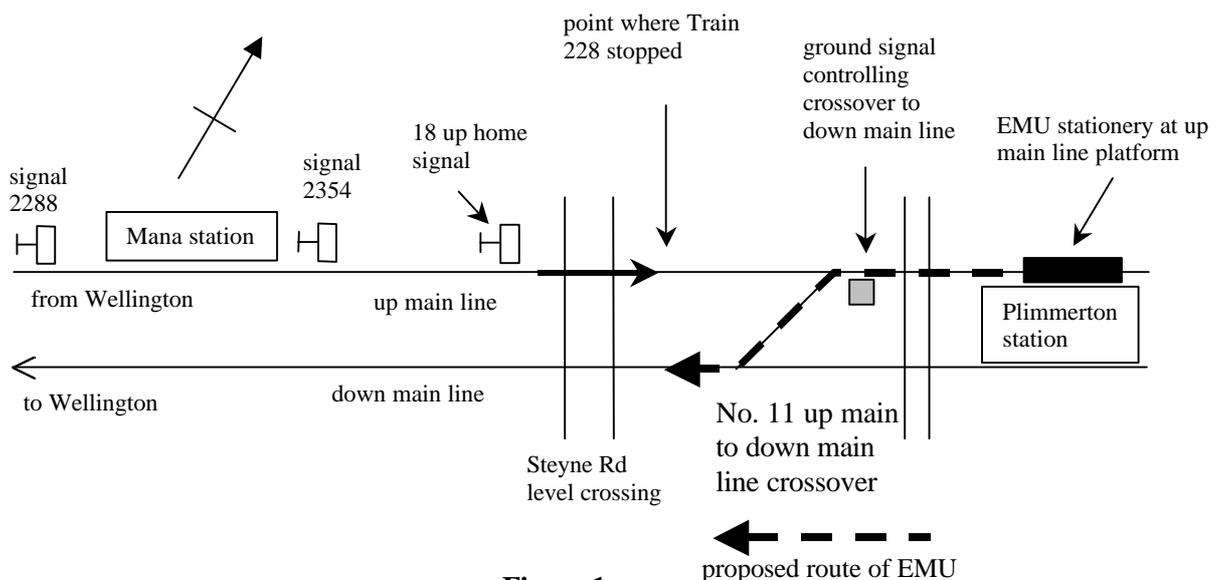
**Figure 1**  
**Signalling plan of Plimmerton**  
(not to scale)

- 1.1.6 Signal 2288 was an Intermediate Stop and Proceed<sup>1</sup> signal positioned 657 m before Signal 2354 (refer Figure 1). The LE recalled this signal had displayed a Clear Proceed indication when his train passed it.

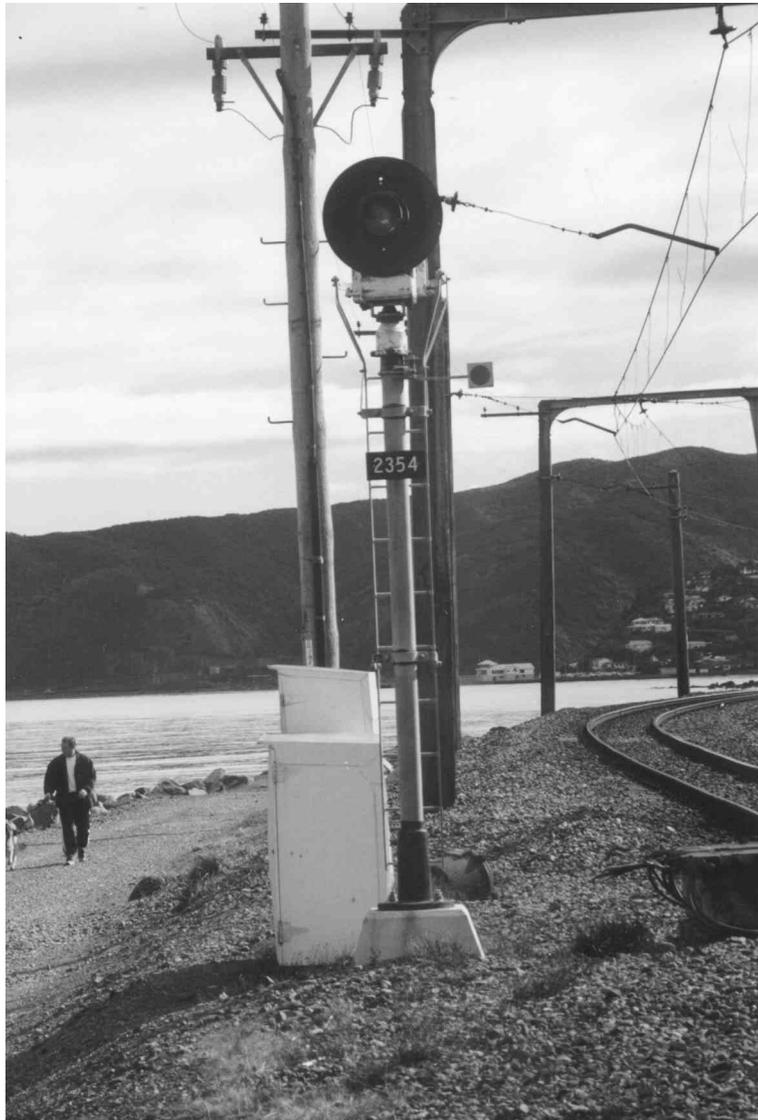
**Figure 2**  
**Signal 2354 Stop and Proceed intermediate signal**

Figure 2 shows Signal 2354, a single unit Stop and Proceed signal.

- 2.1.3 Visibility for Signal 2354, at about 200 m, was within Tranz Rail’s minimum signal sighting policy of 10 seconds of maximum approach speed for locality at the authorised line speed of 70 km/h. The restricted view of 18 up home signal at Plimmerton of 150 m because of the foliage and overhead power pole did not meet the minimum signal sighting requirement. At the maximum authorised line speed of 60 km/h less than 9 seconds line of sight was available.

- 2.2.1 Signal 2288 was clearly visible to the LE as it was positioned alongside a long, straight section of track.
- 2.2.2 Signal 2354 was probably displaying a Caution Proceed indication, but only the LE could have confirmed this and he did not recall seeing it.

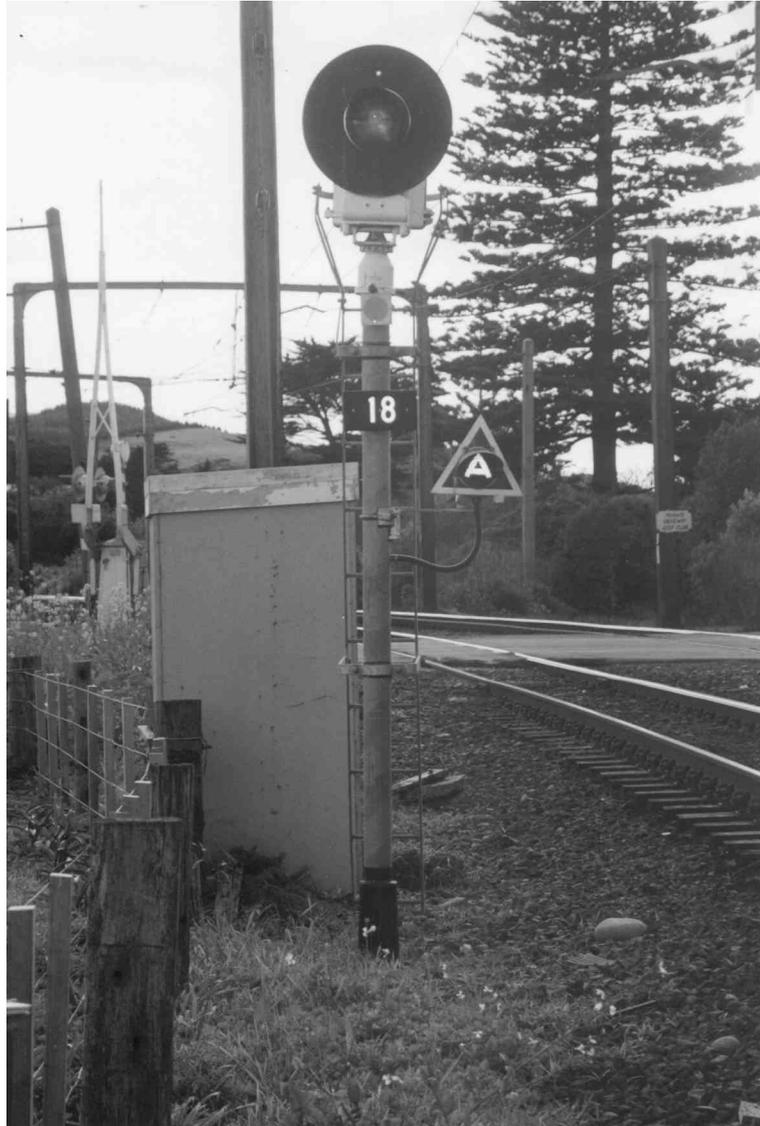
**Figure 3**  
**18 up home Stop and Stay signal Plimmerton**

- 2.1.7 The signal was hidden by a combination of overhanging foliage and a pole supporting the overhead power line, which together reduced the signal sighting distance for Signal 18 below Tranz Rail's specified minimum of 10 seconds. A safety recommendation covering this issue is made in Section 5 of this report.

- 2.2.3 Had the foliage in particular not been obstructing Signal 18 the LE could have sighted the signal about 50 m earlier which at 60 km/h would still have given insufficient stopping distance to avoid the overrun, but the train would probably have approached the level crossing at a slower speed.

- 3.4 The sighting distance of Signal 18 was reduced by foliage and a pole supporting the overhead power supply and did not meet Tranz Rail's minimum signal sighting requirements..

- 5.1.1 Ensure that trackside growth and the location of poles and other structures do not interfere with necessary minimum signal sighting distances. (093/00)
- 5.1.2 Ensure authorised line speed and signal sighting distances provide a safe stopping distance in the event of an Intermediate signal being misread at locations such as Plimmerton where level crossings and conflicting passenger movements create a potential hazard. (094/00)
- 5.1.3 Publish criteria for staff involved in occurrence investigation which ensures locomotive event recorder extraction follows serious operating incidences such as signal overruns. (095/00)

093/00: Tranz Rail has completed a signal sighting inspection confirming that there were issues with trackside growth. Additionally, there was a mobile caravan obstructing the rail lines. The caravan has been removed and the trackside growth has been attended to.
