Report 00-106
shunt Y35
track warrant overrun
Mataura
4 May 2000

Abstract

At approximately 1010 hours on Thursday, 4 May 2000, Y35 shunt overran its track warrant limit at Mataura by 15 km. There was no opposing traffic.

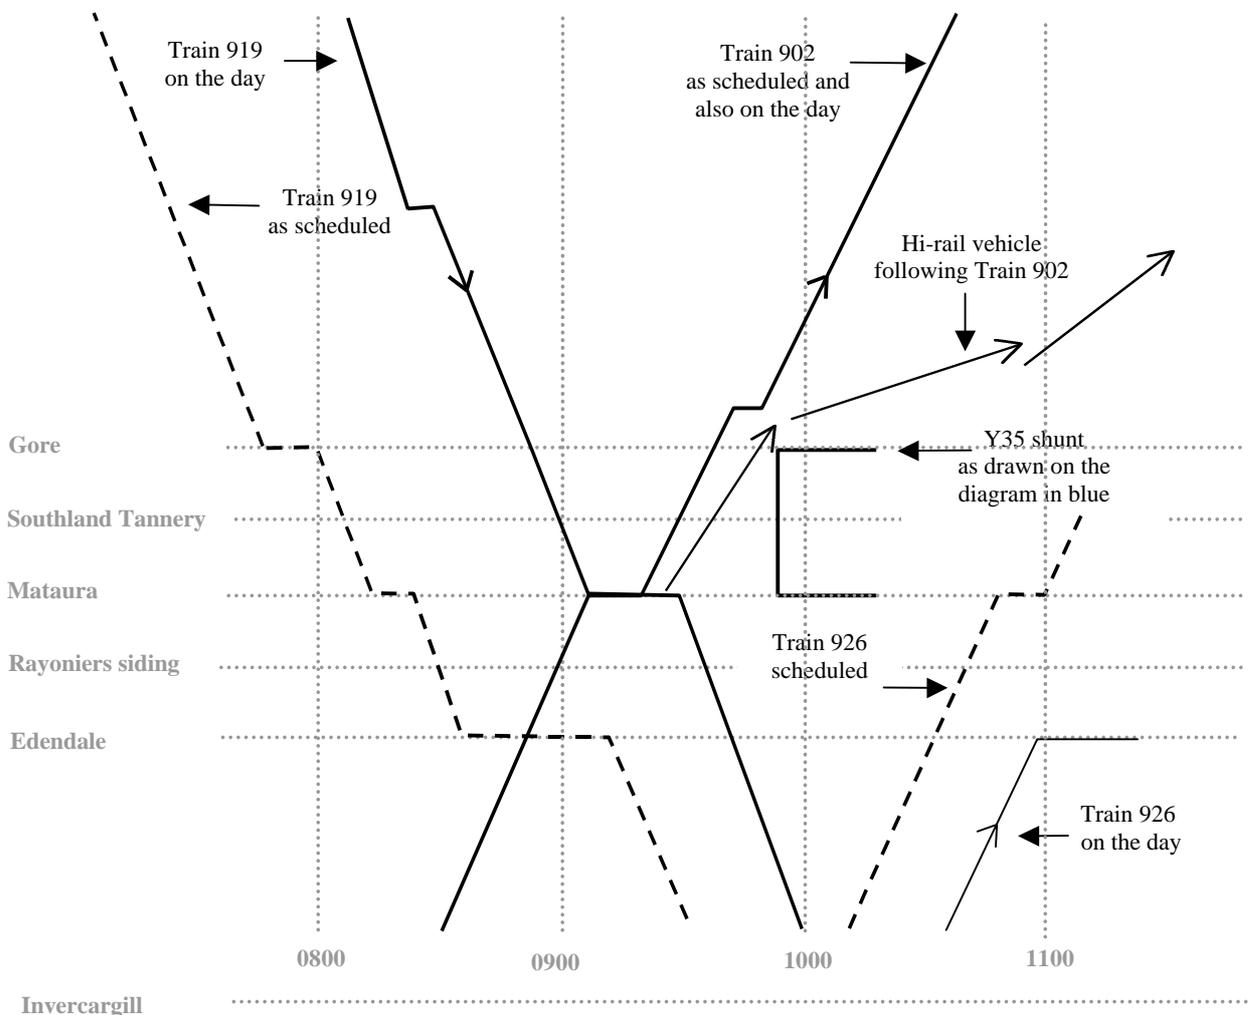
Figure 1
Simplified train control diagram

1.1.6 After checking that Train 902 and the track inspector were clear of Gore the TC prepared a TW for Y35 shunt to work between Mataura and Gore. This was drawn in blue on the train control diagram (Figure 1). At 0945 hours he contacted Y35 shunt and TW 59 was correctly issued and repeated back correct at 0946 hours. The warrant later recovered from Y35 accurately reflected TW 59 as issued.
