Report 00-111
express freight train 630
track warrant overrun

Tapuata

14 June 2000

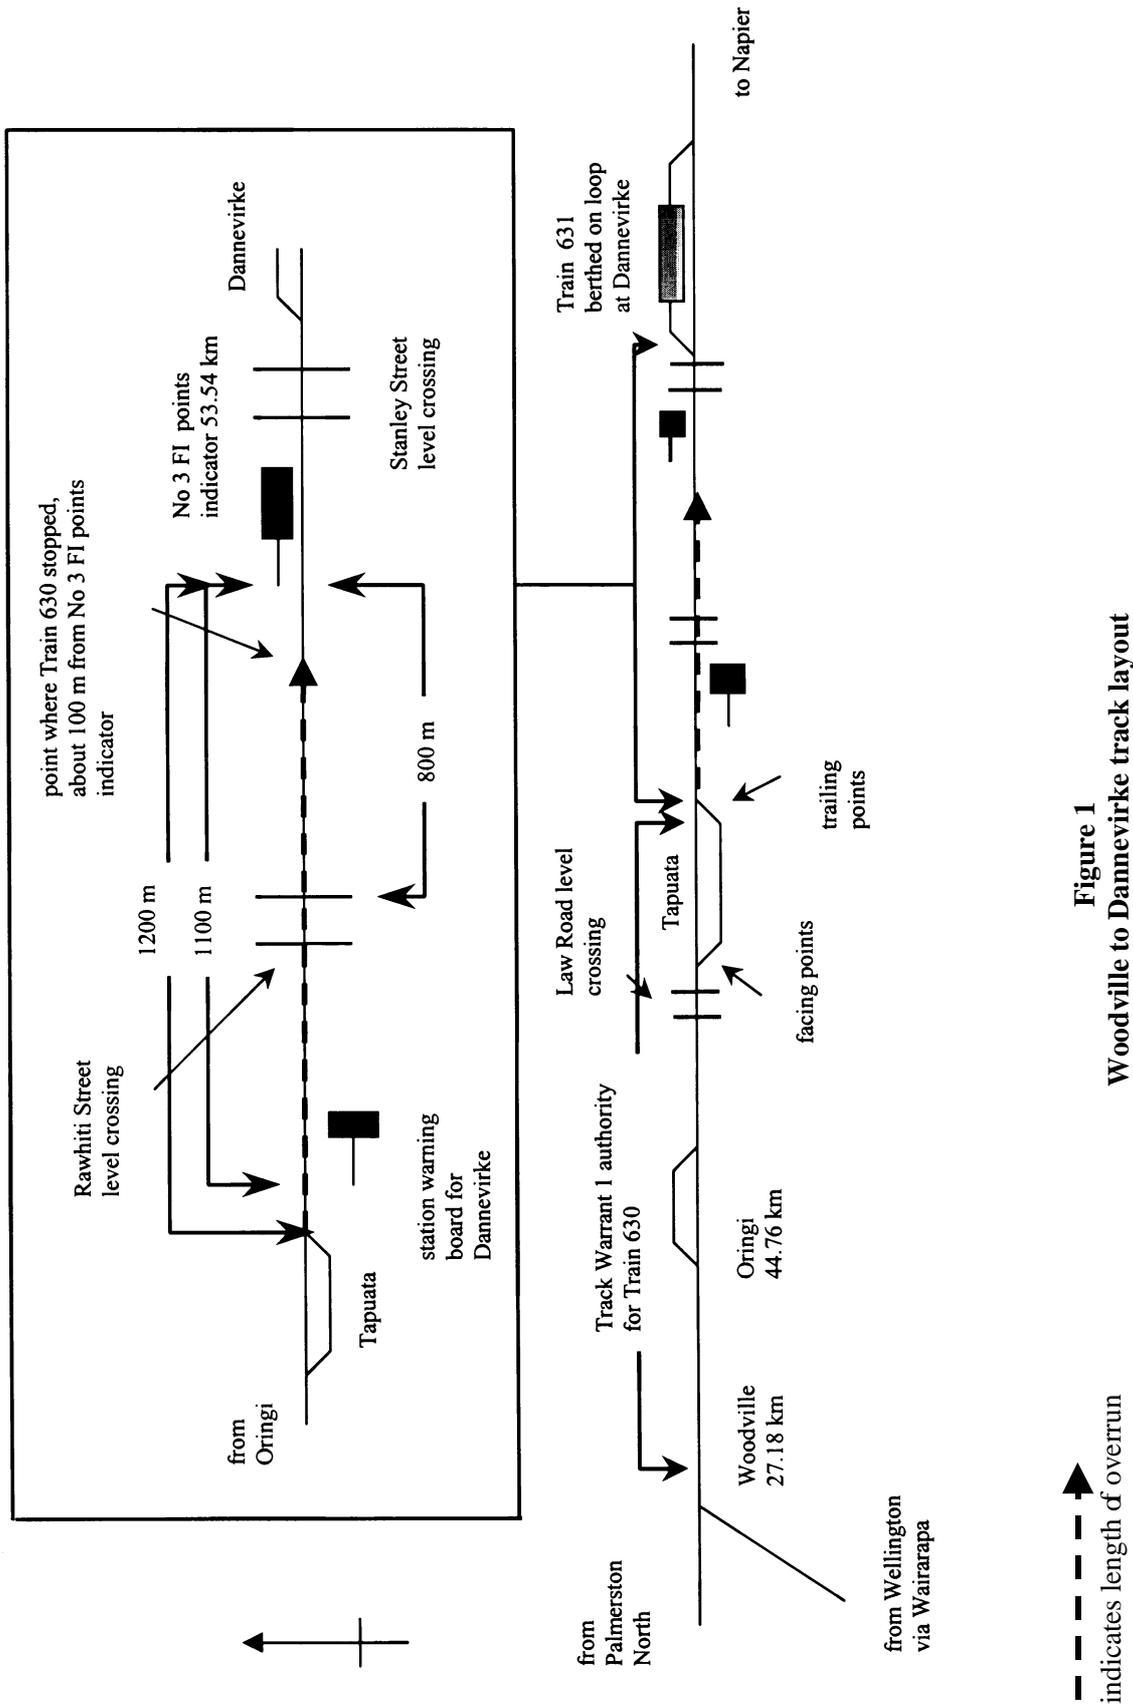
Figure 1
Woodville to Dannevirke track layout
 (not to scale)

- 1.2.3 The distance between the facing points and the trailing points at Tapuata was 428 m (refer Figure 1). The siding between these sets of points was no longer visible as it had been overgrown, but where both sets of points connected to the main line they were free of any growth or vegetation and clearly visible (refer Figure 2 and Figure 3).

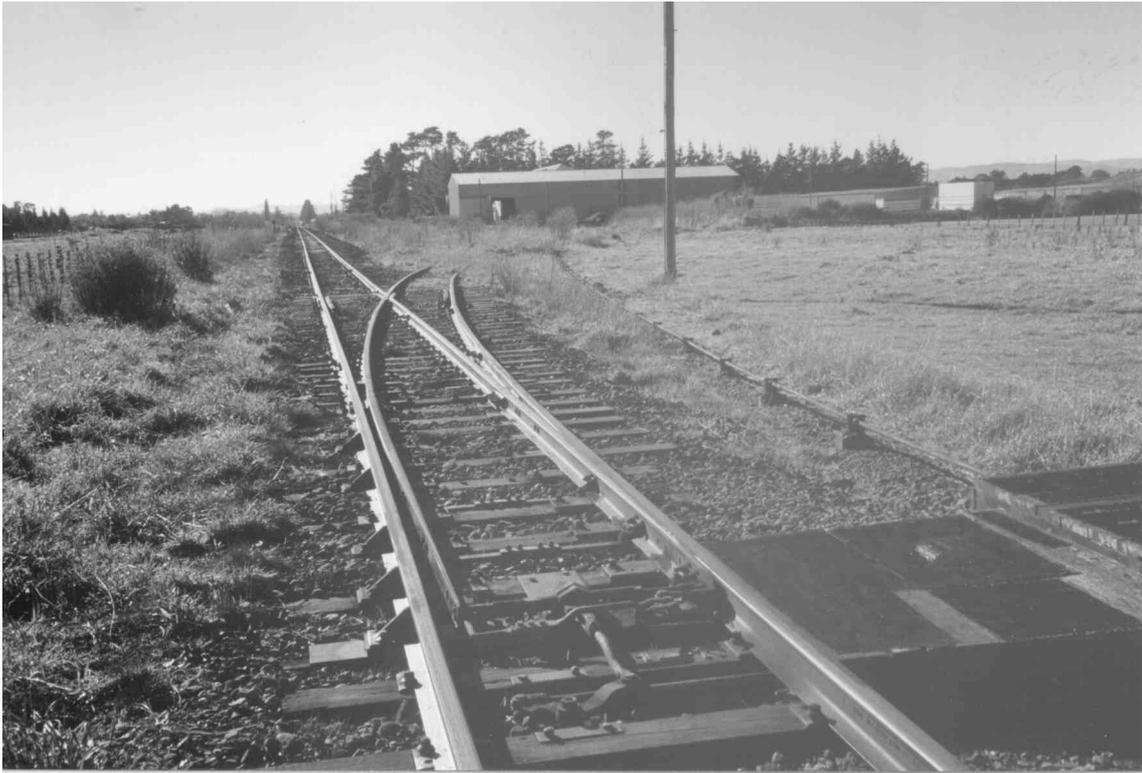
Figure 2
South end facing points approaching Tapuata

- the failure of the locomotive crew who were supposedly looking for identifying features to relate the set of facing points to Tapuata
 - the statements that the facing points were covered in undergrowth when in fact they were clear of any obstructions and highly visible

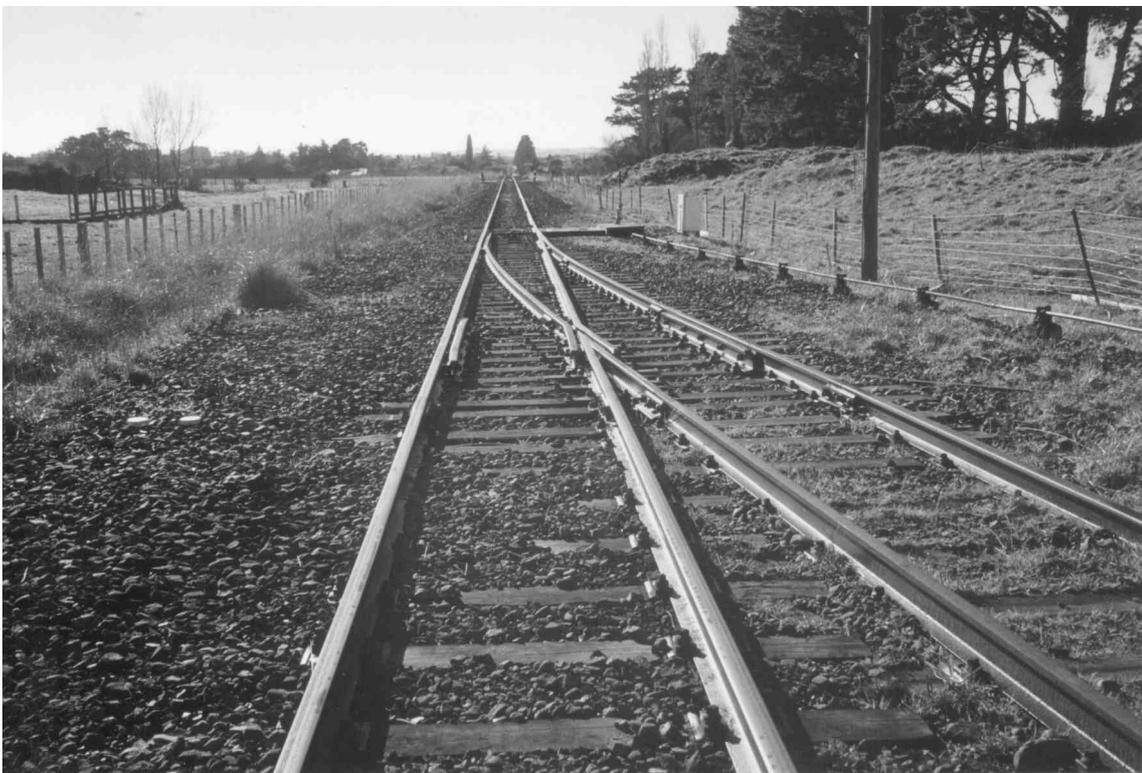
Figure 3
North end trailing points departing Tapuata

- the conflicting statements that the locomotive crew did not see any trailing points then did see them but nearly missed them because they were covered in undergrowth. These points were also clear of any obstructions and highly visible
