Report 00-114

shunting service P28

signal passed at danger

Woodville

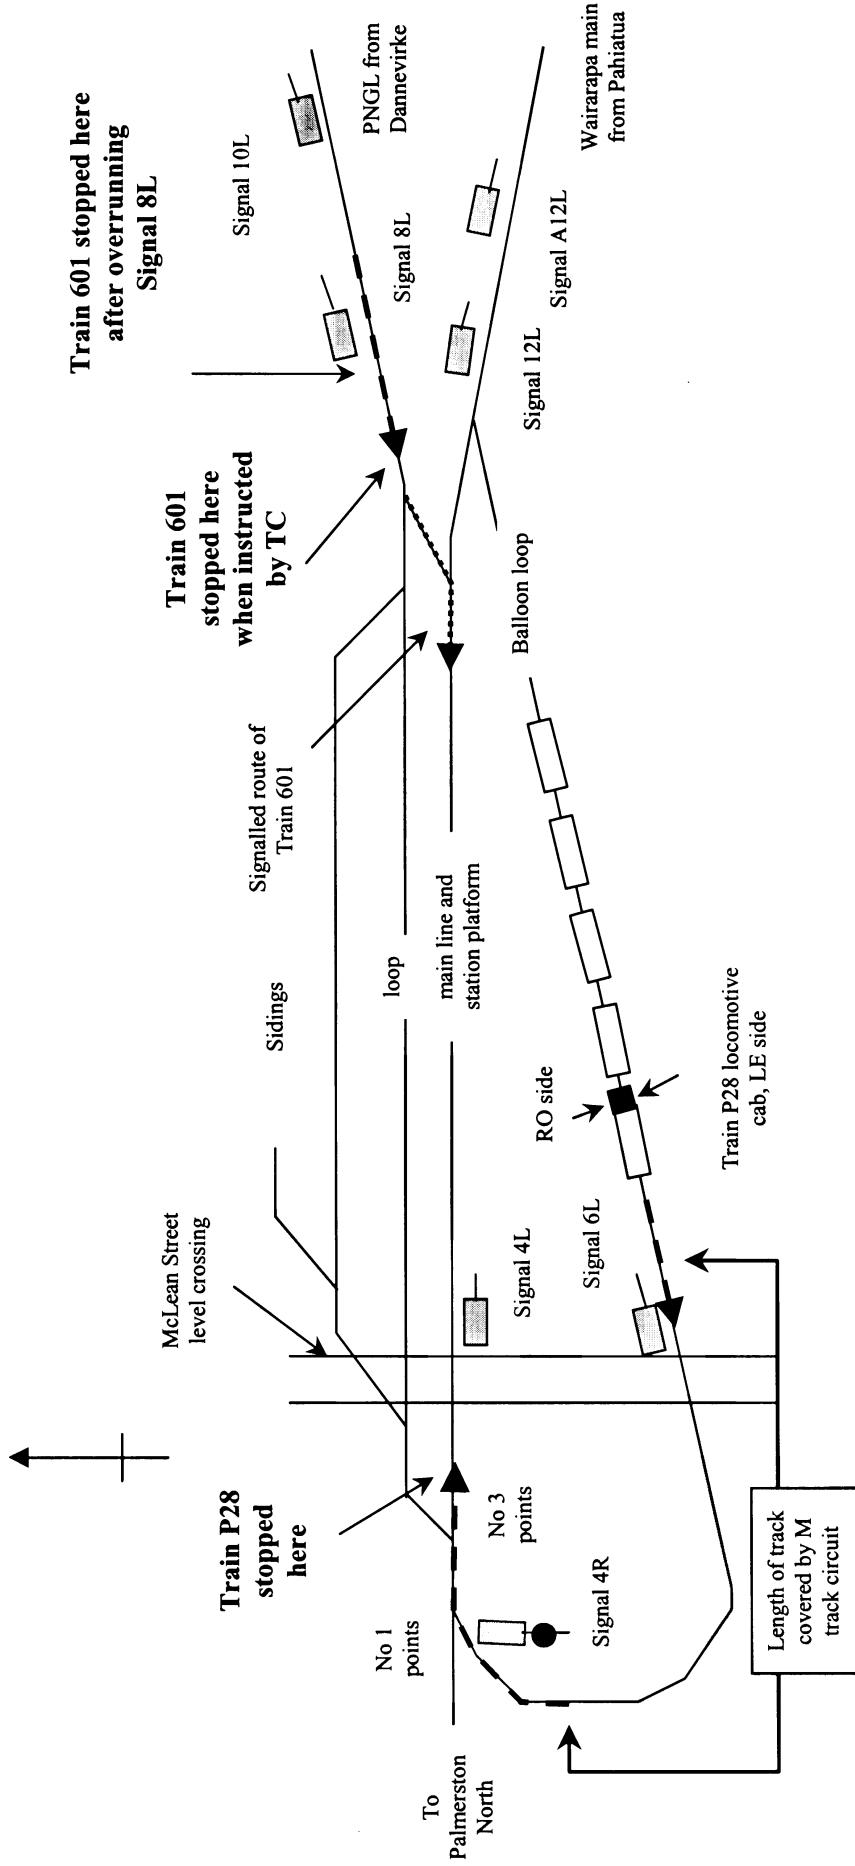
Figure 1
Woodville track layout
(not to scale)

- 1.1.4 The TC cleared Signals A12L, 12L and 6L, which allowed Train P28 to travel around the balloon loop as far as Signal 4R (refer Figure 1) where he planned to hold it for the passage of Train 601 before signalling Train P28 across the main line and into the yard. The TC did not advise the LE of Train P28 of his intentions or of the presence of Train 601 in the area, nor was there a requirement for him to do so.

- 1.1.5 At about 1635 both trains appeared on the TC's centralised traffic control visual display unit (VDU) as they approached Woodville. The TC saw Train P28 enter the balloon loop from the Wairarapa Line at the same time Train 601 passed Signal 10L on the PNGL and approached Signal 8L on its approach to Woodville (refer Figure 1).

- 1.3.2 Signal 4R controlled the movement of trains from the balloon loop to the main line, loop or sidings via Nos. 1 and 3 points. The balloon loop joined the main line via No. 1 trailing points⁵. When Train P28 approached No. 1 points were set for the passage of Train 601 through Woodville on the main line.

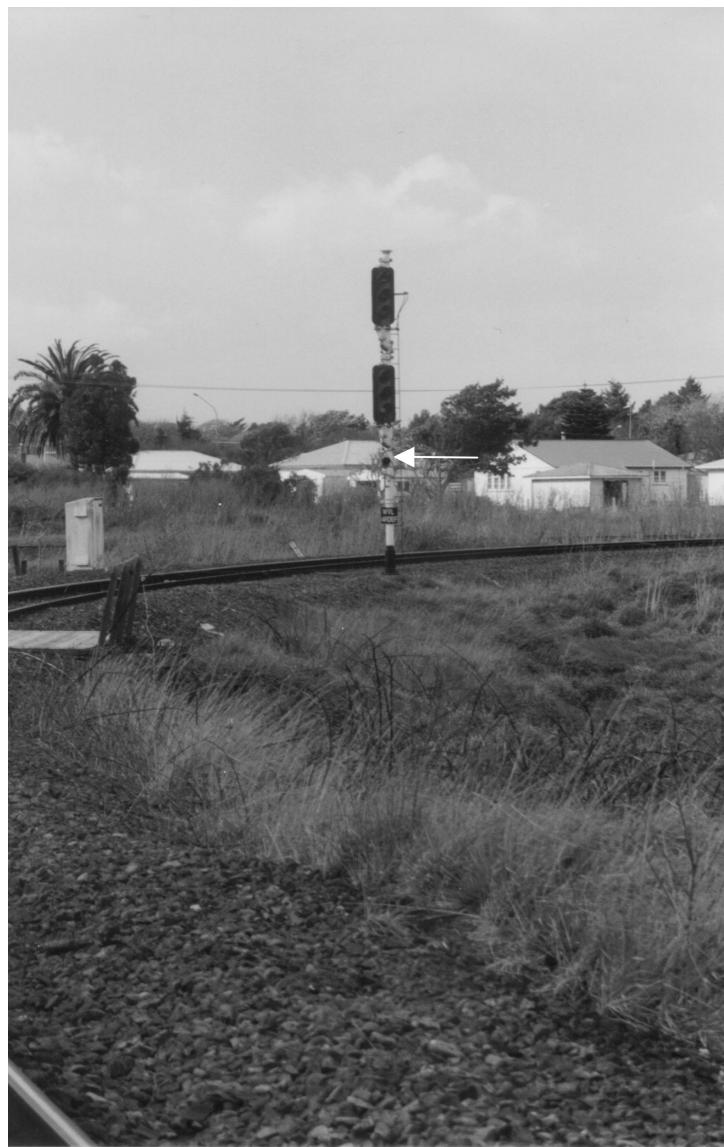
1.2.3 Beyond Signal 6L the track curved to the right as it approached Signal 4R. The LE could not see Signal 4R because of trees, the right hand curve of the track and the length of locomotive hood in front of him so he relied on the RO to sight and relay signal indications to him. Once past the trees the RO had an unobstructed view of Signal 4R, but not the low speed unit, which was angled more in line with the track, making it visible in direct line of sight for about 200 m (refer Figure 2).

Figure 2
Signal 4R from about 200 m away.
The low speed light unit is arrowed.

- 2.4 The low speed light unit on the mast of Signal 4R was initially difficult to detect against a backdrop of dried grass and buildings, however the angle at which it was directed meant its visibility improved as the train approached Signal 4R from around the curve. The RO was sitting on the right-hand side of the locomotive as they approached Signal 4R and would have been able to see the double signal aspects, in this case showing 2 red lights, from about 450 m away. He would also have been able to see the low speed light unit from about 200 m away. If the low speed light had been illuminated it would have been easily visible at this point.
