Report 00-121

express freight Train 828 and express freight Train 951

collision

Middleton

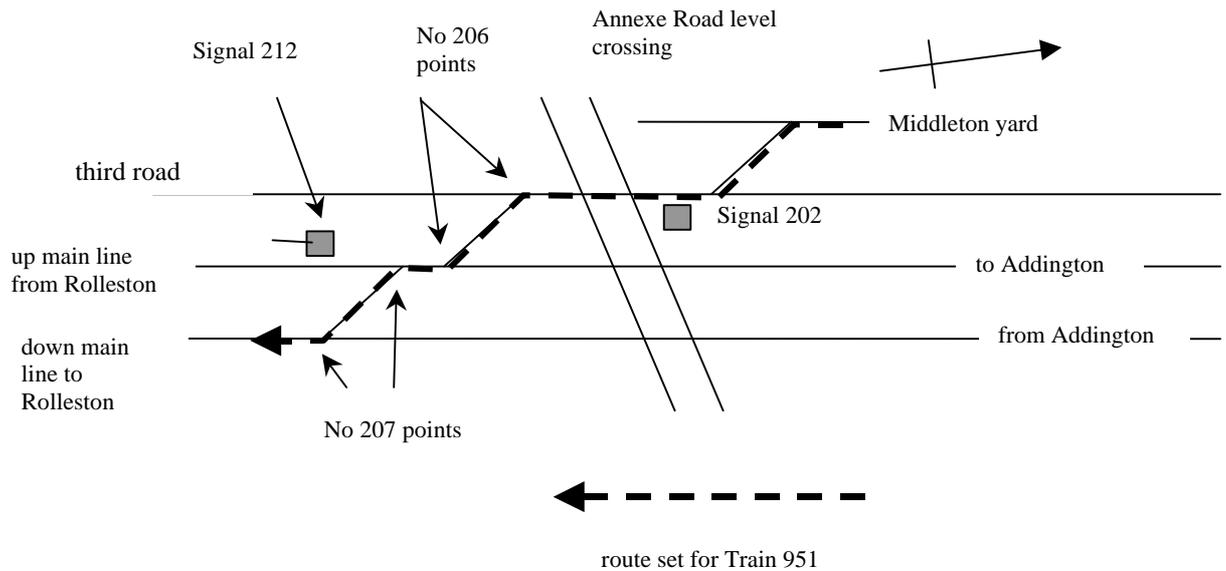
Figure 1
Route for Train 951 departing Middleton
(not to scale)

1.1.9 About this time LE2 called the signalman and advised him that his train was ready to depart. The signalman set the route for Train 951 to depart from the south end of Middleton yard, enter the up main line and cross over to the down main line (refer Figure 1). He called the train controller for permission to dispatch the train and once this had been received he cleared Signal 202 (refer 1.2.3) for Train 951 to depart. Section 7 of the Working Timetable Instruction 7.8 Middleton Shunting Yard, clause 7.8.1 Trains Arriving and Departing - General Instructions, stated in part that:

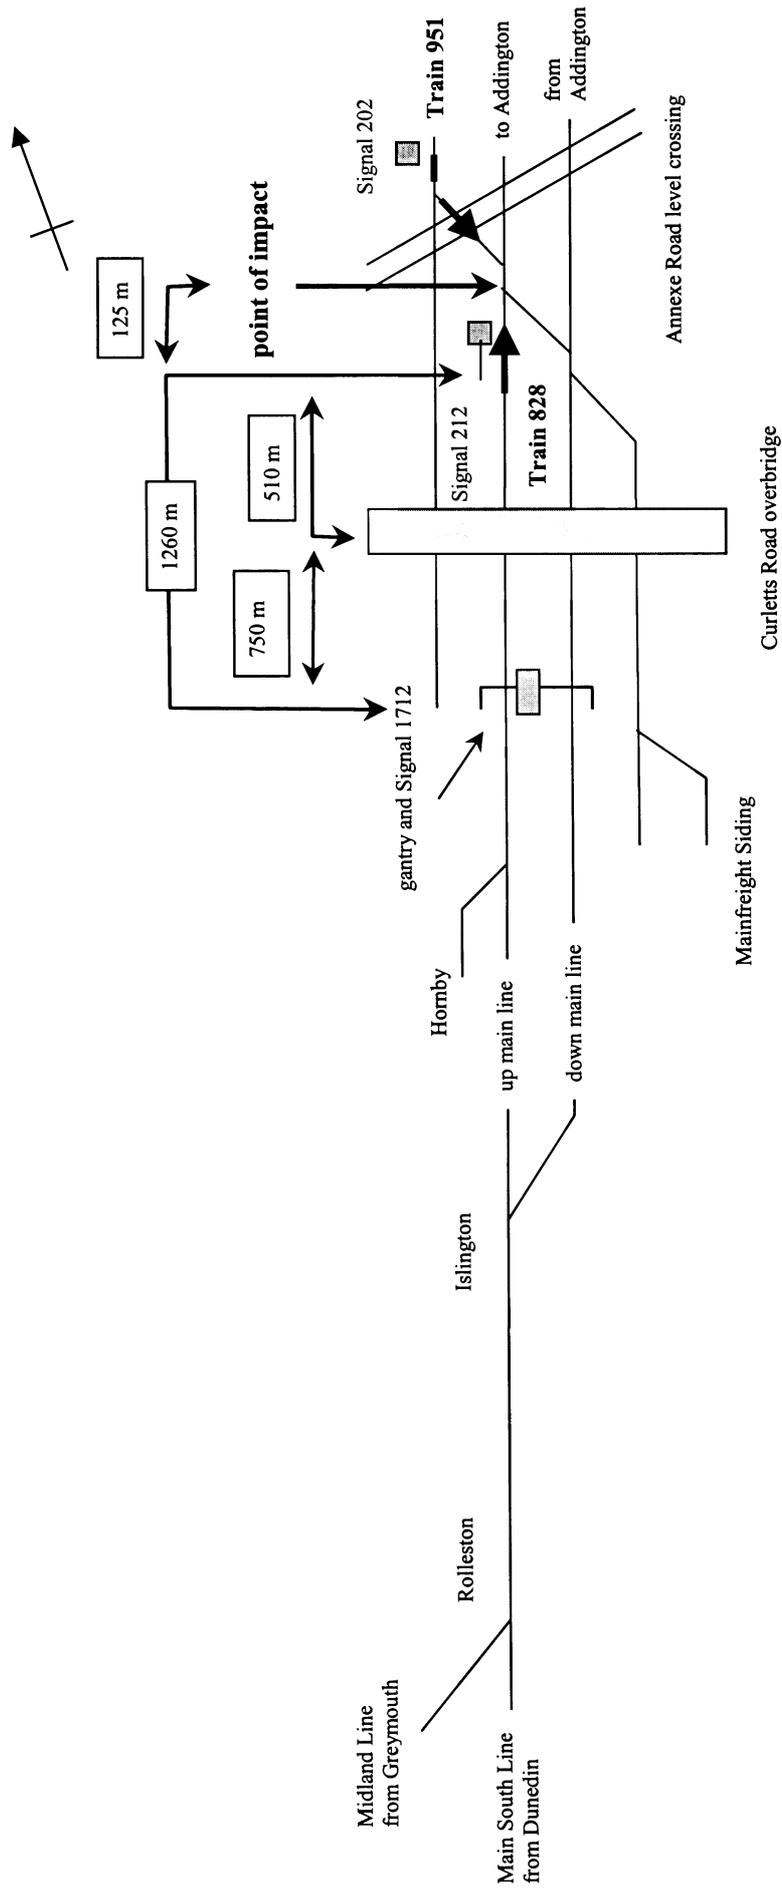
Figure 2
Track plan from Signal 1712 to Middleton
 (not to scale)

- 1.1.14 The point of impact was between 207 points and 206 points, about 125 m past Signal 212 (refer Figure 2).
- 1.1.15 Train 951 was travelling at 22 km/h at impact and Train 828 was travelling at 36 km/h.

- 1.2.7 Signal 1712 was a gantry-mounted stop-and-stay intermediate signal positioned about 1260 m in advance of Signal 212, which acted as a warning to the LE of a train approaching Middleton on the up main line of the indication being displayed by Signal 212. When Signal 212 displayed a “Stop” (red) indication Signal 1712 displayed a “caution proceed” (yellow) indication. If Signal 212 was displaying a low speed indication, as for a train to enter the Middleton yard, Signal 1712 still displayed a “caution normal speed” indication. The only time Signal 212 displayed a “clear proceed” indication was when the route was set for a train to bypass Middleton on the up main line with Signal 212 at “clear proceed” (green).

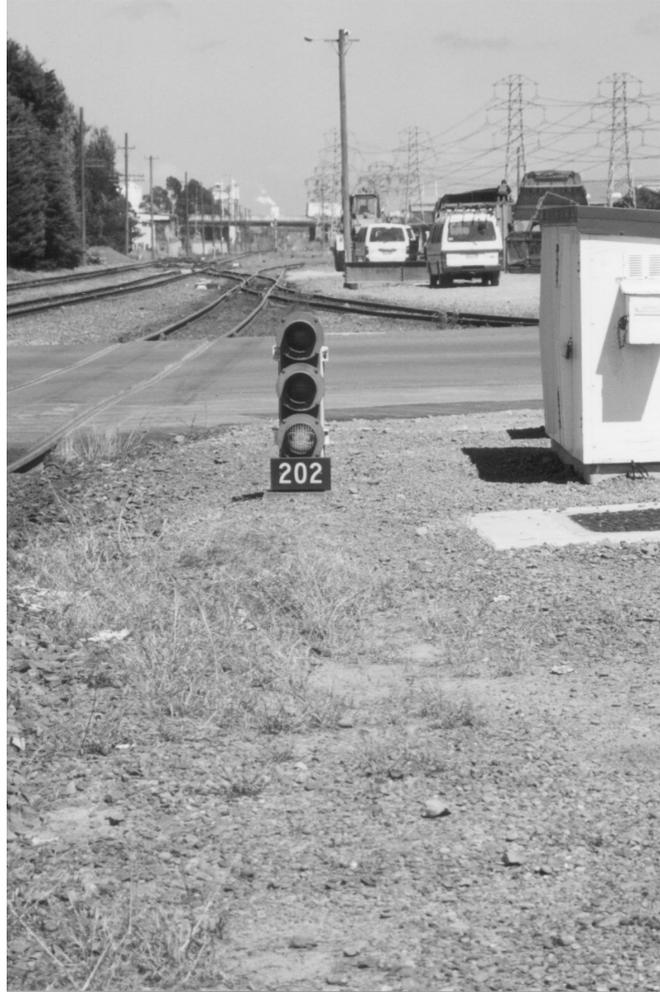
Figure 3
Signal 202 with Points 206 and 207 and Curletts Road
overbridge in the background

- 1.1.10 LE2 said that he could not initially see Signal 202 from where his locomotive was standing because the signal was obscured by a floodlight tower so he moved his train cautiously forward until he could see the signal. From there he saw the “clear proceed” (green) indication on Signal 202 which told him that the route was correctly set for the departure of his train and that he was authorised to proceed. At that time he was unaware that Train 828 was approaching Signal 212 up home signal at Middleton.

- 1.2.3 Signal 202 was a ground signal (refer Figure 3) which authorised the departure of trains from the south end of Middleton and was controlled by the signalman at Addington signalbox. A “clear proceed” (green) indication could only be obtained on Signal 202 after points 206 and 207 had been reversed and the route was correctly set for a departing train to cross to the down main line.

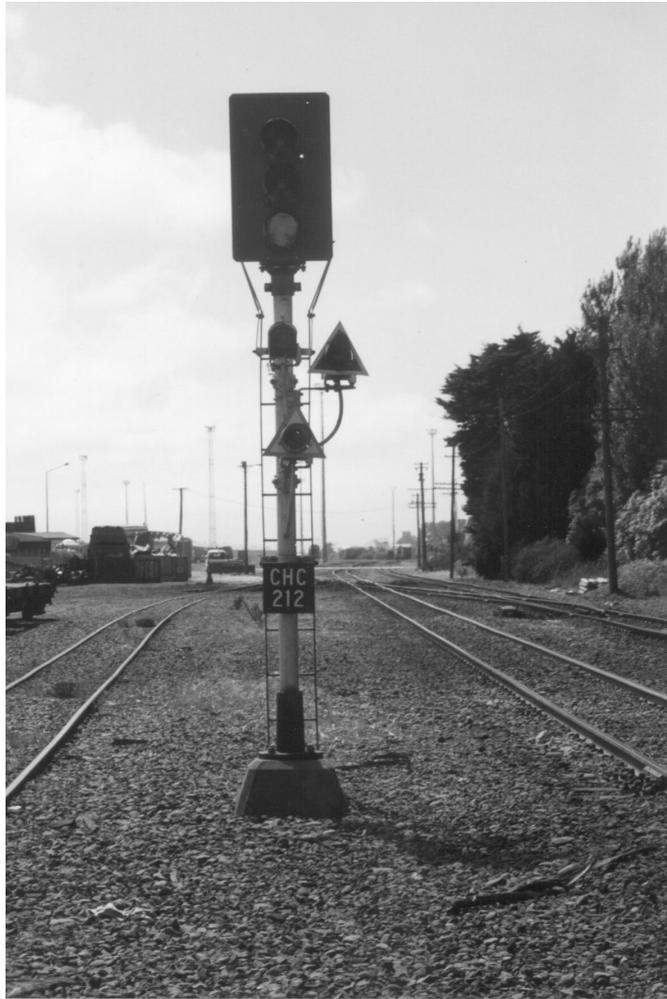
Figure 4
Signal 212 (Up main home signal)

- 1.1.3 Train 828 joined the Main South Line at Rolleston¹, about 17 km south of Middleton, and LE1 recalled that he crossed Train 823 at Rolleston. LE1 said that he slowed for a speed restriction at Hornby, about 3.5 km from Middleton, then remembered passing Mainfreight Siding about 1200 m from Middleton where he saw a “caution normal speed ” (yellow) indication on Signal 1712, a stop-and-stay intermediate signal which was mounted on an overhead gantry spanning the tracks. This advised LE 1 that the section ahead was clear but that the next signal in advance (Signal 212) was at “Stop” or displaying a low-speed indication.

- 1.2.4 Signal 212 was a stop-and-stay up home signal at Middleton (refer Figure 4). It was controlled by the signalman at Addington signalbox. Once the signalman had obtained permission to berth a train he then set the necessary route and illuminated the low speed light on Signal 212 to authorise the train to enter the Middleton yard.

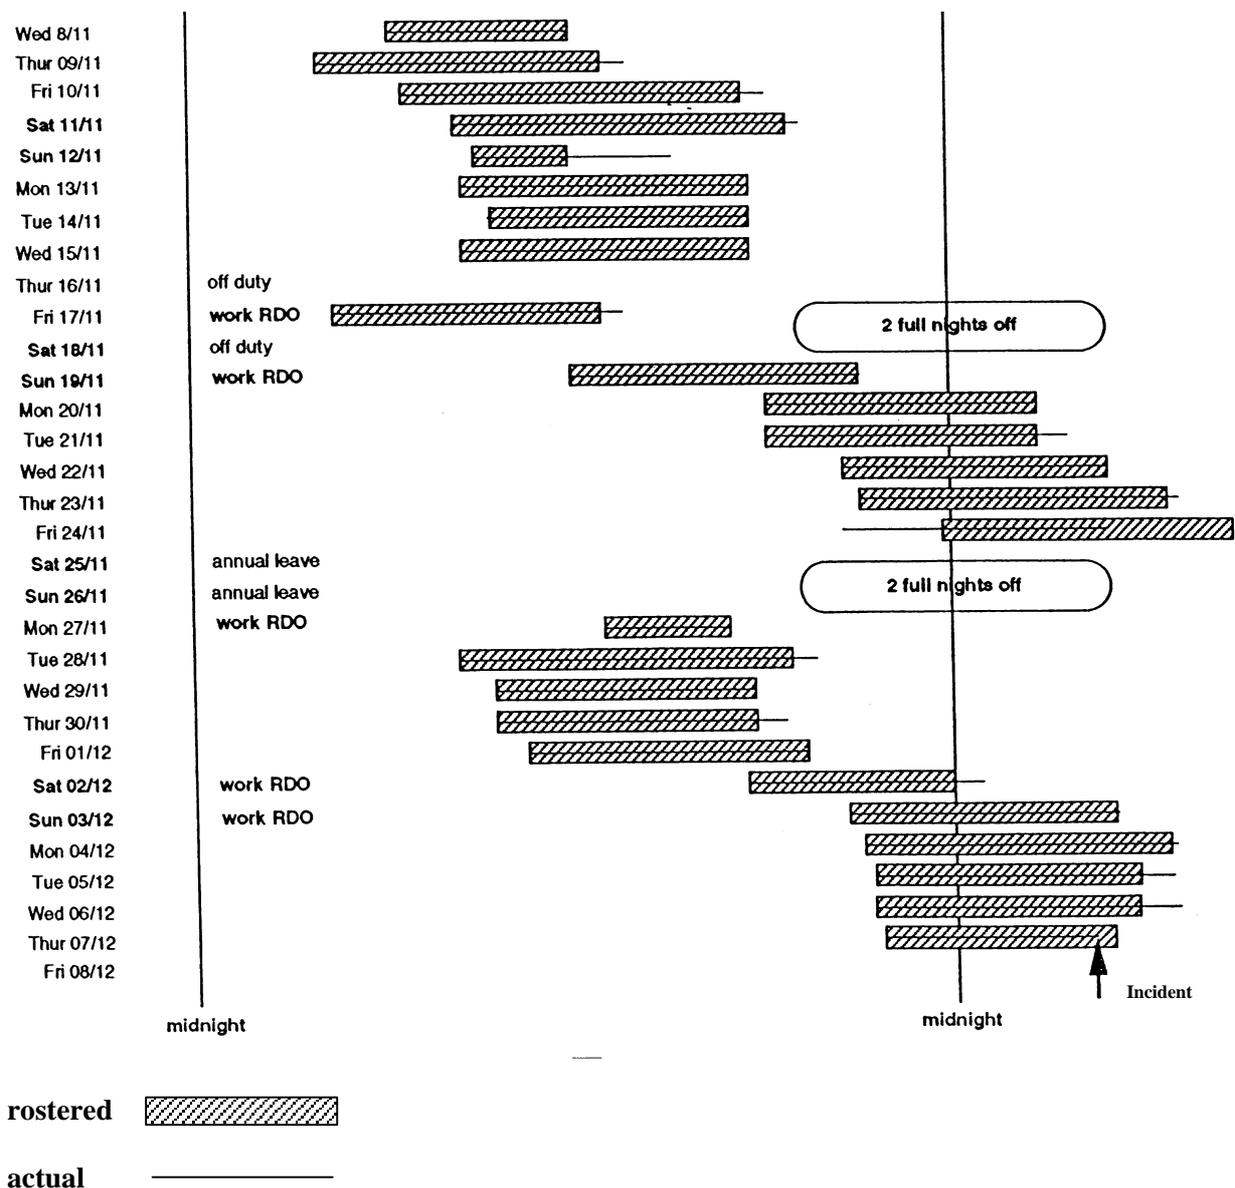
Figure 5
Work patterns for LE1 over the 4 weeks prior to the collision

- 2.6.11 The shift on which the collision occurred was the 11th consecutive shift worked by LE1 and the 6th consecutive night shift. On the preceding weekend he had worked both of his rostered days off and both of these extra shifts involved night work. Based on his preceding work pattern (and in the absence of a detailed sleep history), it seems highly likely that LE1 was experiencing the effects of a cumulative sleep debt at the time of the collision.

- 2.7.7 In the 4 weeks preceding the collision (starting Thursday 9 November), LE1 had worked on 5 of his 7 rostered days off. This resulted in his being on his 11th consecutive shift on the night of the collision. Similarly, because he had worked his rostered day off on 23 October, he had worked 13 consecutive shifts between Wednesday 18 October and Monday 30 October.

- 2.7.10 In the month preceding the collision LE1 had twice been rostered on a block of 5 consecutive night shifts and on both occasions he had agreed to work on a rostered day off immediately prior to starting the block of night shifts.

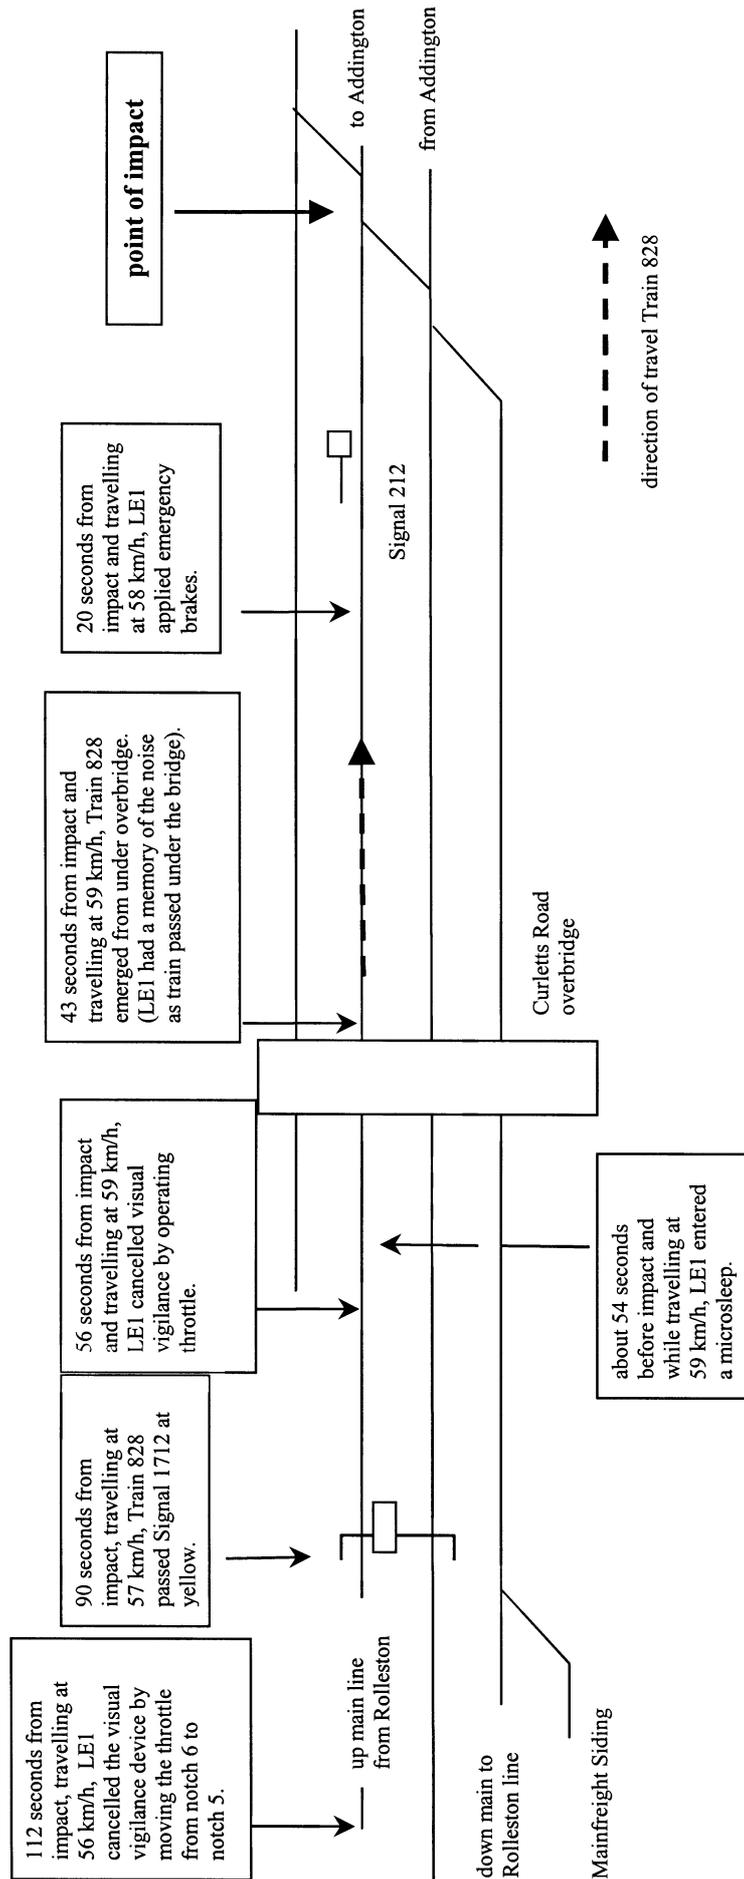
Figure 6
Time sequence of events
(not to scale)

2.2.2 The time sequence of events as derived from the locomotive event recorder for Train 828 is shown in Figure 6.

- 2.2.3 The speed of Train 828 was 56 km/h and the throttle was in notch 5 when LE1 cancelled a vigilance alert about 112 seconds before impact.
- 2.2.4 About 90 seconds before impact the train passed Signal 1712, 1260 m before Signal 212, at 57 km/h. The throttle was in notch 5.
