Report 00-123

Diesel multiple units

Trains 3130 and 3134

collision

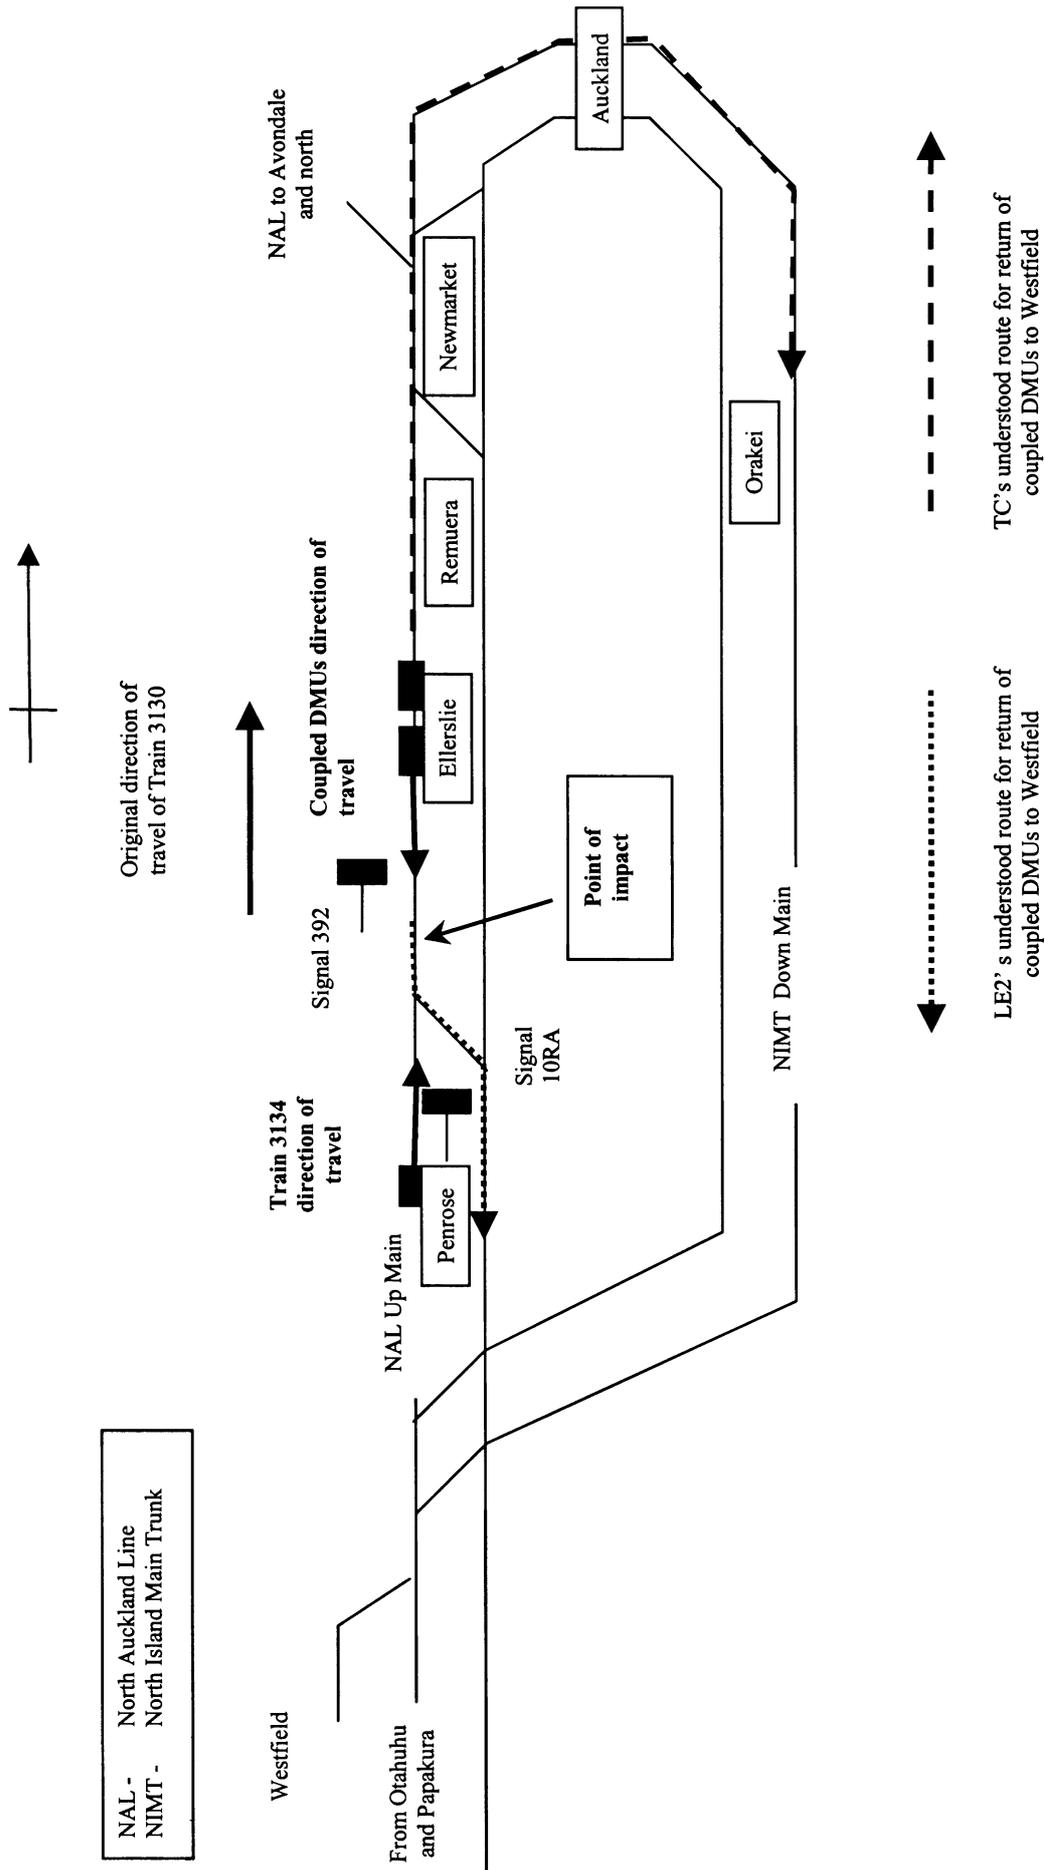
Figure 1
Track layout Westfield to Ellerslie
(not to scale)

- 1.1.2 At about 1048, as Train 3130 was about to depart from Ellerslie (refer Figure 1), LE1 noticed that the DMU air pressure gauge showed zero and that the park brake had automatically applied. He checked the compressor circuit breaker but could not find any fault so he detrained and went to physically check the compressor located on the side of the DMU chassis. He found a pipe had fractured and that the air from the compressor was escaping.

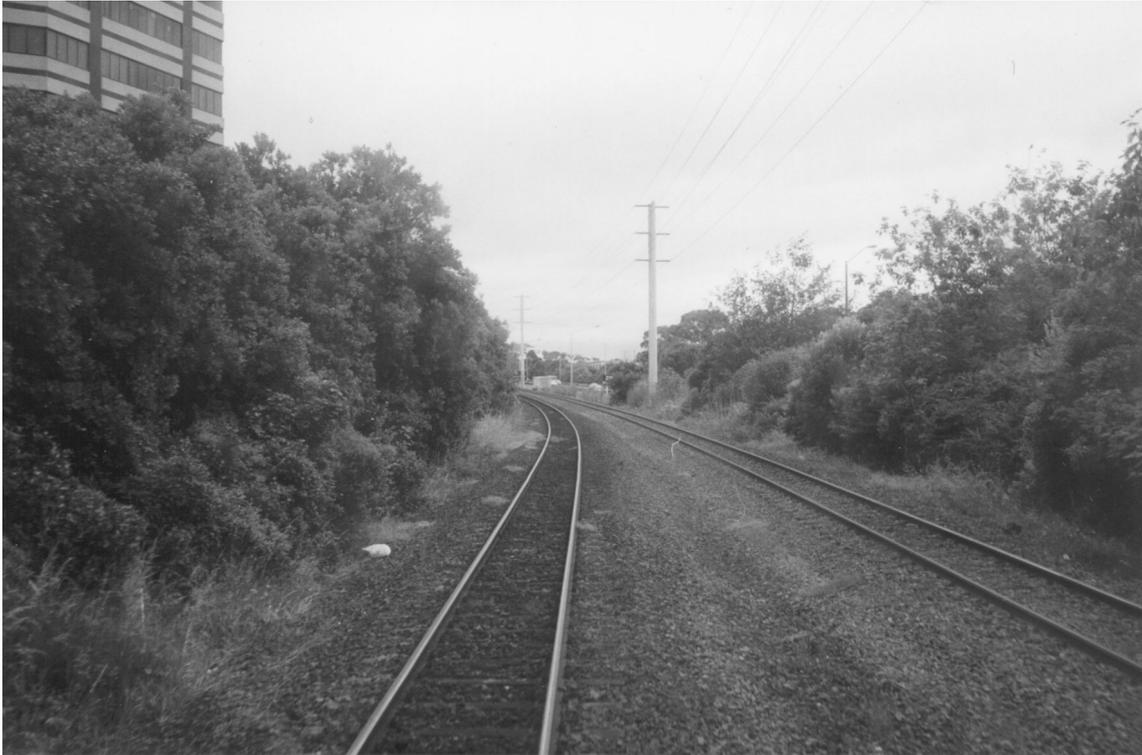
Figure 2
Approaching the final curve before Ellerslie on the up main line in the direction of travel of Train 3134

- 1.2.3 Between Penrose and Ellerslie the up main line negotiated several curves which limited visibility and did not straighten until the point at which LE3 saw the approaching DMU some 190 m away. The section of track where the collision occurred was on a 1 in 47 up grade.
