Report 01-104

express freight Train 547 and express freight Train 531

collision

Mokoia

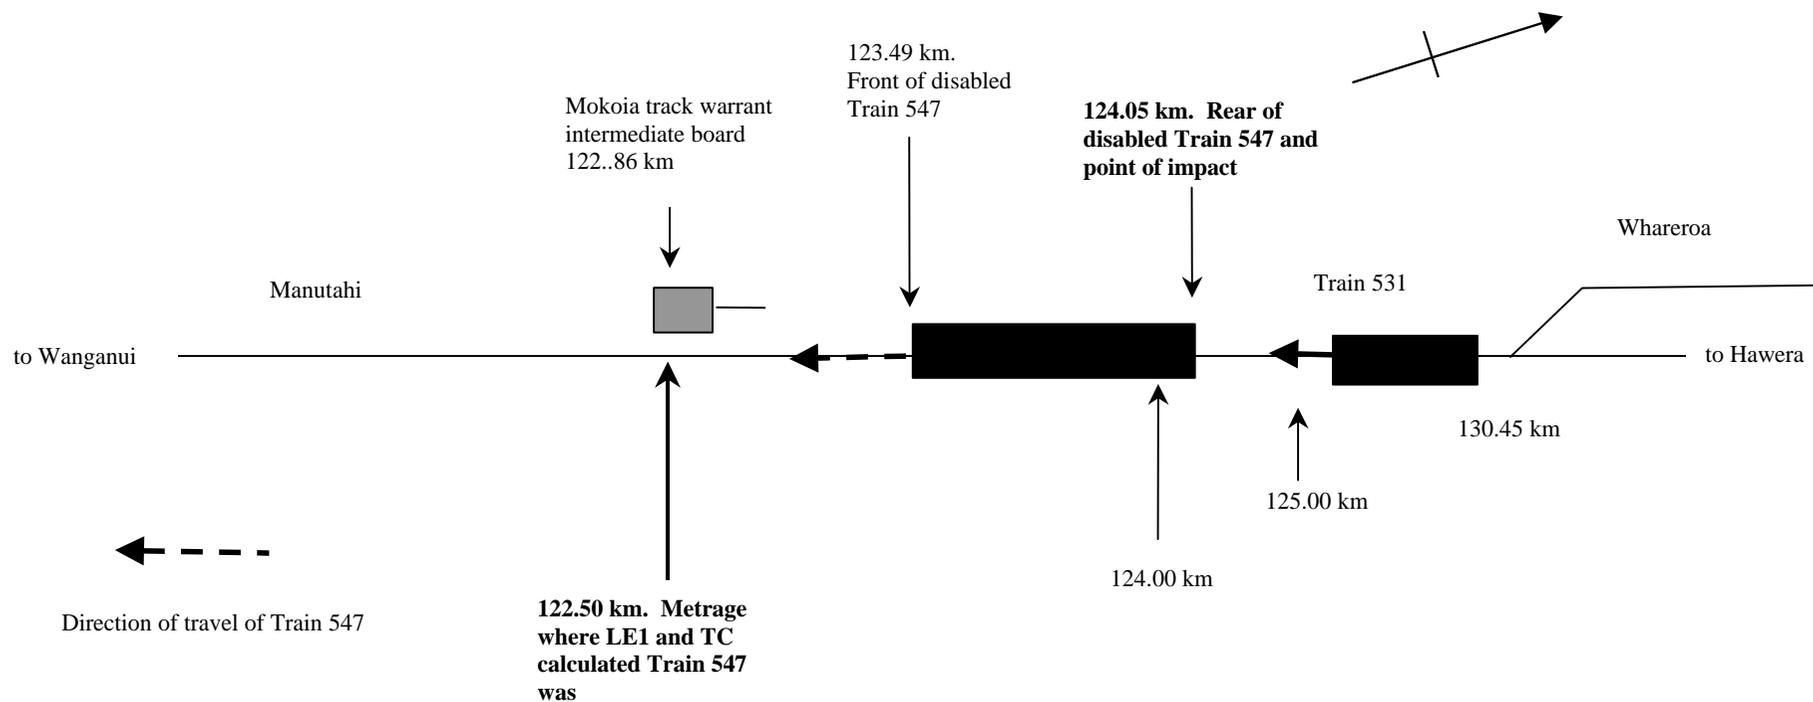
Figure 1
Track plan from Whareroa to Manutahi
(not to scale)

1.1.7 The following conversation took place once LE1 saw the Mokoia track warrant intermediate board (see Figure 1) in the distance:

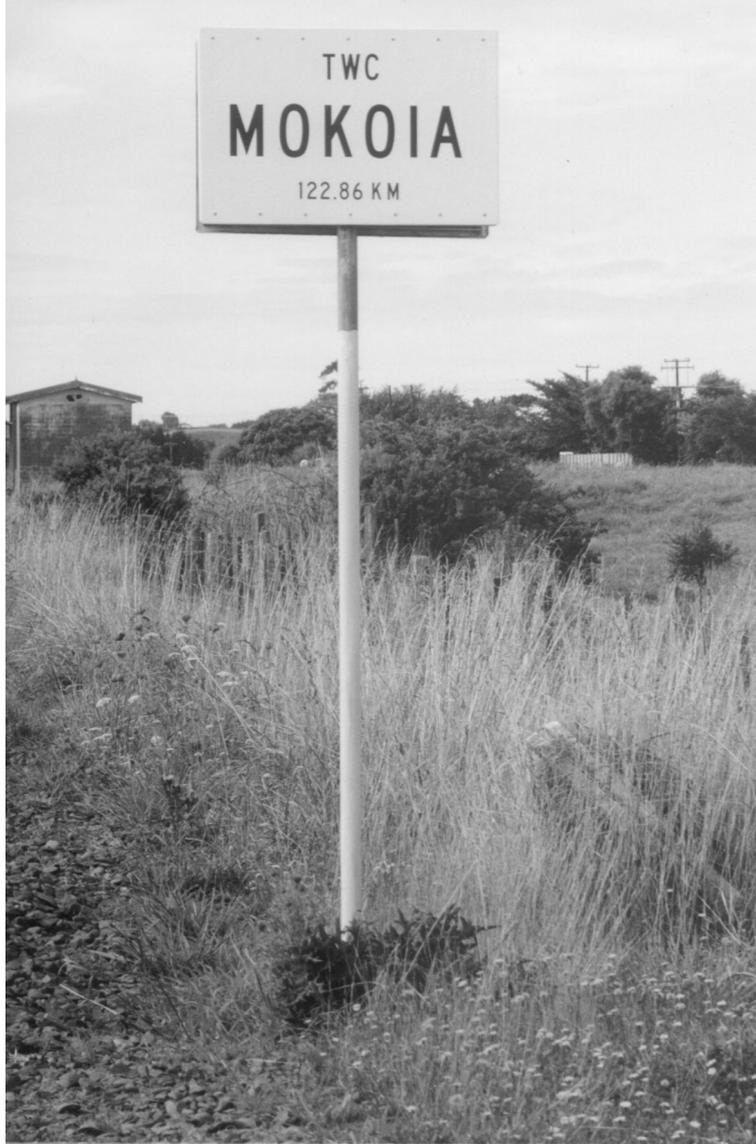
Figure 2
The intermediate board at Mokoia

- 1.2.8 About 30 m north of the Mokoia intermediate board and in the direction in which LE1 was walking was the Mokoia Road level crossing. Beside the level crossing was a small hut with a sign attached which displayed the name of the level crossing and the metrage it was located at (refer Figure 4). LE1 had not walked as far as the level crossing but instead had stopped once he had seen the Mokoia intermediate board at the top of the grade in the distance.

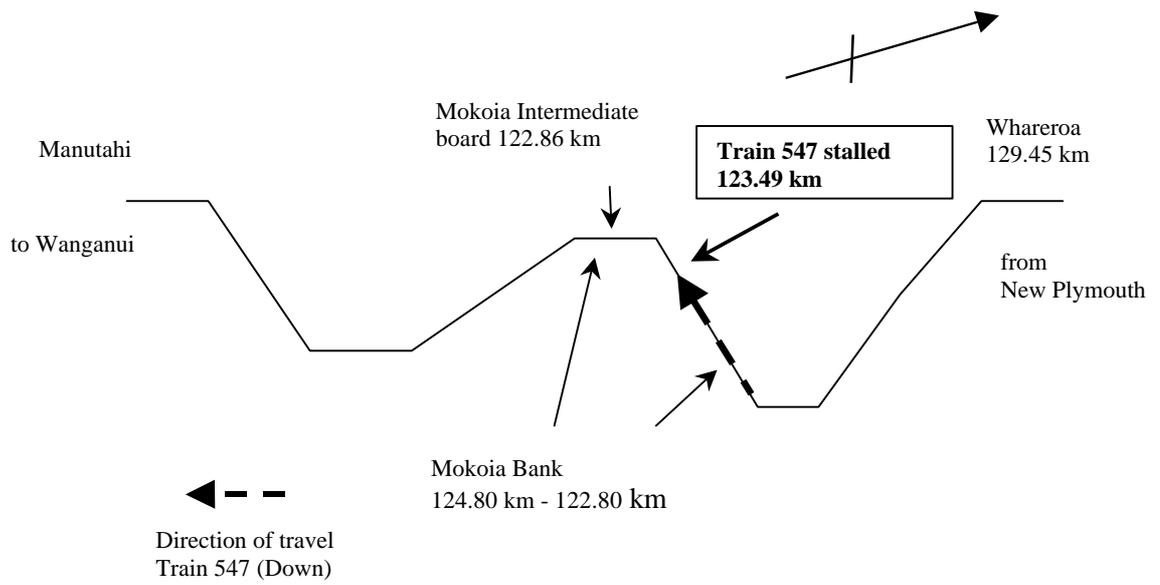
Figure 3
Gradient diagram Whareroa to Manutahi
 (not to scale)

- 1.2.9 A 25 km/h temporary speed restriction was in place between 123.85 km and 123.00 km at the time. Within this restriction there was a 300 m curve (usual maximum authorised track speed 60 km/h) and 2 x 240 m curves (usual maximum authorised track speed 55 km/h). Tranz Rail advised that this speed restriction had been in effect since December 2000 and although the speed restriction was over reasonably steep terrain no other stallings had been reported since it was implemented.
