## RAILWAY OCCURRENCE REPORT

02-117

Express freight Train 328, signal passed at stop, Te Rapa

31 July 2002

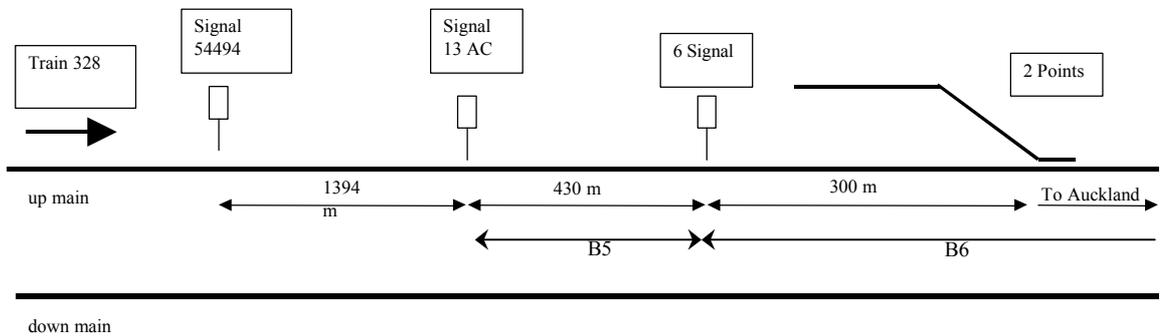
**Figure 1**  
**Layout of signals passed by Train 328 when departing Te Rapa up main**  
**(not to scale)**

- 1.2.1 Te Rapa Yard was a major yard. For north departing trains the yard had an up main, an up through departure road and 2 departure roads (see Figure 1).

- 2.6 The locomotive engineer was experienced at departing trains from the north end of Te Rapa yard. He passed intermediate Signal 54494 and 13 AC Signal each displaying a yellow indication and correctly stopped at the next signal, 6 Signal, which was displaying a red aspect.

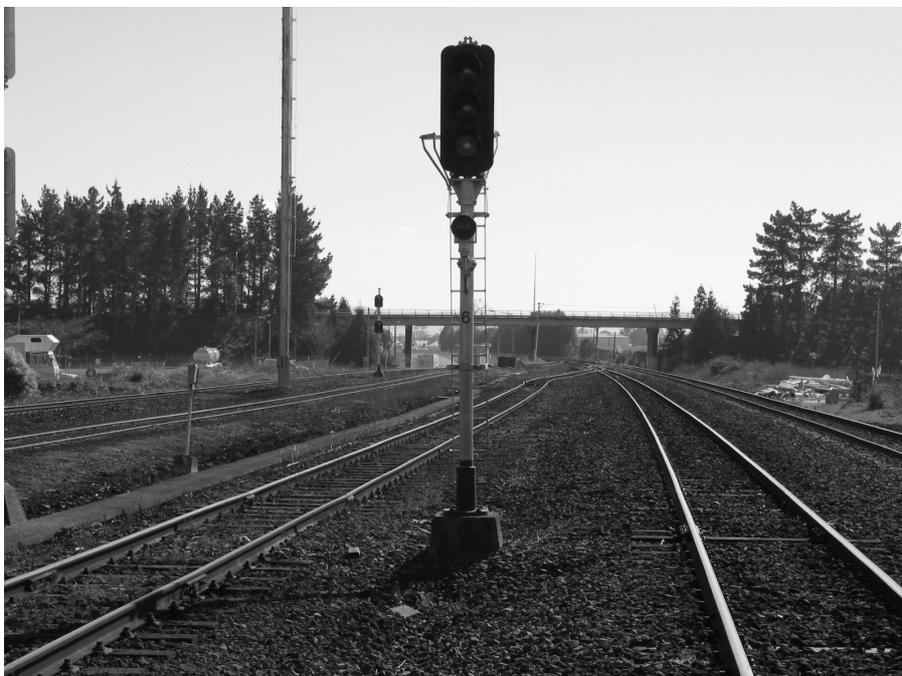
**Figure 2**  
**Up Starting 6 Signal at Te Rapa**

- 1.2.2 Like Signals 54494 and 13 AC, 6 Signal was positioned on the left side of the up main. It was held at stop because a portion of the up main between Te Rapa and Horotiu was obstructed by a hi-rail excavator. The signalman had placed a collar over 6 Signal on his panel as a physical reminder that a section of track in advance of the signal was obstructed.
- 1.2.3 The hi-rail excavator had moved clear of the track before the arrival of Train 328. There were no other trains or track occupations on the up main between Te Rapa and Ngaruawahia, the next crossing station in advance of Horotiu.

- 2.5 The locomotive engineer confirmed that 6 Signal was clearly visible and displayed a red aspect as he approached it. He was an experienced driver and it was not clear why he had any doubts that the signal applied to his train.

- 4.3 Tranz Rail has introduced a flashing yellow over red advance caution signal aspect (second signal in advance at stop), which will be used instead of double caution aspects.
