RAILWAY OCCURRENCE REPORT

03-113 diesel multiple unit passenger Train 3366, passed conditional stop 30 October 2003
board without authority, Glen Innes

Report 03-113

30 October 2003

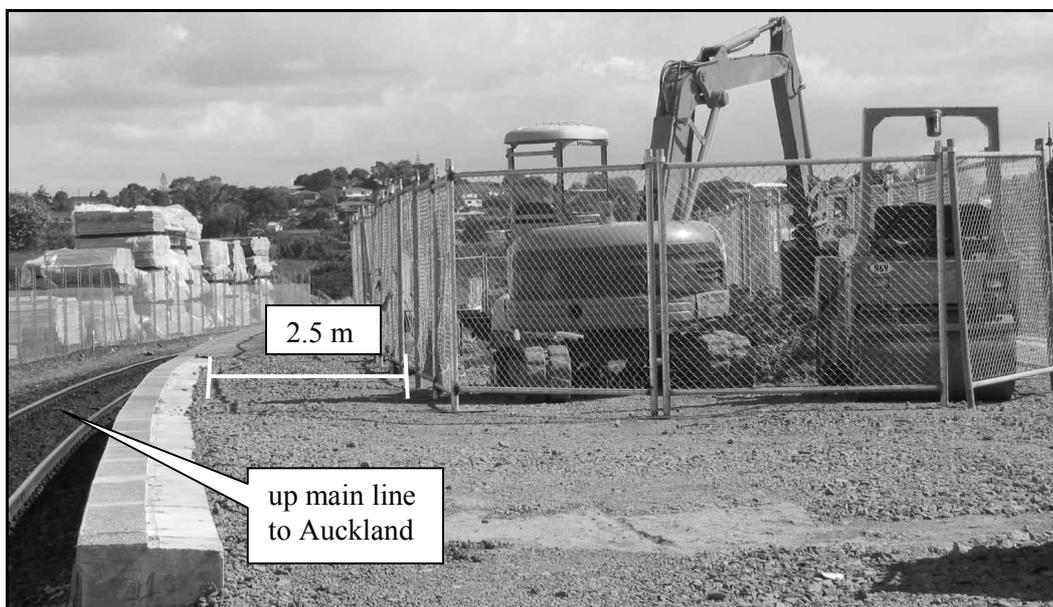
Figure 2
Construction work at Glen Innes Station

1.2.2 The station platform and passenger facility was being upgraded. The construction area was contained within a steel security fence (see Figure 2).

1.2.3 There was no construction activity on the up main side of the platform when Train 3366 approached the platform. Passengers waiting to board the train had about 2.5 m of usable platform between the security fence and the platform edge.

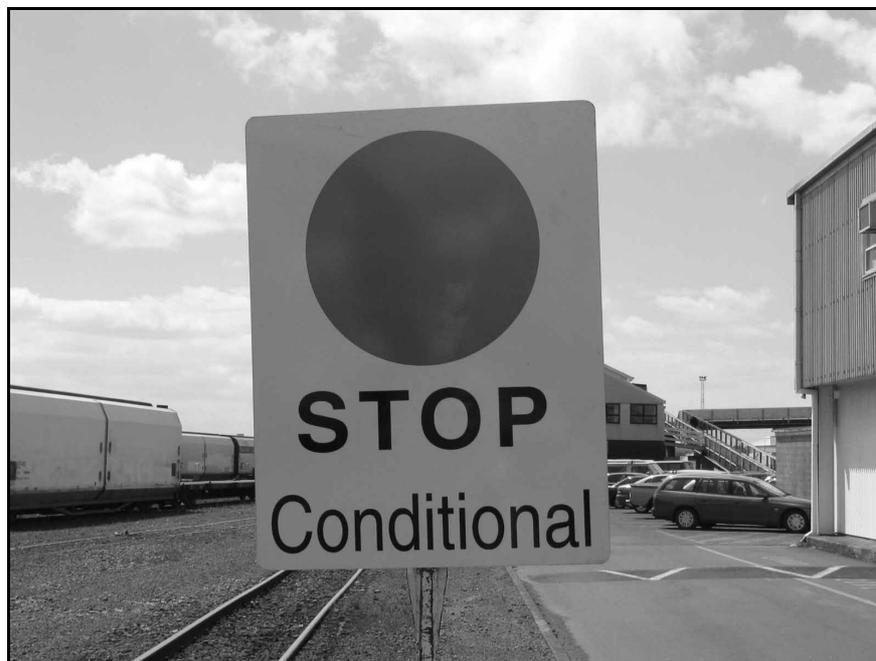
Figure 3
Conditional Stop Board

1.4.2 The CSB has a reflectorised white background with reflectorised red circle and matt black type (see Figure 3).

- 2.12 Tranz Rail's operating rules and regulations required trains to stop at all signals displaying a red aspect or for red flags and wait until authority is received to pass that signal or flag. Although the CSB displayed a reflectorised red circle, it was also marked with the word "conditional", and Tranz Rail's rules at the time permitted the CSB to be passed without having to stop short of the board, if permission had been granted. To use a roading analogy, because of the red circle, the signage represented a compulsory stop. However, the operating rules treated the CSB as if it was a give way and permitted, with authority from the PIC, the CSB to be passed without the need to stop. In view of the amendment made to Tranz Rail's Rule 905 (g) requiring trains to stop at CSBs and the locomotive engineer to contact the PIC for authorisation to pass the CSB, no safety recommendation covering this issue has been made.

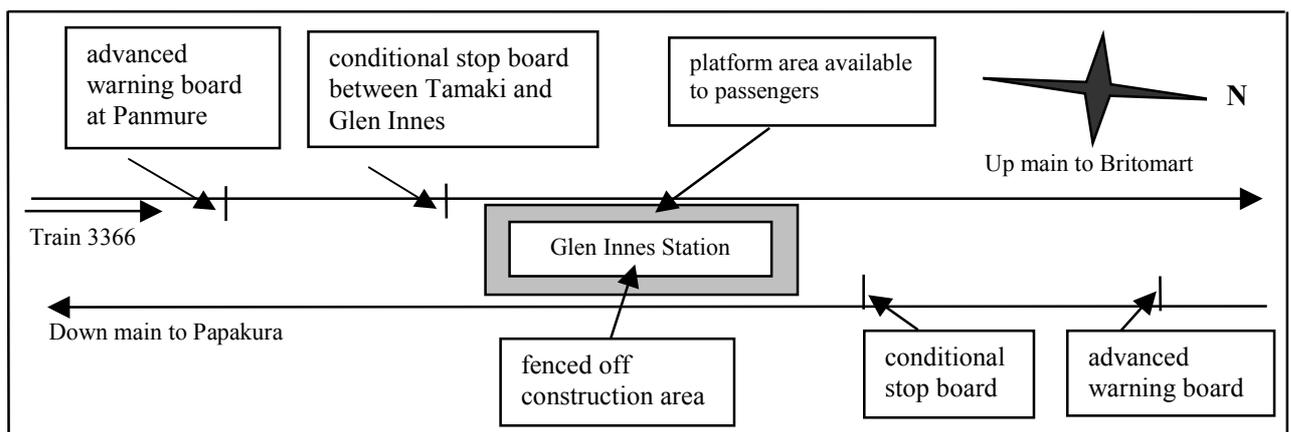
Figure 4
Location of Advance Warning Boards and Conditional Stop Boards (not to scale)

1.4.4 The PIC erected AWBs and CSBs to protect the work site at Glen Innes (see Figure 4).

- 3.1 Conditional Stop Protection was appropriate for the work being undertaken at Glen Innes Station.
- 3.2 The Conditional Stop Boards and Advanced Warning Boards were erected at appropriate locations in accordance with documented procedures.
- 3.3 The LEMU of Train 3366 had passed through the worksite without incident on another train some 2 hours earlier.
- 3.4 The known poor performance of the Channel 1 radio system in the Tamaki area contributed to the incident.
- 3.5 Train 3366 entered the work area without the train crew clearly establishing that they had proper authorisation to do so.
- 3.6 Although at the time of the incident Train 3366 was being driven by a trainee LEMU, the minder driver was responsible for the safe operation of the train.
