RAILWAY OCCURRENCE REPORT

04-111

express freight Train 736, track occupation irregularity
involving a near collision, Christchurch

14 April 2004

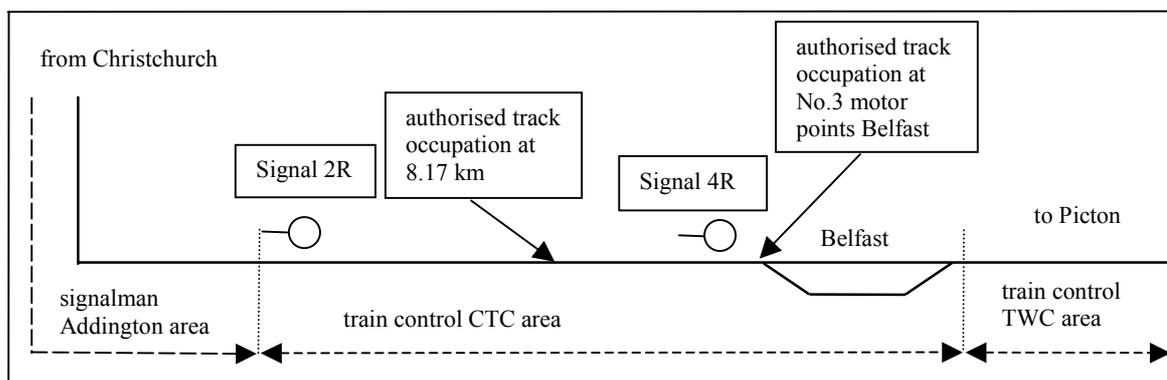
Figure 1
Christchurch-Belfast section (not to scale)

- 1.2.1 The MNL between Signal 2R at Christchurch and Picton was single line over a distance of 347.60 km. Train movements and track occupations on the line were controlled from the national train control centre in Wellington.
- 1.2.2 The CTC signalling system operated between Signal 2R at Christchurch and Belfast and from Vernon to Picton. In these sections the train controller controlled points and signal indications and monitored progress of trains on a VDU as they travelled through the track circuited areas.

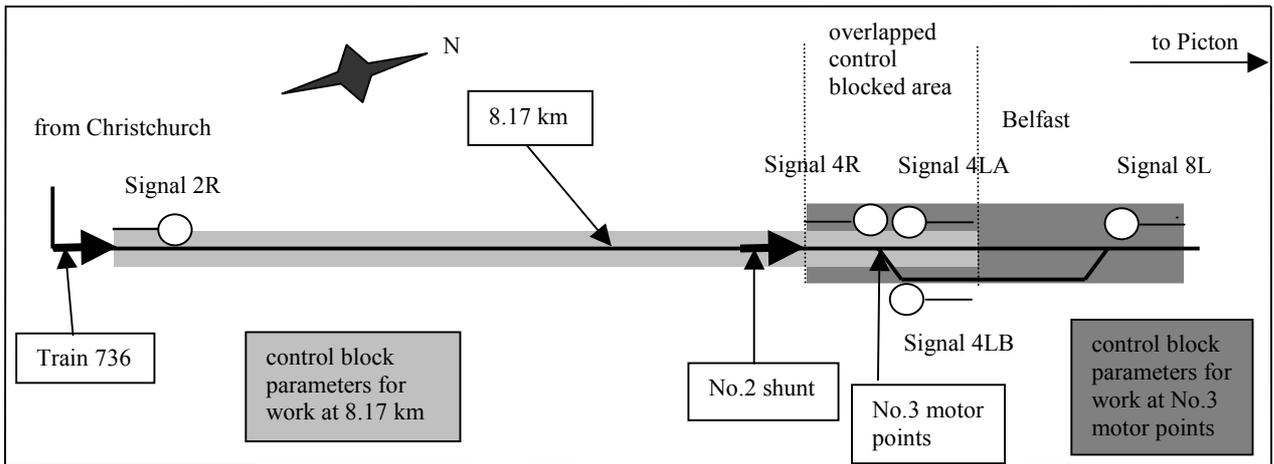
Figure 2
Christchurch-Belfast section showing the overlapped control blocked area (not to scale)

- 1.2.9 The application of 2 adjacent control blocks, one at Belfast, and the other in the section between Christchurch and Belfast, created an overlap situation (see Figure 2). To allow a train to be routed from the section, provision was made for the removal of an appropriate control tag within a control block section to permit the changing of a set of points and the clearing of a signal.

- 2.3 The control block protecting the worksite at 8.17 km prevented command access to No.3 points because of the overlap of the 2 control block parameters. Train controller 2 was not sufficiently conversant with the full capability of the process, and therefore improvised by adopting a work-round practice whereby the control block protecting the worksite at 8.17 km was removed to allow No.2 shunt to enter the loop at Belfast.

- 2.4 Once No.2 shunt had entered the loop and No.3 points had been restored to normal, train controller 2 overlooked the reinstatement of the control block to protect the worksite at 8.17 km, probably because his attention was diverted to ongoing TWC tasks. Had he reinstated the control block, Train 736 could not have been signalled past Signal 2R at Christchurch and the incident would have been prevented.

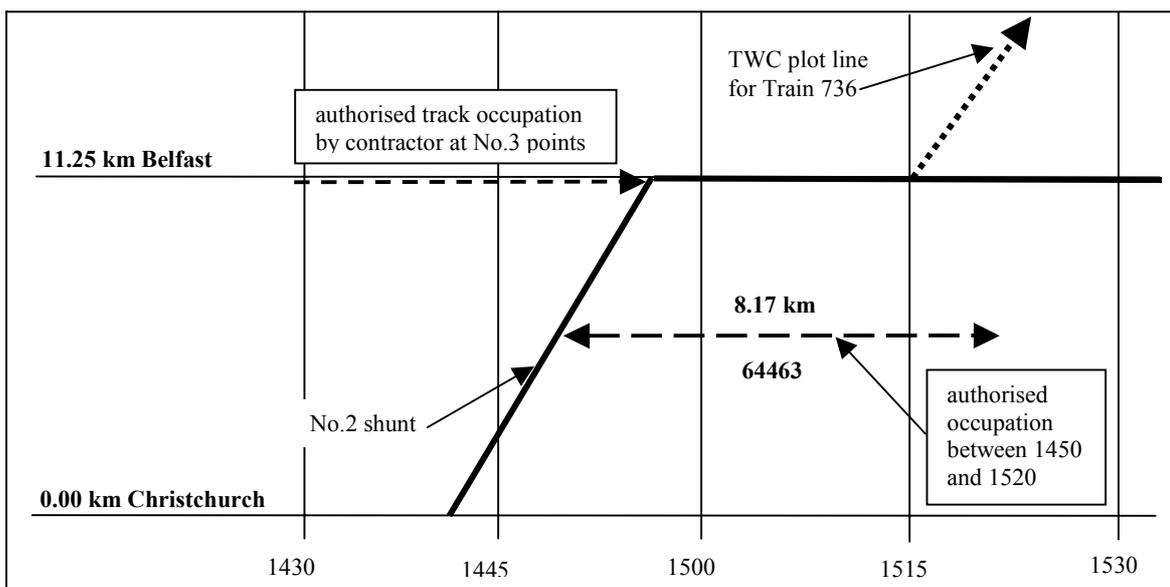
Figure 3
Information on train control diagram when Train 736 departed Christchurch (not to scale)

- 1.3.3 When train controller 1 authorised the track occupation at 8.17 km, he drew a horizontal line on the train control diagram between 1450 and 1520, endorsed with the metrage and the radio call sign of the PIC (see Figure 3). Although train controller 1 applied the control block, he did not confirm with the PIC that the control block had been applied.

1.3.10 At 1458, train controller 2 issued track warrant No.66 to the locomotive engineer of Train 736 giving him authority to travel north from Belfast to Waipara. He correctly plotted the track warrant authority line in blue pen on the train control diagram. He could not recall if he drew a pencilled plot line from Christchurch for the anticipated train path to link with a 1515 departure from Belfast, and no such line appeared on the train control diagram.

1.3.11 At 1501, train controller 2 received a request from the signalman at Addington to release Signal 2R at Christchurch for Train 736 to proceed from Christchurch to Belfast. He could not recall if he referred to the train control diagram before placing Signal 2R to proceed at 1503.

- 2.5 Train controller 2 had 2 separate opportunities to plot Train 736's expected 15-minute path from Christchurch to Belfast: the first when he issued the track warrant to the locomotive engineer and the second when the signaller at Addington applied for a release on Signal 2R.

- 2.6 Had train controller 2 referred to the train control diagram on either of these occasions and plotted the train journey, he would have been alerted to the conflicting occupations. A safety recommendation emphasising that the train control diagram is the primary tool of a train controller has been made to the Chief Executive of ONTRACK.

- 5.1 On 22 April 2005 the Commission recommended to the Chief Executive of ONTRACK that he:
 - 5.1.1 incorporate an instruction in the Rail Operating Code confirming that the train control diagram is the primary tool for planning the movement of rail service vehicles and track occupations. (005/05)
 - 5.1.2 review the Rail Operating Code with a view to clarifying those instances where staff are to be relieved from duties when involved in an operating occurrence. (040/05)
- 5.2 On 5 May 2005 the Chief Executive of ONTRACK replied in part:
 - 5.2.1 005/05 ONTRACK accept the recommendation.
 - 5.2.2 040/05 ONTRACK does not intend to implement this recommendation. ONTRACK together with Toll Rail have reviewed the instruction in the Rail Operating Code and found it fit for purpose in its current format.

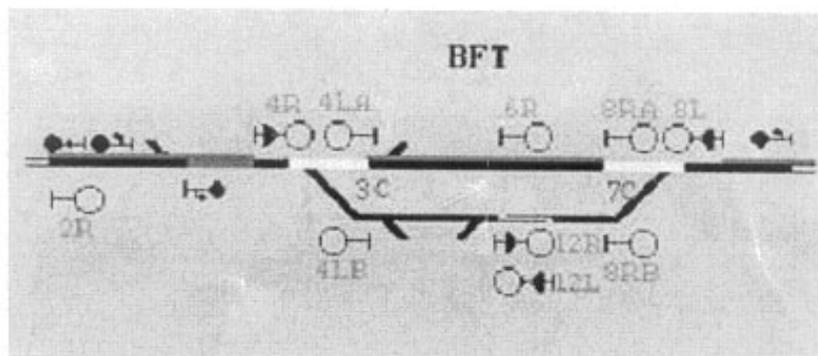
Below is a picture of BFT with blocking applied. This will be used as a reference to explain what can be done in case a set of points needs to be moved for shunting under blocking conditions.

In this instance blocking has been applied on the main line. If, for operational reasons, a train needs to get to the loop, and there is still a gang active on the main line, the following can be done:

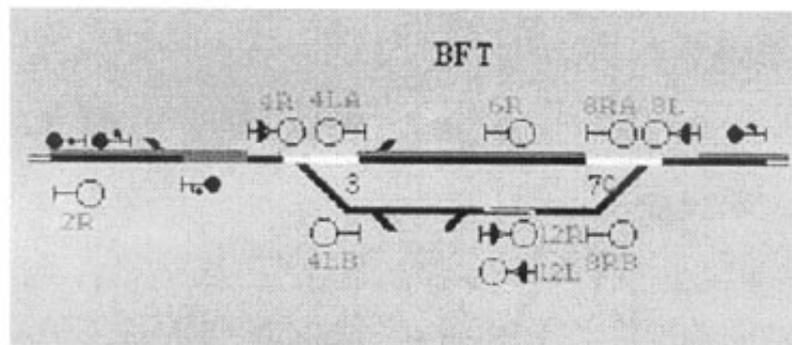
- Right click on 3 points.
- From the menu that appears, select the option called "Control Tag".
- A window will open with a button called "Clear" at the top.
- Left click "Clear", and this will remove the control tag from 3 points.

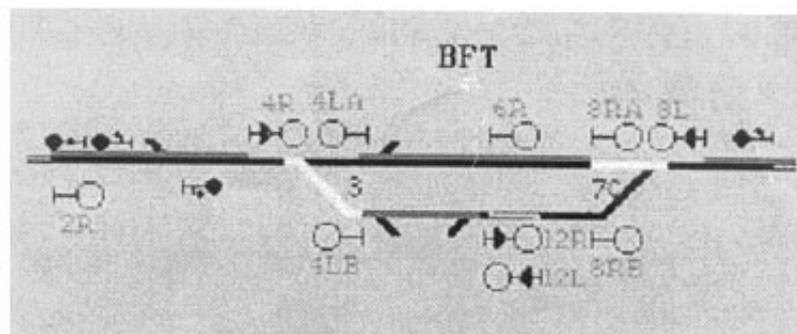
- 3 points can now be moved to reverse as per regular operation.
- Note that the blocking on 4R signal in this case, is now removed. 4R can be called to clear as per normal.

Once the train is in the loop and clear of the point's track, the points can be put back in the normal position and re-tagged manually.

If the points are put back to normal, the signal (4R) will re-tag within 5 seconds. ***Be careful not to clear the signal in that time!***
