## RAILWAY OCCURRENCE REPORT

04-118      Report 04-118, express freight Train 725, track occupation      20 July 2004  
irregularity leading to a near collision, Tormore-Scargill

TRANSPORT ACCIDENT INVESTIGATION  
COMMISSION  
NEW ZEALAND

**Report 04-118**  
**express freight Train 725**  
**track occupation irregularity leading to a near collision**  
**Tormore-Scargill**  
**20 July 2004**

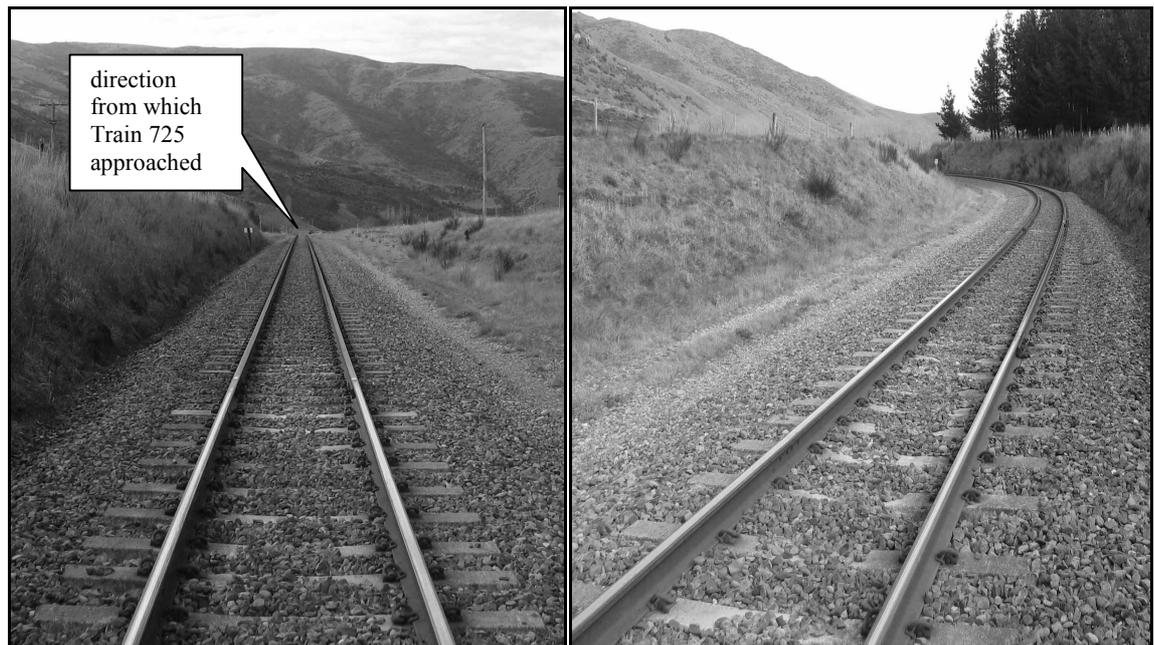
**Figure 1**  
**Worksite at 99.5 km, looking north (left) and south (right)**

- 1.1.1 On Tuesday 20 July 2004, at about 1325, a Transfield Services<sup>3</sup> track ganger and track maintainer arrived by road at 99.5 km between Tormore and Scargill on the MNL to repair a track geometry exceedance that had been detected by the track evaluation car<sup>4</sup> earlier in the day.
- 1.1.2 The track ganger performed an individual train detection<sup>5</sup> (ITD) safety check to determine if he and the track maintainer could undertake the track occupancy under their own protection. Because the ITD criteria of clear vision and hearing ability could not be complied with, the track ganger advanced the status of the occupation to a foul time<sup>6</sup> request (see Figure 1).

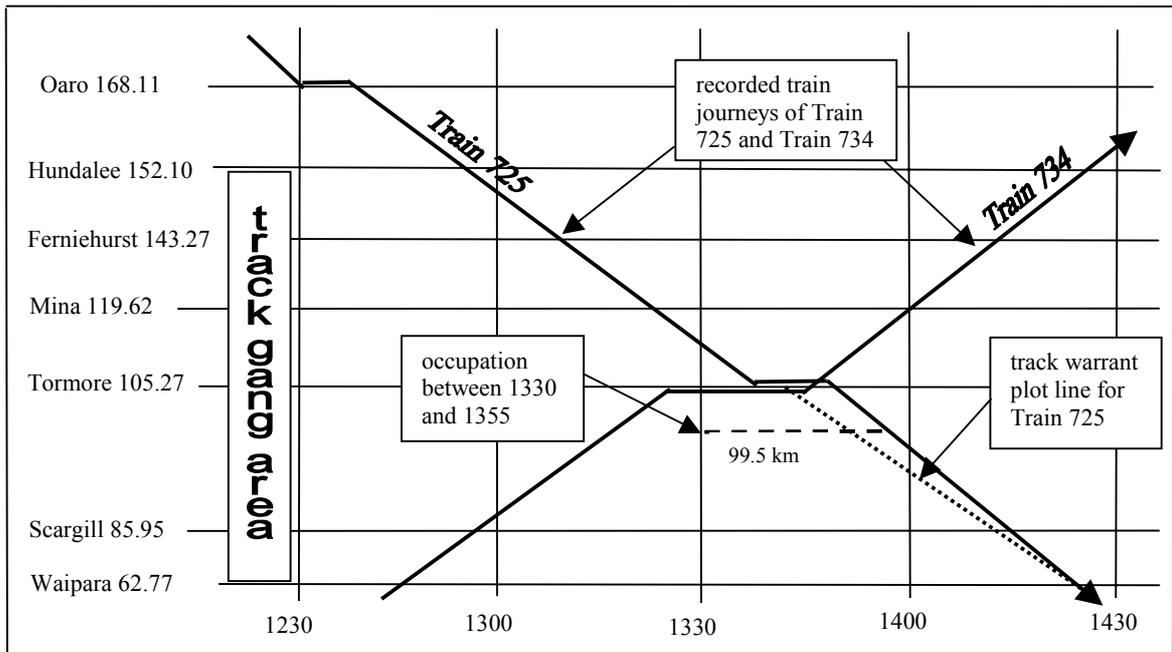
**Information recorded on the train control diagram after Train 725 had travelled south of Waipara (not to scale)**

- 1.3.13 The track ganger had about 30 years' track maintenance experience, all in the north Canterbury area. He had lived and worked from Mina all his working life. His area of responsibility was from Hundalee to Waipara, a distance of about 89 km (see Figure 2).

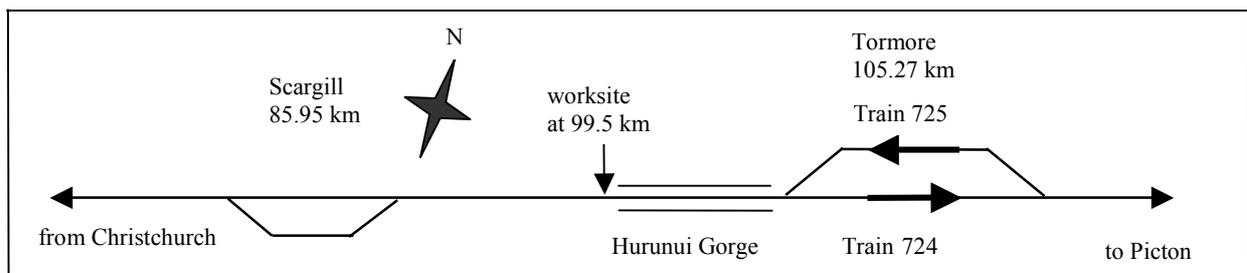
**Track layout between Tormore and Scargill (not to scale)**

1.2.1 The MNL between Christchurch and Picton was single line over a distance of 347.60 km. Train movements and track occupations on the line were controlled from the national train control centre in Wellington. Proportionally, track warrant control (TWC) was the principal operating system on the line. Immediately south of Tormore the MNL traversed the Hurunui Gorge (see Figure 3).
