RAILWAY OCCURRENCE REPORT

05-102

track warrant control irregularities, Woodville and Otane

18 January 2005

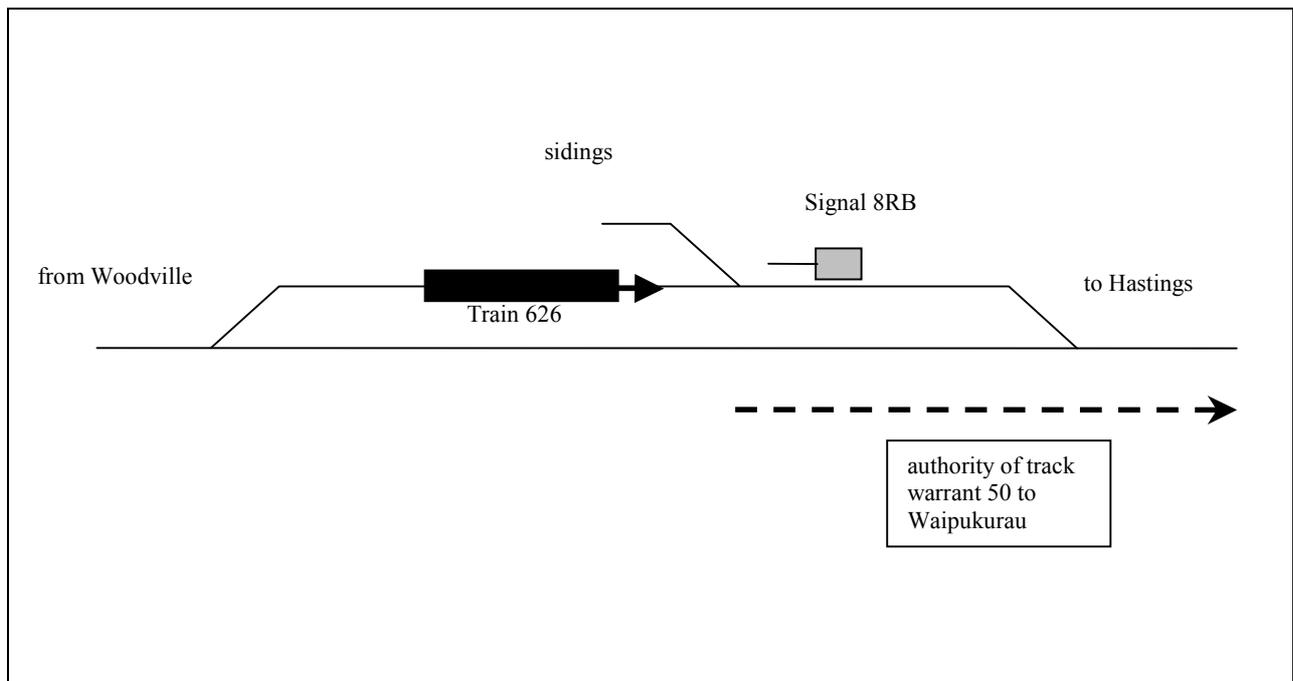
Figure 2
Shunting arrangements at Takapau (not to scale)

- 2.1.6 Between Woodville and Hastings the PNGL was single track so, to enable opposing trains to cross, sections of double line, or crossing loops, were provided at Oringi, Dannevirke, Makotuku, Takapau, Waipukurau and Otane. To control such crossings, train controllers stipulated berthing instructions on the track warrant.
- 2.1.7 The signalling at Takapau was remotely controlled from ONTRACK's² national train control centre in Wellington. When shunting the sidings at Takapau, it was usual for northbound trains to require the train controller to clear 8RB Up Starting Signal from Loop to proceed to allow room for the shunting manoeuvre to be undertaken (see Figure 2).

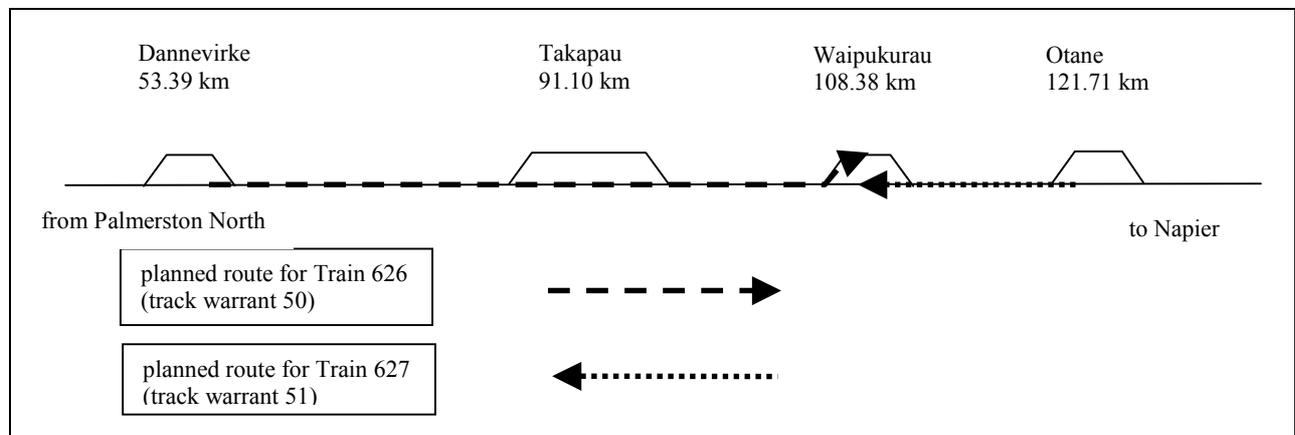
Figure 3
Relationship of localities to the planned crossing (not to scale)

- 3.2.1 Operations on the PNGL south of Hastings on the day included a planned crossing of northbound express freight Train 626 with southbound express freight Train 627 at Waipukurau. Such planned crossings were standard procedure on the single line track operated under the TWC system. Figure 3 shows the relationship of localities to the planned crossing.

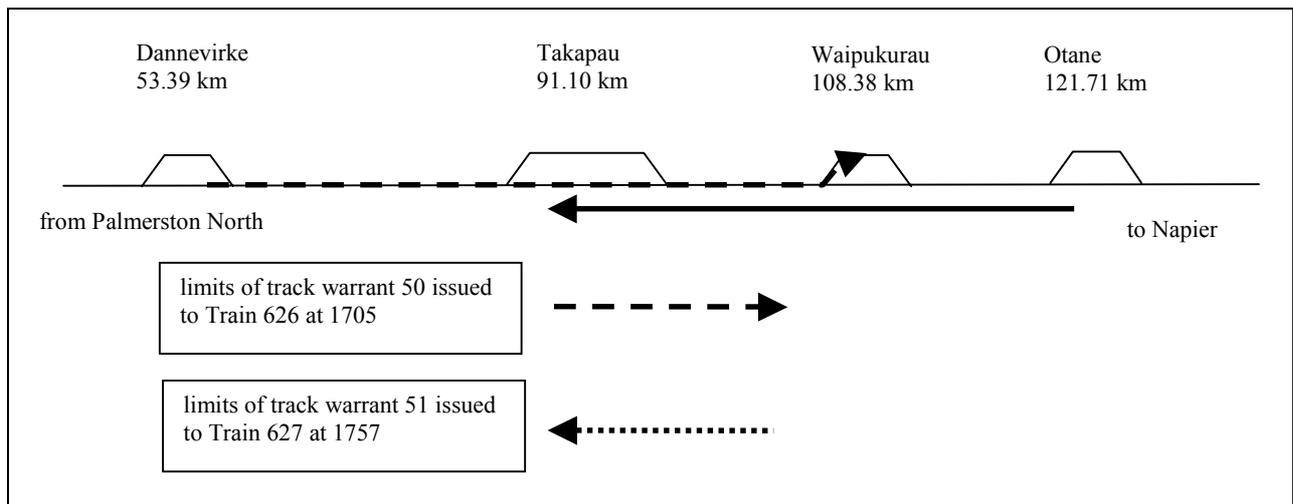
Figure 4
The limits of track warrants 50 and 51 as issued (not to scale)

- 3.2.2 Comparisons between the 2 track warrants as prepared in TWACS and as read out by the train controller are as follows:
- track warrant 50, as prepared, authorised Train 626 to proceed from Dannevirke to the loop at Waipukurau to cross Train 627 (see Figure 3)
 - track warrant 50, as read out at 1705, authorised Train 626 to proceed from Dannevirke to the loop at Waipukurau to cross Train 627 (see Figure 4)
 - track warrant 51, as prepared, authorised Train 627 to proceed from Otane to the main line at Waipukurau to cross Train 626 (see Figure 3)
 - track warrant 51, as read out at 1757, authorised Train 627 to proceed from Otane to the main line at Takapau to cross Train 626 (see Figure 4).

- 4.14 The track warrant readout / readback procedure provided 4 opportunities for the train controller to have identified the transposing of "Waipukurau" to "Takapau". However, he twice missed the opportunity while reading the track warrant out to the locomotive engineer, and twice more when it was read back to him. A safety recommendation covering the introduction of a cross-checking procedure for station names when preparing and issuing track warrants has been made to the Chief Executive of ONTRACK.

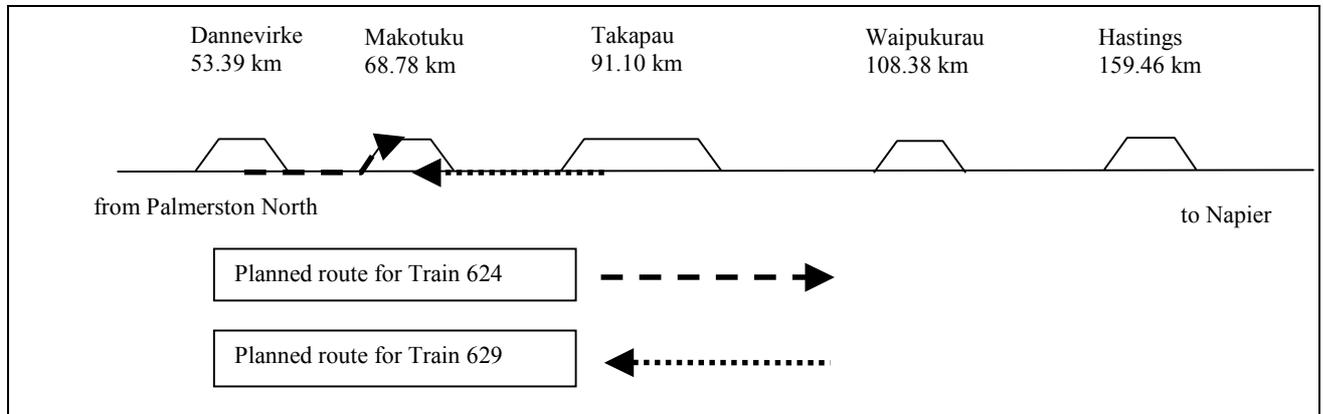
Figure 5
Relationship of localities to the planned crossing (not to scale)

5.2.1 Operations on the PNGL south of Hastings on the day included a planned crossing of northbound express freight Train 624 with southbound express freight Train 629 at Makotuku. Such planned crossings were standard procedure on the single line track operated under the TWC system. Figure 4 shows the relationship of localities to the planned crossing.

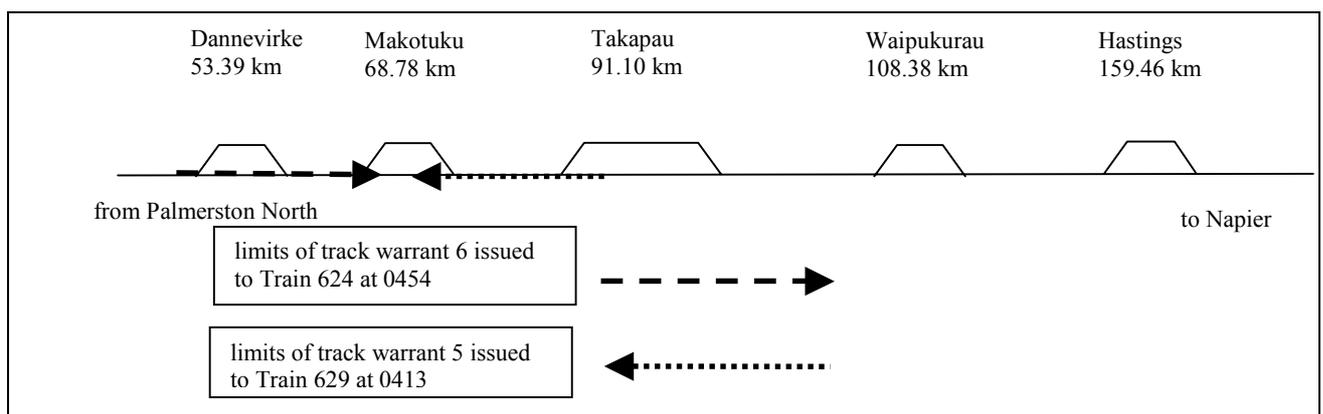
Figure 6
The limits of track warrants 5 and 6 as issued (not to scale)

- track warrant 5, as prepared, authorised Train 629 to proceed from Hastings to the main line at Makotuku to cross Train 624 (see Figure 5)
- track warrant 5, as read out at 0413, authorised Train 629 to proceed from Hastings to the main line at Makotuku to cross Train 624 (see Figure 6)
- track warrant 6, as prepared, authorised Train 624 to proceed from Woodville to the loop at Makotuku to cross Train 624 (see Figure 5)
- track warrant 6, as read out at 0454, authorised Train 624 to proceed from Woodville to the main line at Makotuku to cross Train 624 (see Figure 6).
