## RAILWAY OCCURRENCE REPORT

05-105      express freight Train 829, track occupation irregularity, Kokiri      3 February 2005

**TRANSPORT ACCIDENT INVESTIGATION COMMISSION  
NEW ZEALAND**

**Report 05-105**  
**express freight Train 829**  
**track occupation irregularity**  
**Kokiri**  
**3 February 2005**

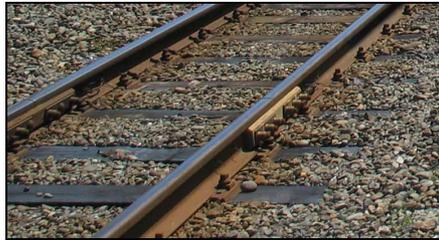
- 1.1.1 On Thursday 3 February 2005, at about 0615, two Transfield Services<sup>3</sup> track workers arrived by road at 191.06 km, between Kokiri and Stillwater on the Midland Line (ML), to replace a pair of failed insulated rail joints<sup>4</sup> at 191.88 km that had been causing intermittent failures to the signalling system in the area (see Figure 1).

**Figure 1**  
**A pair of insulated rail joints similar to those replaced at 191.88 km**

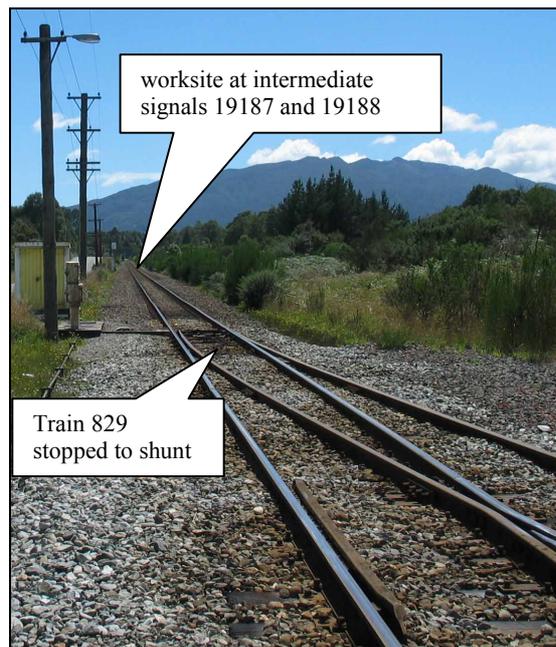
**Figure 2**  
**West end of Phoenix meat company siding looking towards intermediate signals 19187 and 19188**

- 1.1.5 The track workers on-tracked their hi-rail vehicle (HRV) at a level crossing at 191.06 km and travelled about 800 m to the worksite adjacent to intermediate signals 19187 and 19188 (see Figure 2).

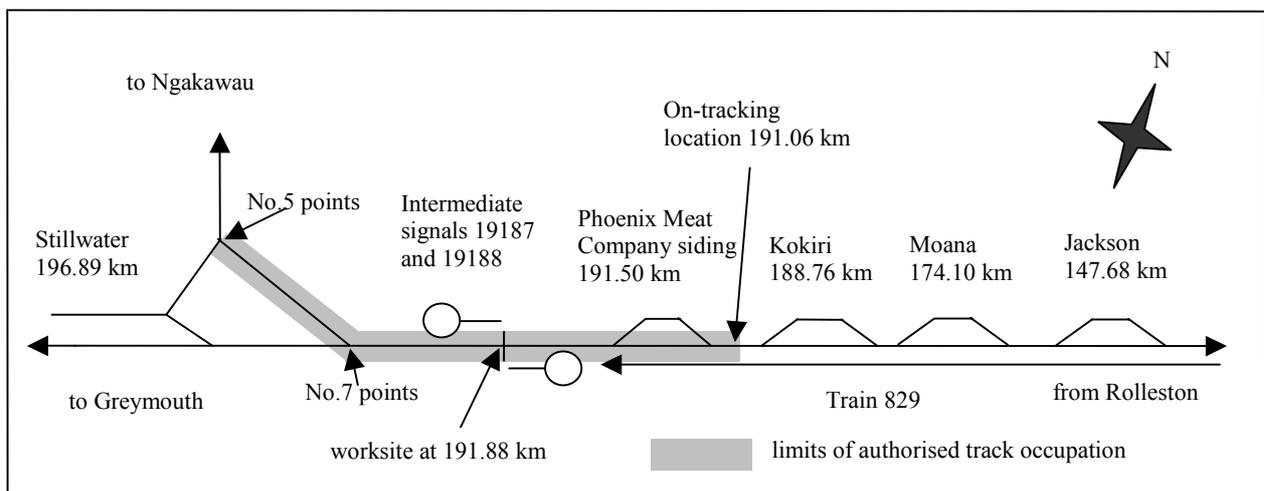
**Figure 3**  
**Track layout between Jackson and Stillwater (not to scale)**

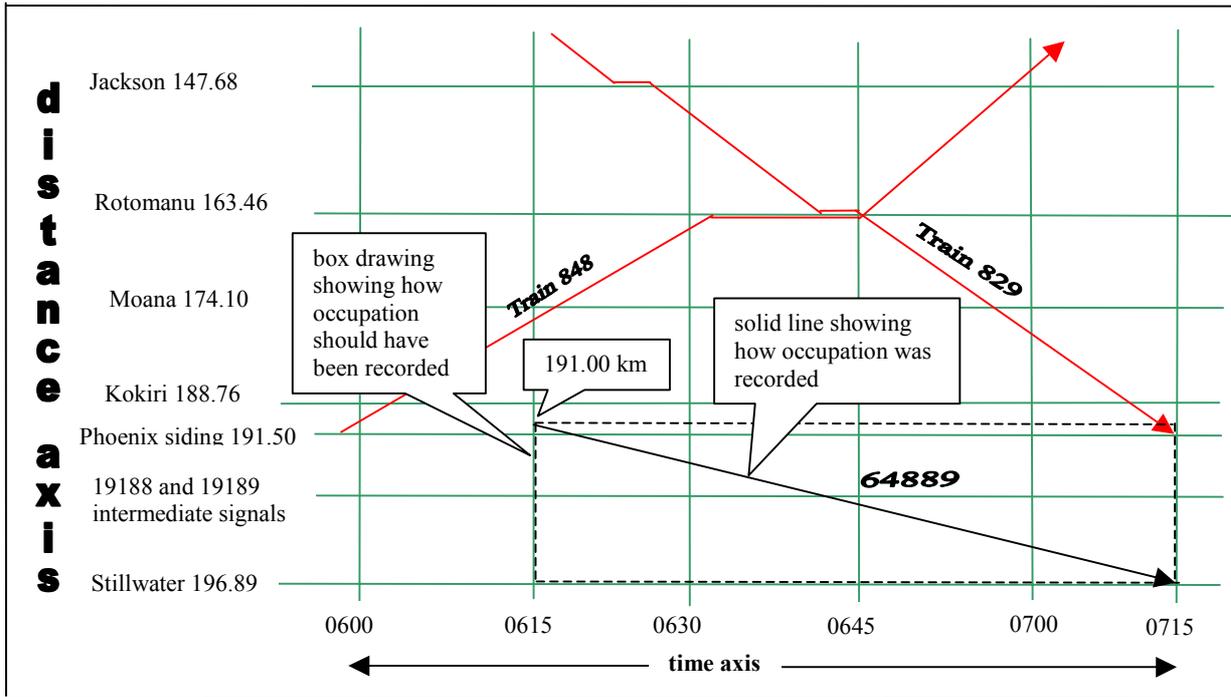
**Figure 4**  
**Train control diagram (not to scale)**  
 Note the dashed boxed lines are for clarity only

- 2.23 The application of Rule 915 was appropriate for the work that was being undertaken by the track workers on this occasion, and they had valid reasons for an earlier than normal start. The train controller could not explain why he recorded the occupation on the train control diagram as a 'proceed' instead of a 'work-between', after he had come to clear understanding with the track workers that they could work between the limits of the occupation. The slip was probably a result of his fatigue caused by accumulated sleep debt.

- 3.2 The performance of the train controller was probably impaired due to a cumulative sleep debt.
- 3.3 The recording of the occupation as a 'proceed' instead of a 'work between' on the train control diagram led the train controller into believing that it was safe to continue to advance Train 829 to Phoenix siding despite the 15-minute buffer conditions.
