## RAILWAY OCCURRENCE REPORT

05-107

diesel multiple unit passenger Train 3037, wrong routing, signal passed at danger and unauthorised wrong line travel, Westfield

14 February 2005

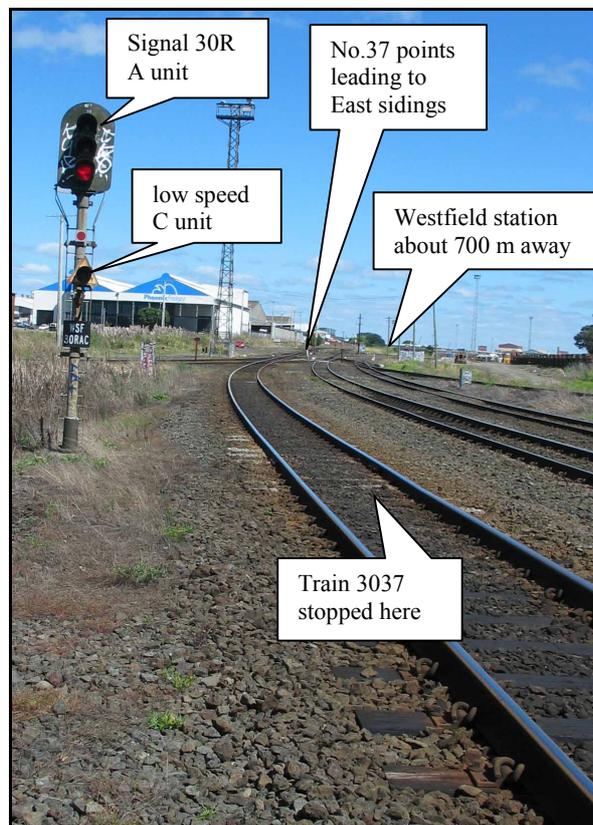
**Figure 1**  
**Signal 30R at Westfield, looking south**

- 1.1.4 When Train 3037 approached Westfield, the LEMU slowed and stopped at Signal 30R which was displaying a stop indication. Shortly afterwards, the signal aspect changed to proceed and the LEMU passed the signal (see Figure 1).

- 1.7.8 Within seconds of stopping at Signal 30R, the aspect of the signal changed to a low speed which meant that all points were in the proper position but the track may be occupied or suitable for low speed only. The LEMU decided to pass the signal although he had not encountered a low speed aspect on this signal during his OJT. He said he thought he was following the DMU that was then stopped on the Down main at Westfield station, and he was being signalled in behind it.

- 2.17 Likewise, with more experience, the LEMU would probably have realised that a low speed aspect on Signal 30R only directs movements through any one of 3 diverging routes away from the Down main instead of routing a movement in behind another at Westfield station. However, in view of the safety actions taken by Connex immediately after the incident to augment their practical and theory signal awareness training for new LEMUs and, retrospectively use this incident to educate all their certified LEMUs, no safety recommendation has been made.

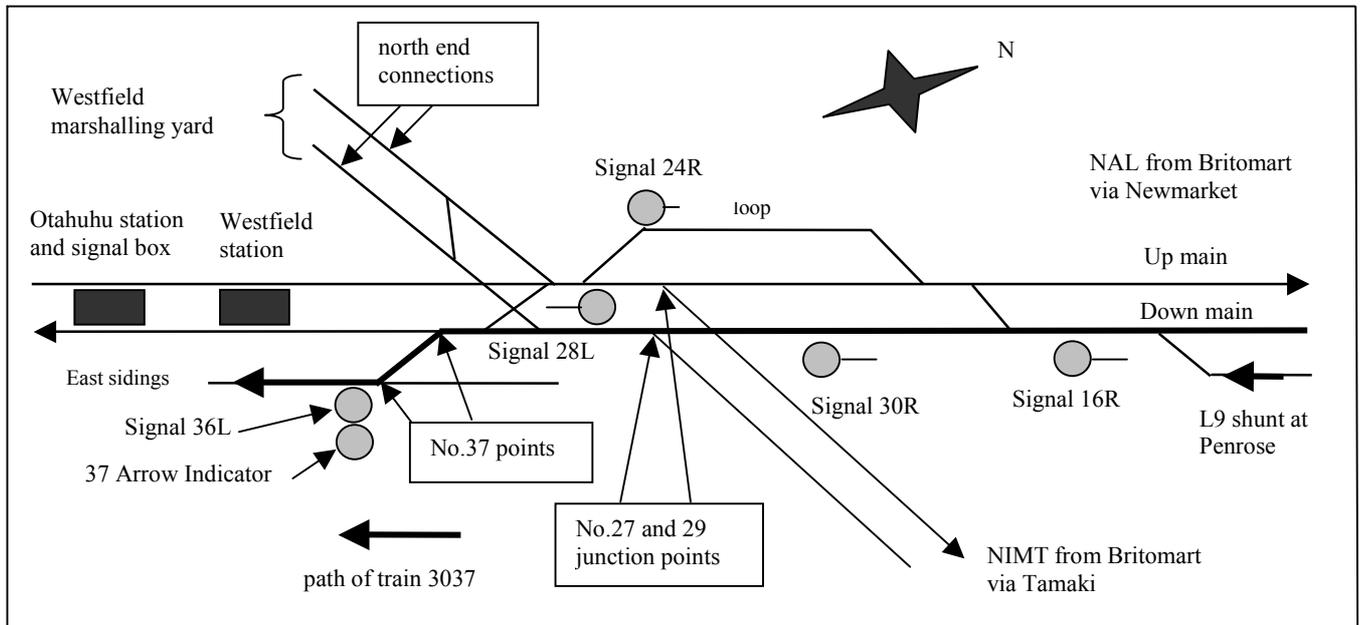
**Figure 2**  
**Track layout at Westfield (not to scale)**

- 1.1.5 Approaching No.37 points, the LEMU noticed they were set for the East sidings and realised immediately that he had been wrong routed. Not wishing to delay other services, the LEMU continued partially into the East sidings and stopped (see Figure 2).
- 1.1.6 At the request of the SBC, the LEMU moved a short distance forward and cleared No.37 points behind him, and they then discussed a plan for Train 3037 to regain the Down main. The plan involved Train 3037 travelling from the East sidings to the loop from where it would be signalled from Signal 24R back on to the Down main (see Figure 2).

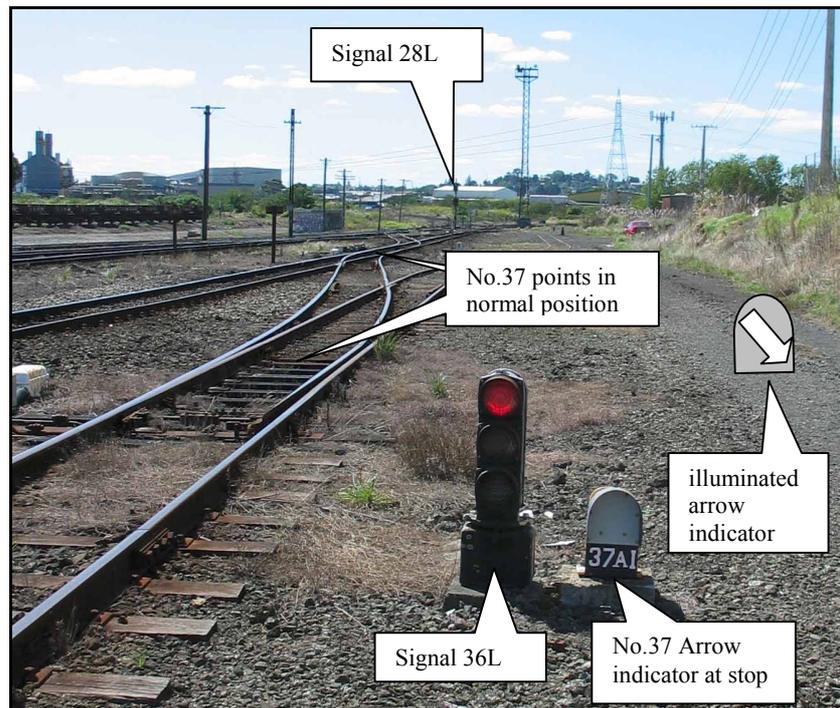
**Figure 3**  
**Signal 36L with adjacent No.37 Arrow Indicator and illuminated inset**

- 1.2.4 Signal 36L was a colour light shunting signal that, with a yellow or green aspect, authorised trains to exit the East sidings over No.37 points and travel on the Up main up to, or beyond, Signal 28L. There was an arrow indicator adjacent Signal 36L. When the arrow indicator was illuminated, trains could pass Signal 36L at stop and travel over No.37 points in the normal position and access other Toll Rail controlled sidings (see Figure 3).

- 1.7.11 The LEMU changed his driving position to the cab at the other end of the DMU. He said that he saw Signal 36L at stop but thought the signal applied for movements along the siding. As No.37 points were still in the reverse position and Signal 28L in the distance was at stop, he moved the DMU forward onto the Down main where he had come from, and stopped adjacent Signal 28L and advised the SBC what he had done.
- 1.7.12 When the SBC advised the LEMU to return to the East sidings, the LEMU changed his driving position and drove Train 3037 back into the East sidings.

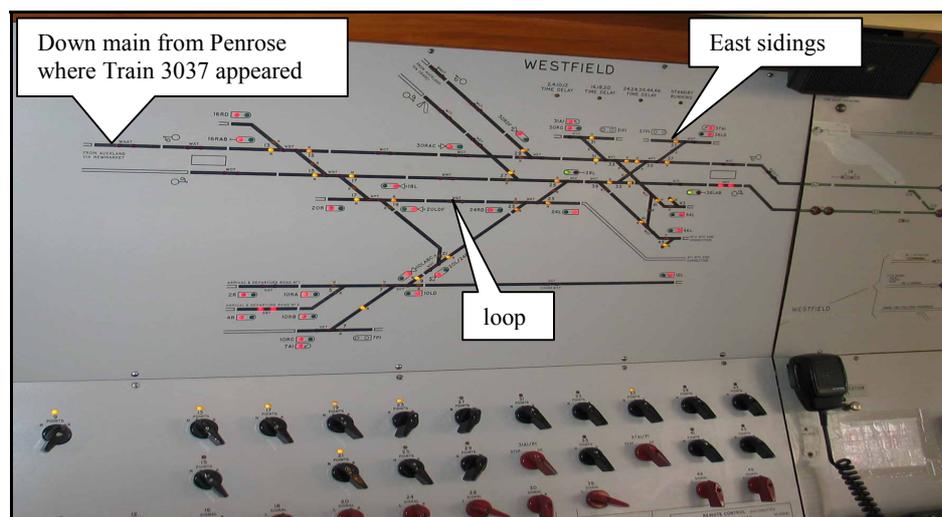
**Figure 4**  
**Otahuhu signal box panel displaying the Westfield signalling and interlocking arrangements**

- 1.7.13 On 28 September 2004, the SBC transferred from a Tranz Metro train manager's position and commenced theory training in order to attain signalman's qualification. During the 2-week course in Wellington, he passed a written progressive assessment test of his knowledge of correct radio procedures. The test included a question relating to the use of standard terms and phrases during radio transmissions.
- 1.7.14 The SBC commenced a 7-week OJT period with a minder signal box controller on 9 October 2004. Due to the widespread use of local names by operating personnel at Westfield-Otahuhu, the SBC had adopted a workaround process of applying stickers to the signal panel. These stickers provided a visual reference to the actual location and its proper location name until he became familiar with the local names (see Figure 4).

- 1.7.15 Some of the local names in use were:

Standard names	Local names
East sidings	greasy pig; Peter Baker Transport
Loop	Westfield loop; one arrival Westfield; one short

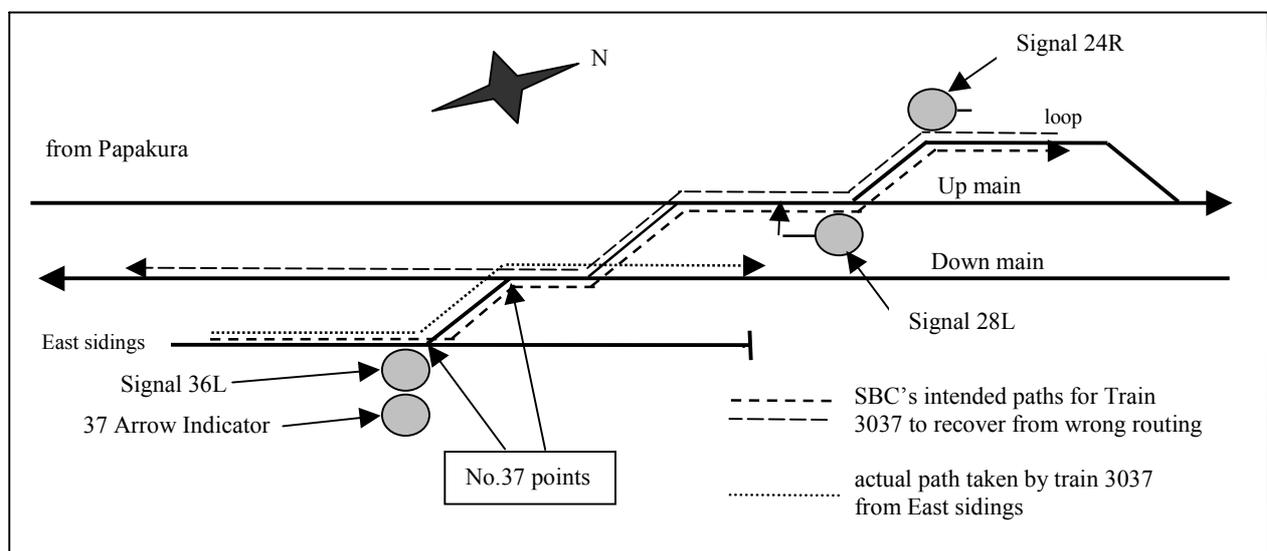
**Figure 5**  
**Detailed track layout at Westfield (not to scale)**

- 1.7.22 Once Train 3037 was inside the siding, the SBC intended to signal the train to the loop (see Figure 5), which would then allow him to clear Signal 24R and reroute the train back on to the Down main and continue to Papakura. He discussed the plan with the LEMU.

- 1.7.23 The SBC was interrupted with other duties before he could implement his plan, and when he looked at the panel, he saw that Train 3037 had exited the East sidings in an Up direction and wrongly entered the Down main. The SBC radioed the LEMU and instructed him to return to the East sidings.
- 1.7.24 When Train 3037 arrived back into the East sidings, the SBC notified the train controller of the incidents.
