RAILWAY OCCURRENCE REPORT

05-117 express freight Train 211, signal passed at stop, Rangitawa 12 May 2005

**TRANSPORT ACCIDENT INVESTIGATION COMMISSION
NEW ZEALAND**

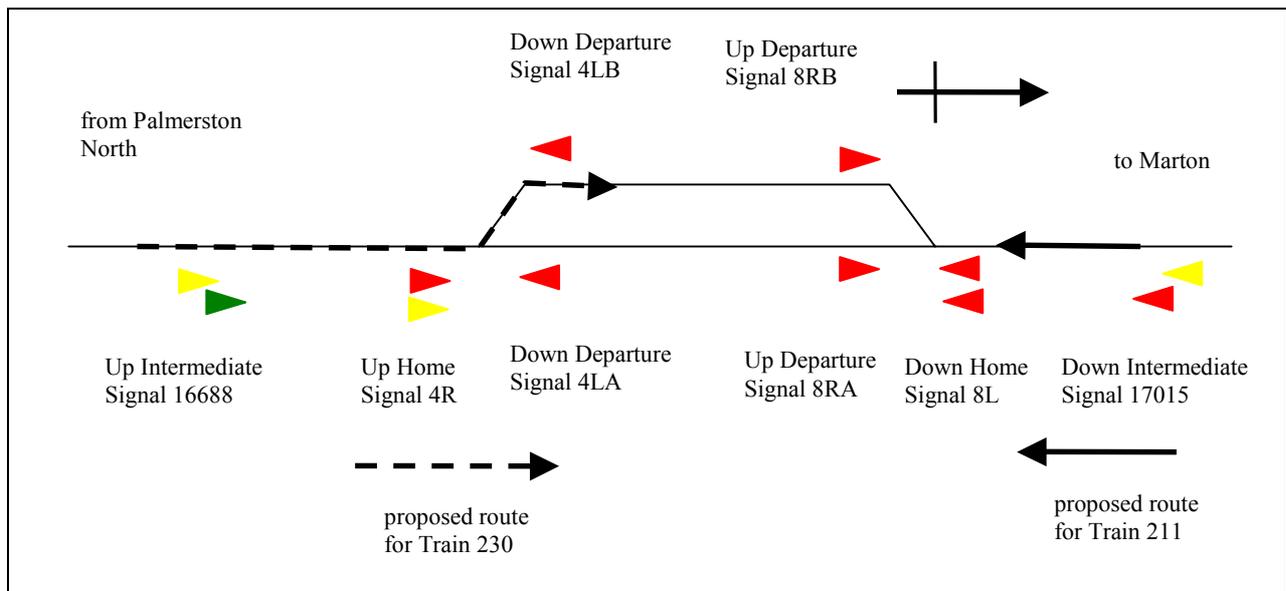
Figure 1
Site diagram of Rangitawa showing routes and signalling indications
 (not to scale)

1.2.4 Signal indications displayed in Figure 1:

For Train 230:

- Up Intermediate Signal 16688 - proceed at normal speed, prepared to reduce to medium speed at next signal (Signal 4R)
- Up Home Signal 4R - proceed at medium speed, prepared to stop at next signal (Signal 8RB)
- Up Departure Signal 8RB - Stop

For Train 211:

- Down Intermediate Signal 17015 - proceed at normal speed, prepared to stop at next signal (Signal 8L)
- Down Home Signal 8L - Stop

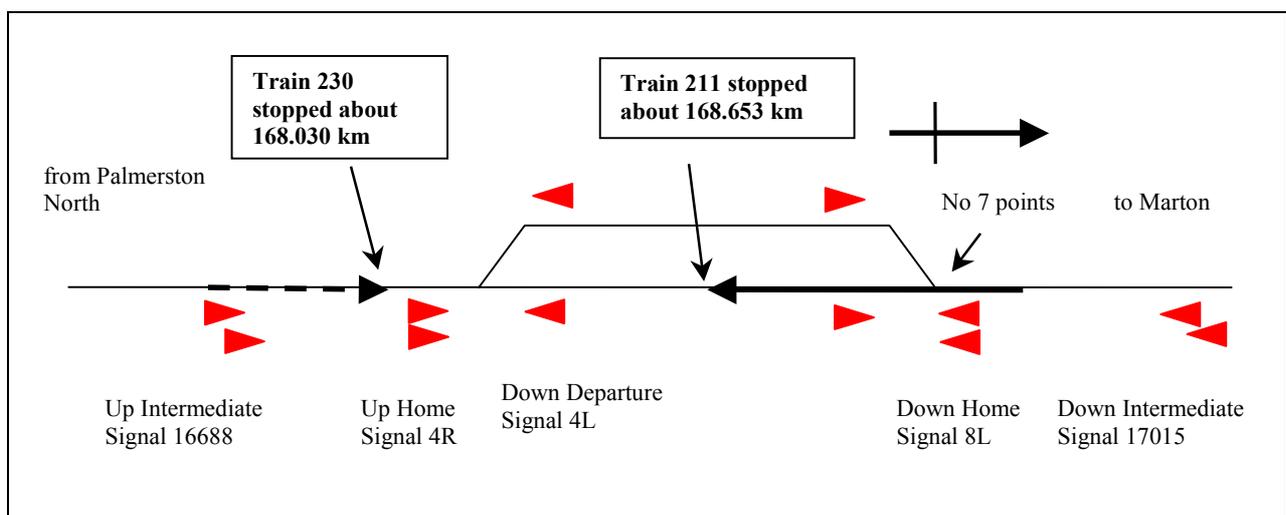
Figure 2
Site diagram of Rangitawa after signal overrun
 (not to scale)

1.2.5 Signal indications displayed in Figure 2:

- Up Home Signal 4R - Stop (reverted)
- Down Home Signal 8L - Stop (unchanged)
- Down departure Signal 4L - Stop (unchanged)

1.2.6 Up Home Signal 4R reverted to Stop in front of Train 230 as soon as Train 211 passed Down Home Signal 8L at Stop.

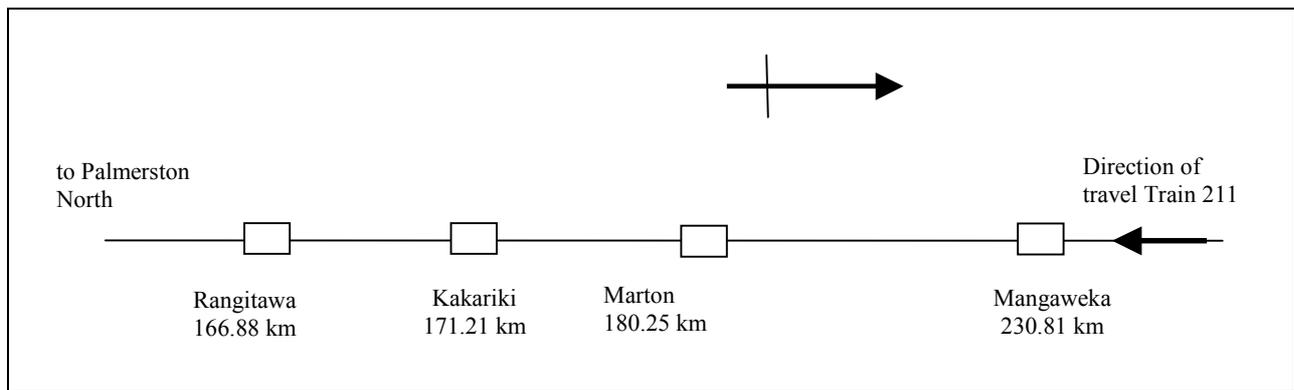
Figure 3
Locations of respective stations (not to scale)

1.5.4 He said he had felt wideawake for most of the return trip but recalled he had fallen asleep near Mangaweka (see Figure 3). He had awakened and corrected the speed of the train. He recalled passing through Marton and he thought he had passed through Kakariki at about 0400, after which he had fallen asleep again. He recalled waking up just after his train had passed the Down Home Signal at Rangitawa and entered the main line.
